Report No: KM008864

| Equipment Type | Fuel Gas Scrubber | Location | Portable, Clairmont Yard |

| RAE Engineering and Inspection Ltd 4810 - 93 Street Edmonton, AB, T6E 5M4 ph: 780-469-2401 fx: 780-468-2422 | | | | Inspection Date: | | 22-Mar-24 | | Ultrasonic Thickness Examination | | | | | | | |

Ultrasonic Thickness Examination

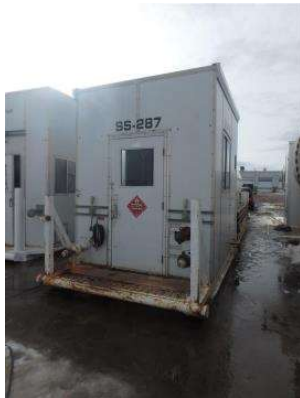
Figure: 1

The building was generally in good condition and well supported. The doors and windows functioned well and were in good condition. The cladding was generally in good condition.

Building

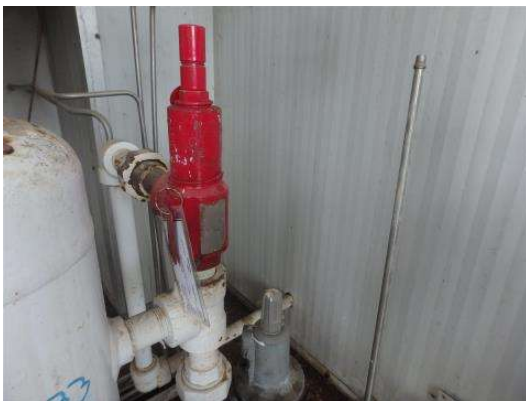
Figure: 2

The PSV was located on associated piping. The vent size was adequate and vent lines were positioned safely. The outlet piping provided positive drainage for the PSV. The PSV is due for service therefore the PSV needs to be serviced and service report needs to be sent to RAE Engineering and Inspection Ltd. for data entry.

PSV

1. The PSV is due for service therefore the PSV needs to be serviced and service report needs to be sent to RAE Engineering and Inspection Ltd. for data entry.

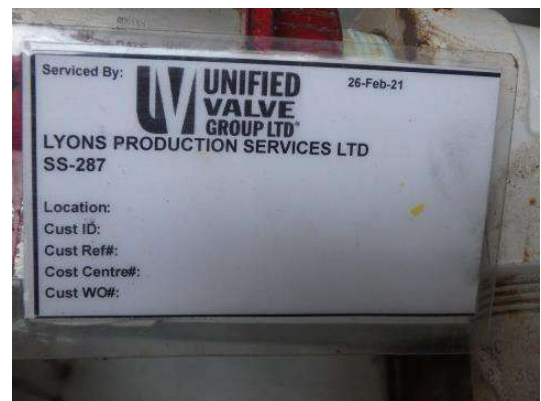
Figure: 3

PSV Service Tag - Front

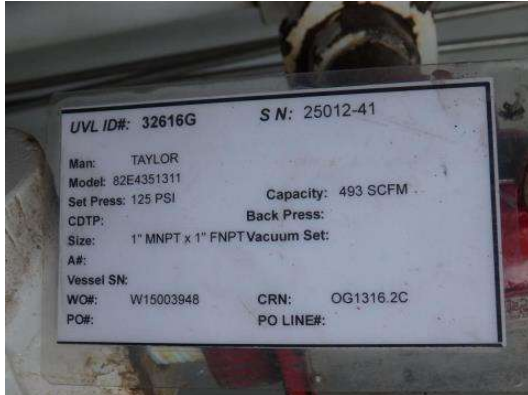
Figure: 4

PSV Service Tag - Back

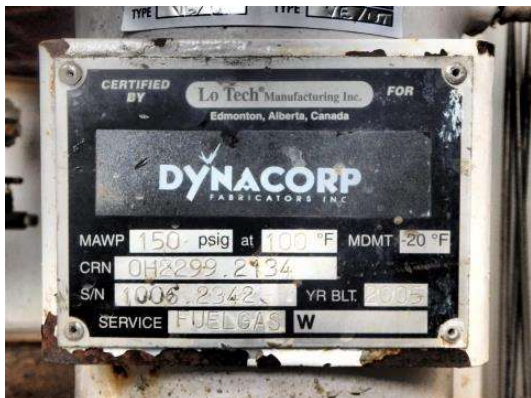
Figure: 5

Nameplate

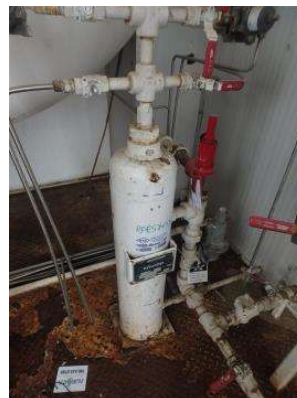
Figure: 6

The vessel was identified per RAE-number and serial number stamped on the nameplate of the vessel. The top head, shell, nozzles and gauges appeared to be in good condition. There was no stress evident on piping or nozzle connections. There was no evidence of leakage at the piping connections. There was no damage or distortion evident on the vessel surface. The vessel was not insulated it was painted and generally in good condition. There were no structural attachments to the vessel. The vessel was adequately supported.

Vessel Overview

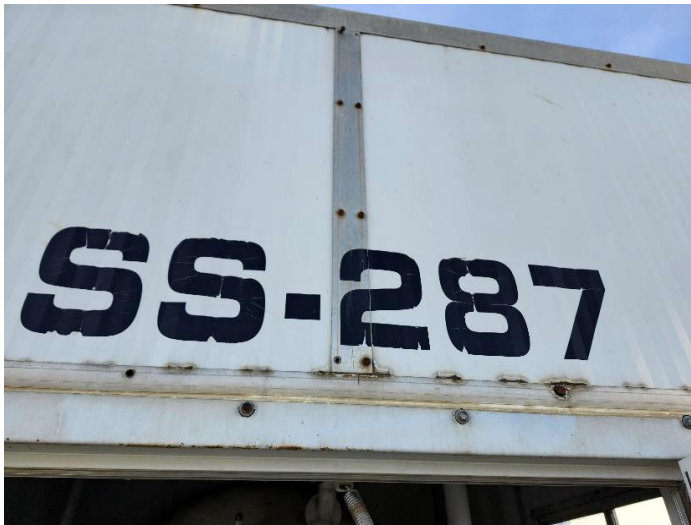
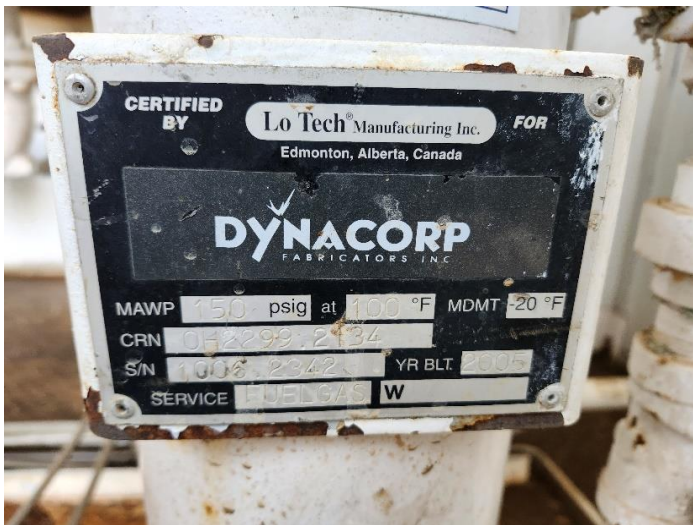
View of Nameplate & Unit Number

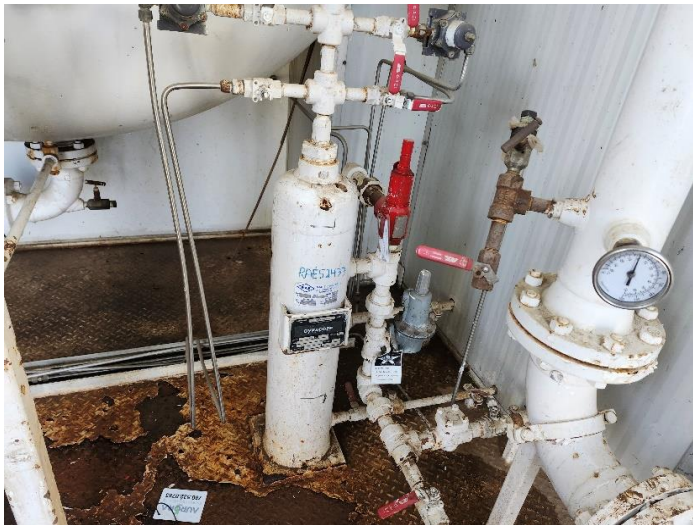
Overall View of Equipment

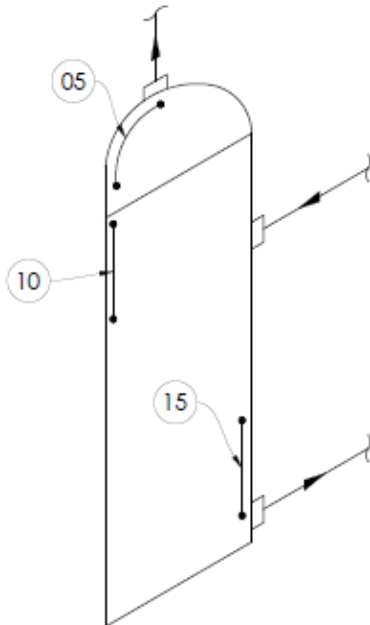
EQUIPMENT CML ISO DRAWING

Results: The measurements obtained from the inspection locations show the thickness of all of the components inspected to be consistent. There were no signs of wall thinning, internal corrosion, erosion, laminations or inclusions at the time of inspection.
