Client	Tara Energy Services	Inspection Date	Mar 14, 2024		
Prov. Reg. #	AB 0543257	Inspection Type	VE / VI / PSV / UT		
Equipment Type	Horizontal Separator	Location	Portable, Clairmont Yard		
Tag/Equip.		LSD	AB		
Status	In Service	Downhole LSD			
Manufacturer	Dynacorp Fabricators Inc	Area	Grande Prairie		
Serial Number	2J50594	Year Built	2005		
CRN #	T2246.213	Service	Sour		
Comp/Unit Id	SS-287	Manway	Yes		
Nat.Board #		Coating			
Interim Insp'n		Interim Type			
Next Thorough Insp	2027	Next Insp Type	VE / VI / PSV / UT		
Length		Height			
Volume	658 ft³	Client Reference			
Owner	Tara Energy Services	RT	1	HT	YES
Foreman	Jeff Warr	RAE Job No.	PR0002839		
ABSA	Plant: H Vessel: P Process: W Special: W	ASME	Sec. VIII div. 1		
History Log	AB-25 - entered March 10, 2021 PSV Service Report - dated February 25, 2021 - entered March 10, 2021 Vessel previously owned by Lyon's Production - bought by Tara as per Oct.2023 ESR - entered November 30, 2023 Inspection Report Complete - Inspection Date: 2024-March-14 Inspection Type: VE/VI/PSV/UT

Component	Shell				
MAWP	285.0 PSI @ 100 °F		MDMT	-49 °F @ 285.0 PSI	
Material	SA-516-70N		Material Thickness	0.625 in	
Diameter	78 in		Length	216 in	
Corr

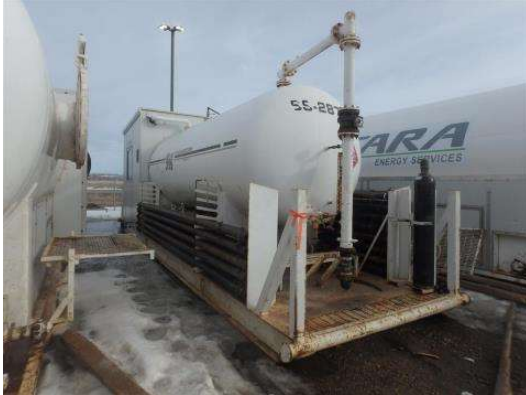
Figure: 1

Unit Overview

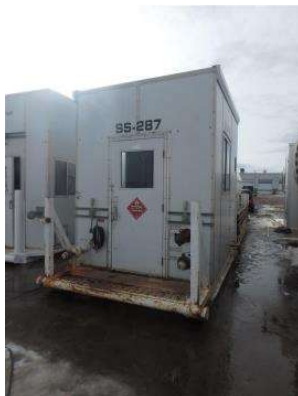
Figure: 2

The building is generally in good condition and well supported. The floor was clean and was steel plate. The building is well lit, the windows were in good condition and the doors function well. There were no combustibles in the building. There was generally good access to the equipment in the building.

Building

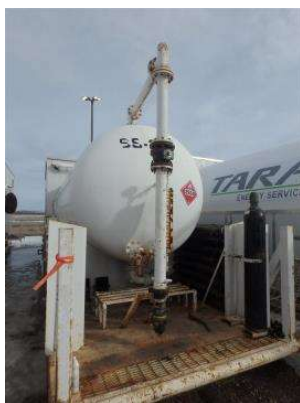
Figure: 3

There is no damage, distortion or stress evident on piping. The piping is painted. There was no significant surface corrosion on the piping. The piping is well supported and anchored.

Inlet Piping

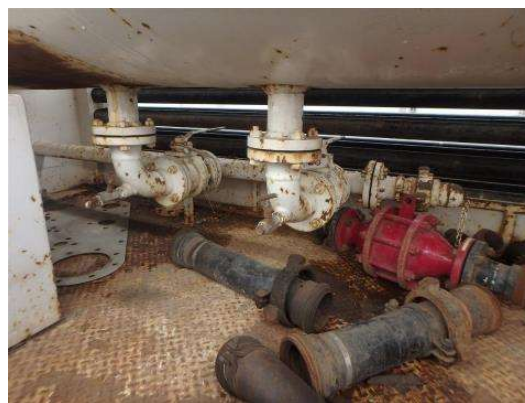
Figure: 4

Drain Piping 1

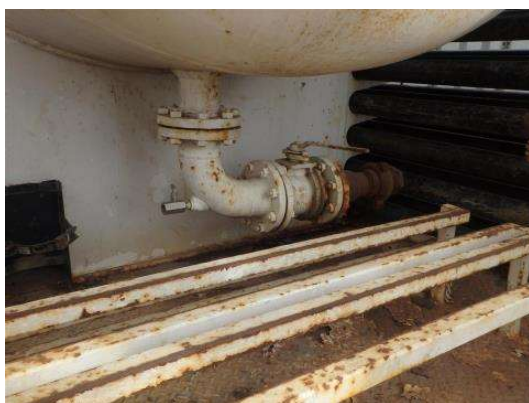
Figure: 5

Drain Piping 2

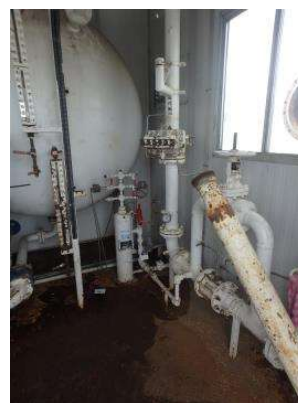
Figure: 6

Meter Run Piping

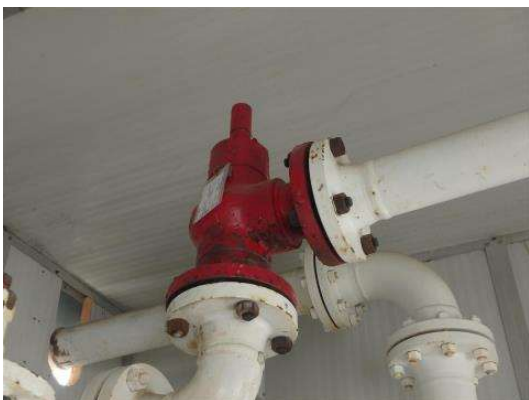
Figure: 7

The PSV was in good condition, and was mounted in the vertical position. The vent size was adequate and vent lines were positioned safely. The outlet piping provided positive drainage for the PSV. The PSV is due for service therefore the PSV needs to be serviced and service report needs to be sent to RAE Engineering and Inspection Ltd. for data entry.

PSV

2. The PSV is due for service therefore the PSV needs to be serviced and service report needs to be sent to RAE Engineering and Inspection Ltd. for data entry.

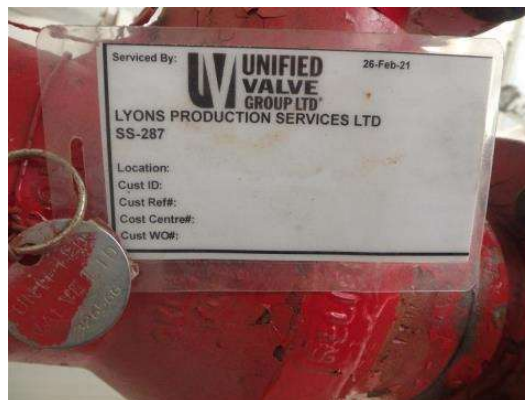
Figure: 8

PSV Service Tag - Front

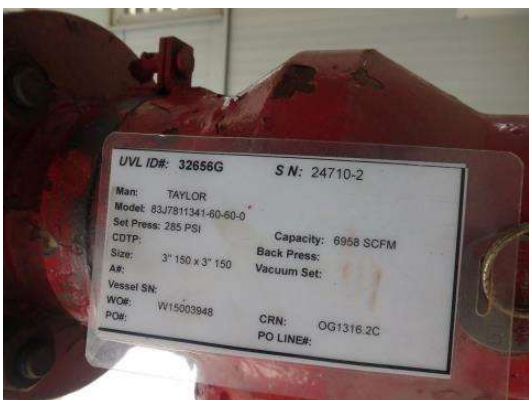
Figure: 9

PSV Service Tag - Back

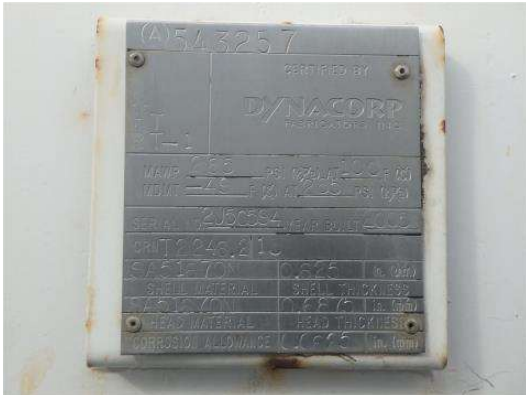
Figure: 10

The vessel is partially located inside a building. The nameplate was legible and securely mounted to the vessel. The head and shell appeared to be in serviceable condition. The vessel is not insulated. The vessel was fully painted and the paint was in serviceable condition. There was scattered corrosion visible on the vessel surfaces. There was no damage, distortion, or stress evident on piping connections. The vessel was adequately supported. There are no structural attachments on vessel.

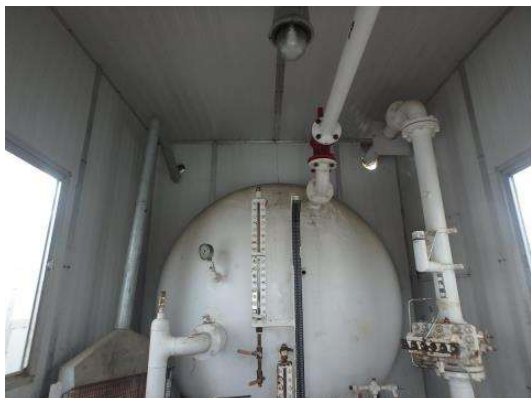
Figure: 12

Vessel Overview 2

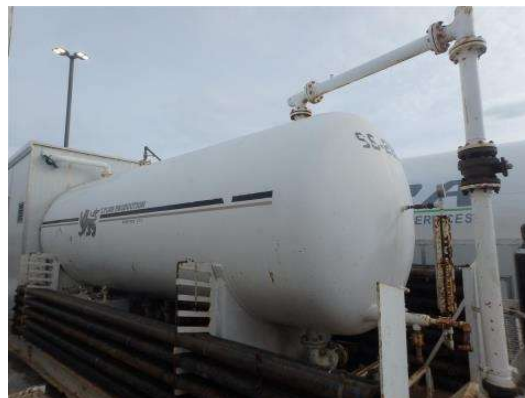
Figure: 13

Vessel Overview 3

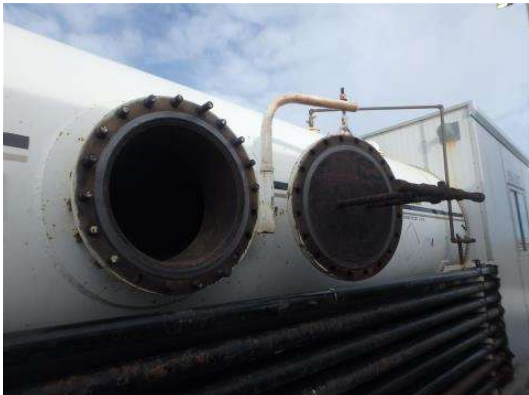
Figure: 14

Manway

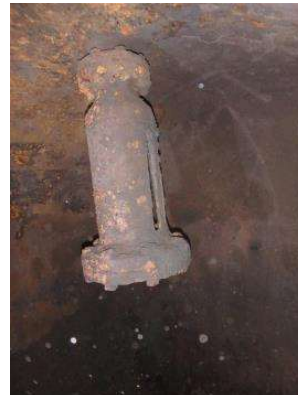
Figure: 15

Inlet Nozzle

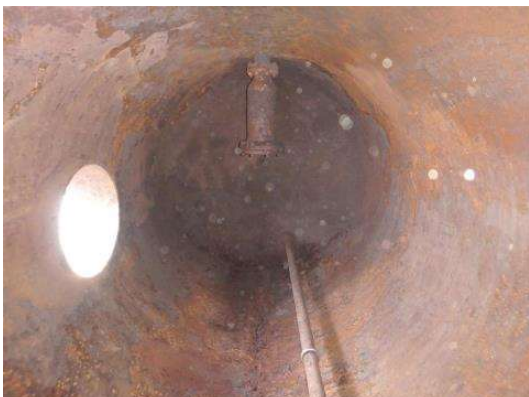
Figure: 16

Inlet End Overview

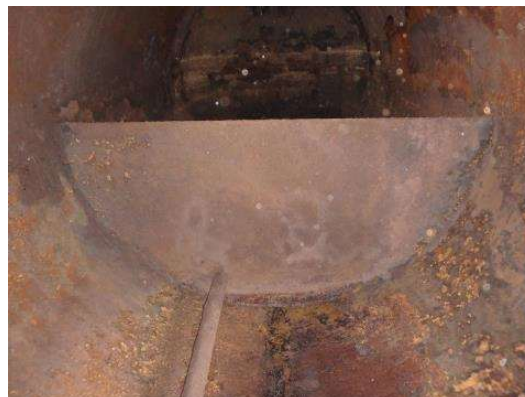
Figure: 17

Weir

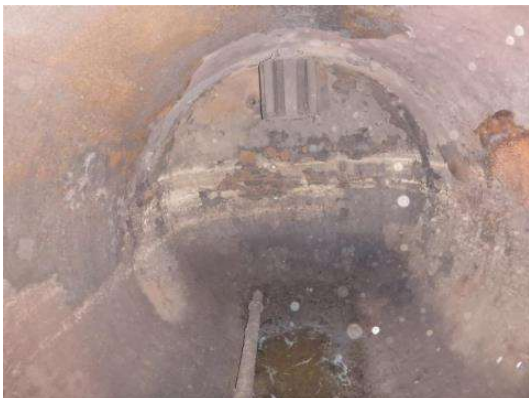
Figure: 18

Outlet End Overview

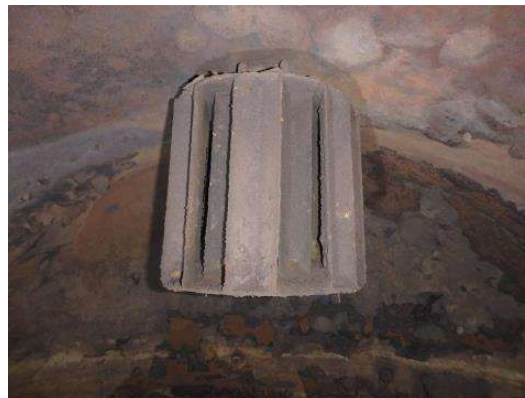
Figure: 19

Demister

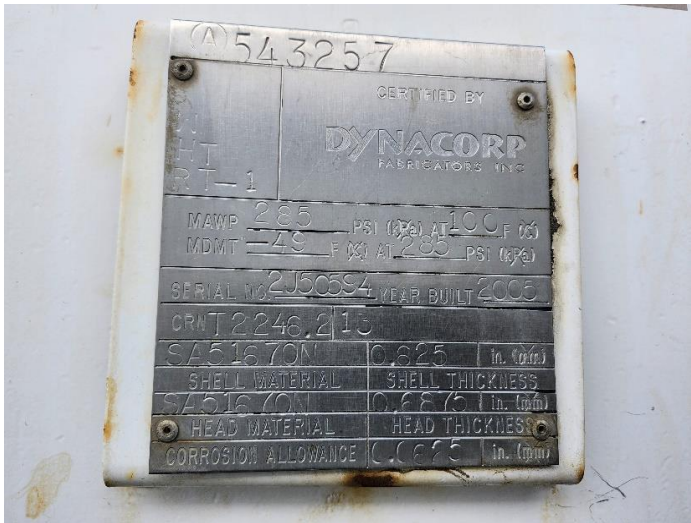
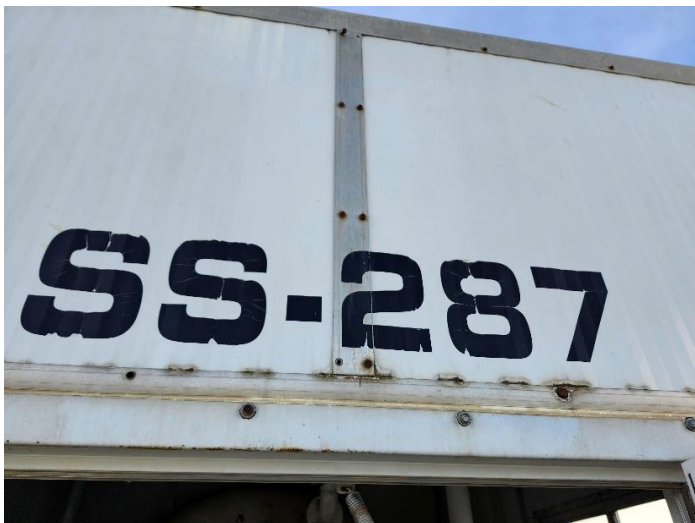
View of Nameplate & Unit Number

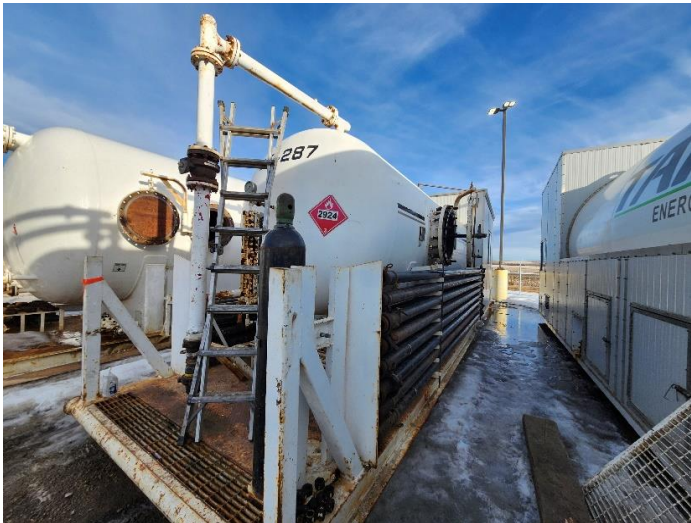
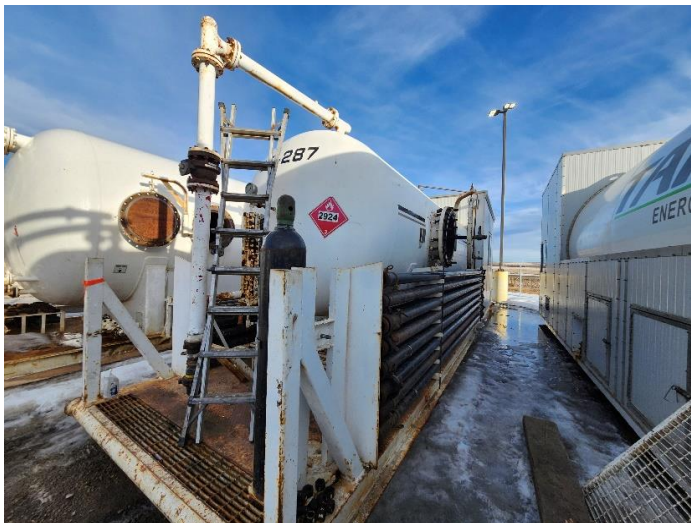
Overall View of Equipment

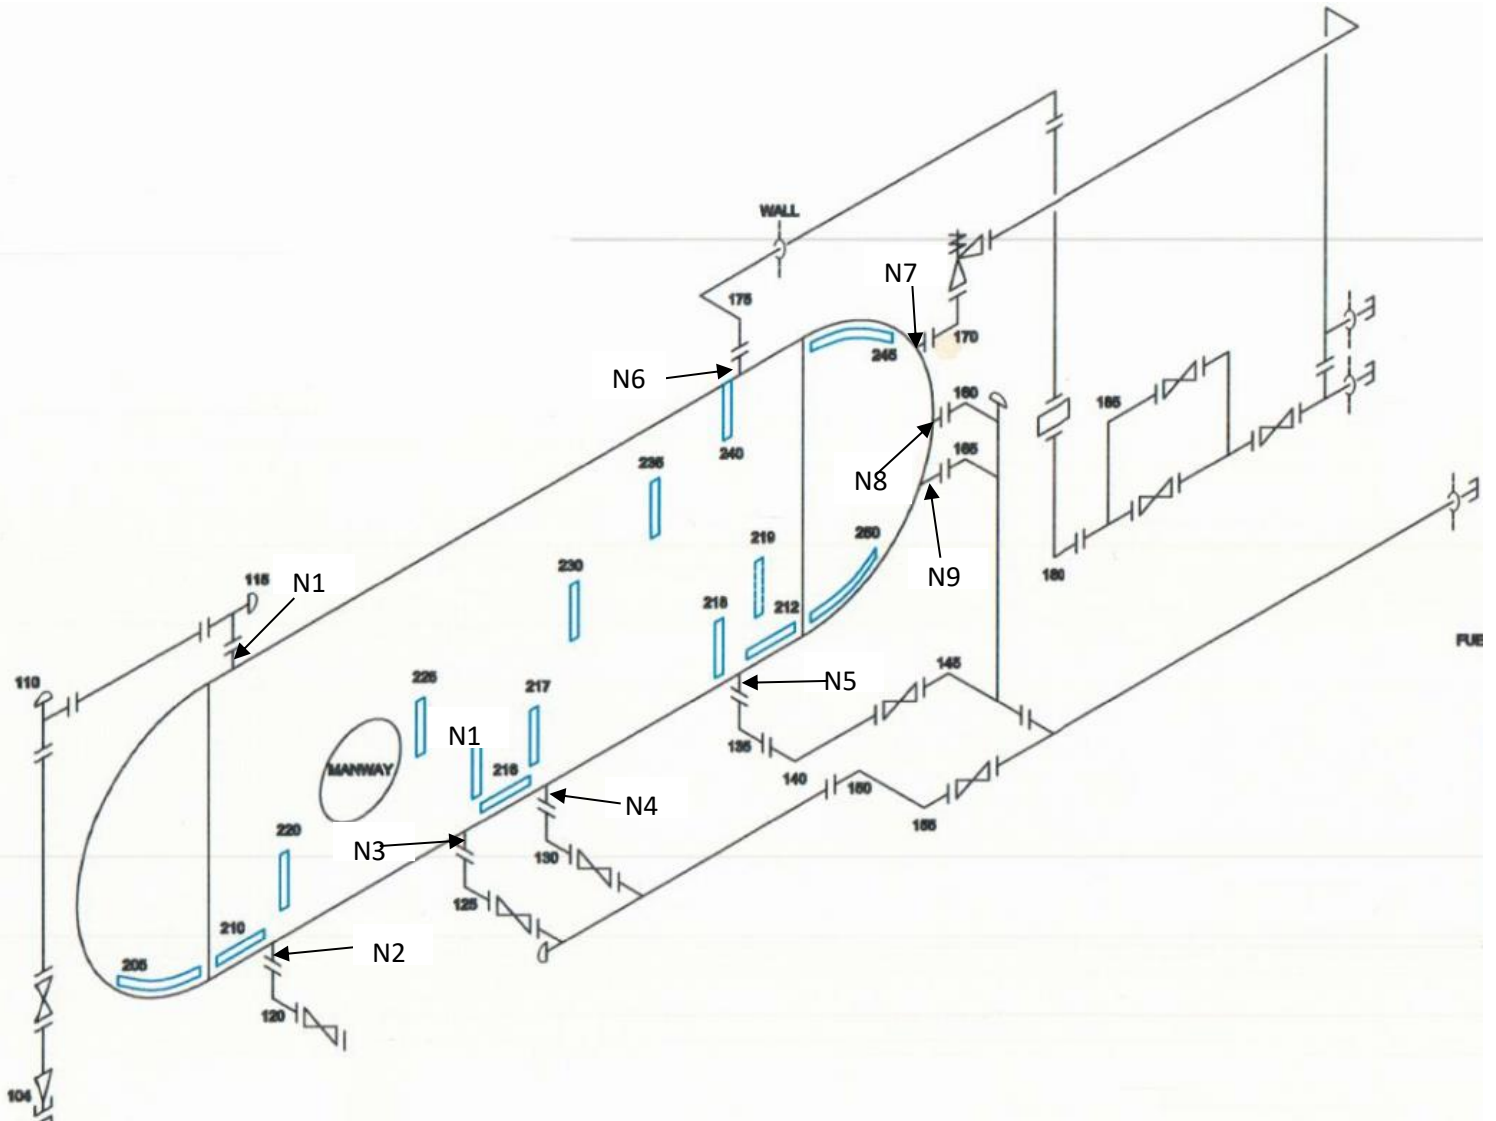
EQUIPMENT CML ISO DRAWING

At the time of inspection TML210 noted to be below minimum nominal thickness and below corrosion allowance by 0.4mm, therefore this needs to be addressed.

Results: The measurements obtained from the inspection locations show the thickness of all the components inspected to be at or around nominal with the exceptions of **CML 210, 215, 216, 217, 220, 235, 240, N1 & N2** which were found to be lower than nominal minus ASME tolerance. (Refer to flag summary page)

1. At the time of inspection TML210 noted to be below minimum nominal thickness and below corrosion allowance by 0.4mm, therefore this needs to address. Option are to have the bottom section of vessel coated as soon as possible.
