Fueled Pump Package Inspection Report

Provided by Surepoint

October 30, 2024

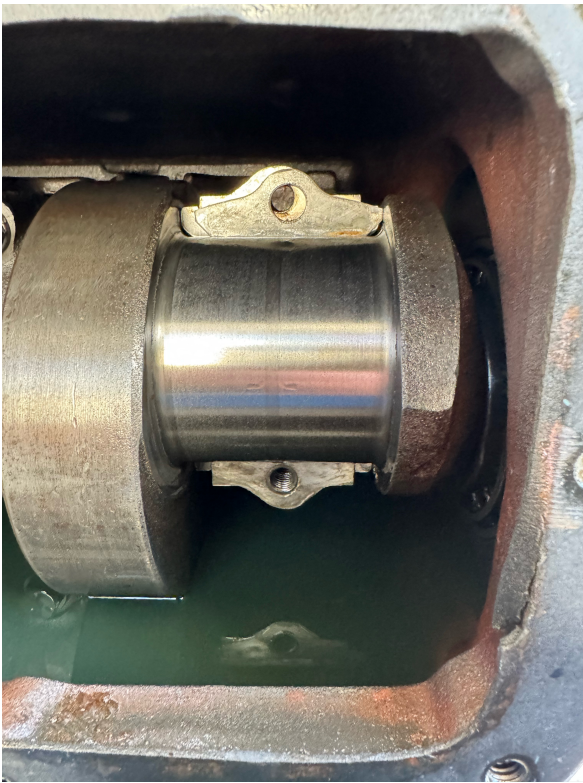
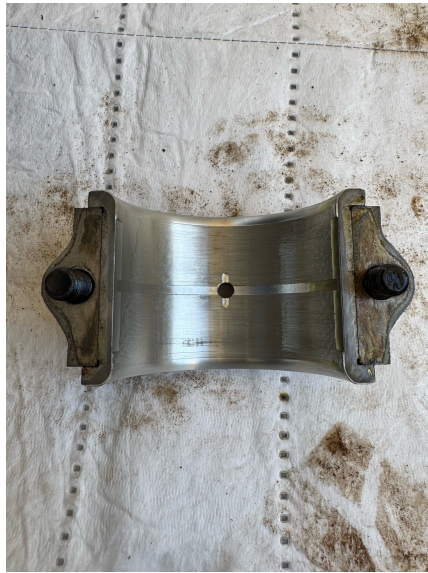
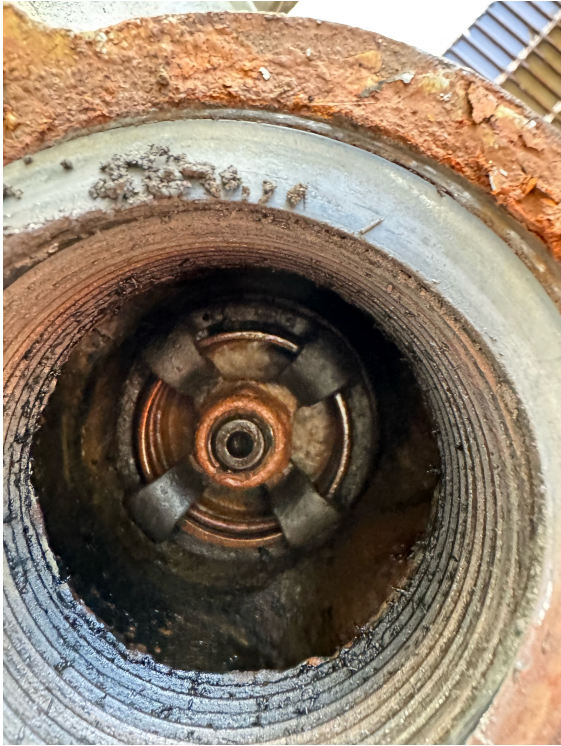
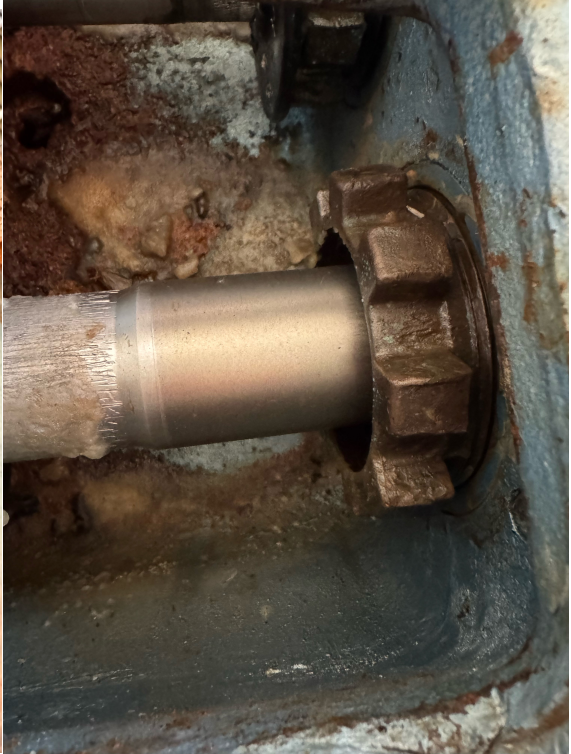
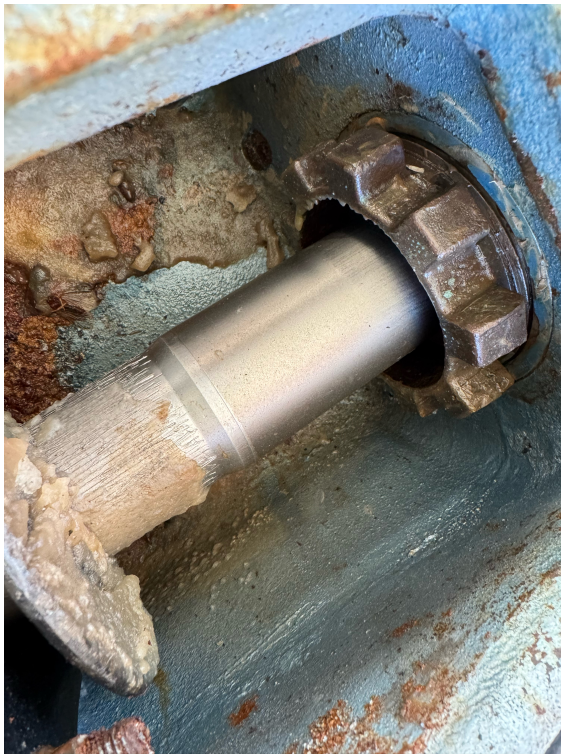
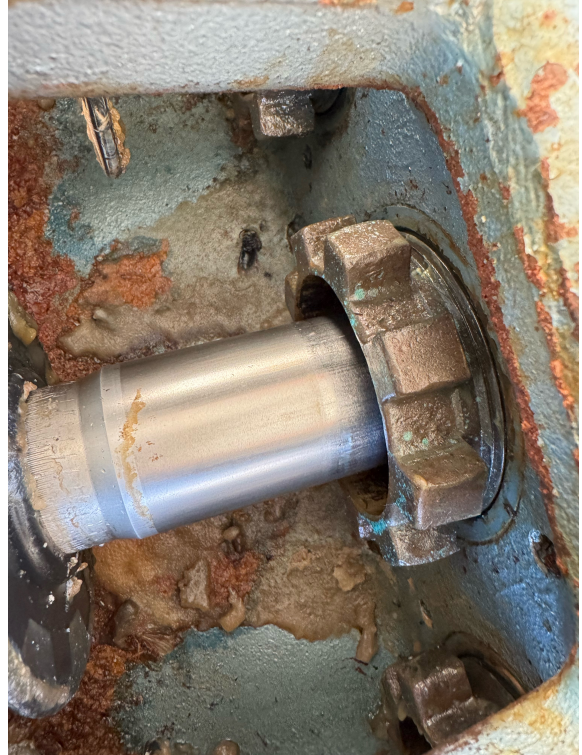
1. Power End Inspection

- 1.1 – Lube oil is clean
- 1.2 - Crankshaft condition is good
- 1.3 - End play is good
- 1.4 - Connrod bearings are good
