**PRESSURE VESSEL  
VISUAL INSPECTION  
REPORT**

Report #: **156732-MD-65**  
Inspect Date: 03/21/2012  
Page: 1 of 24  
Insp. Co. Job #: 156732

Insp. Comp: Matrix Inspection District: Grande Prairie - North Field: Firebird  
Location: 14-01-098-08W6 Unit / Skid #: 16718 LSD: 14-01-098-08W6  
Jurisdiction #: A2738569 Equip Tag #: HT Serial #: HT-6605  
CRN #: K.5298.2 Nat'l Bd #: N/A Year Built: 1991  
Manufacturer: Larsen & D'Amico Equipment Description: Other: Horizontal Treater  
Status: In Service - Equip. Type: Vessel: Treater Service: Sweet  
MAWP Shell: 50 Psi @ 200 °F Volume: 45 m³ Code Stamp: ☒ Y ☐ N  
MAWP Tube: @ Height/Length: 30 Ft. Insulated: ☒ Y ☐ N  
MDMT: 32 °F RT: RT-3 Size/Diameter.: 96 in. O.D. PWHT: ☐ Y ☒ N  
Support Saddle Vessel on Original CNRL Inventory List: ☐ Y ☒ N Manway: ☒ Y ☐ N  
C.A.: 1.6 mm Coated: N/A Clad: N/A J.E.: 0.85 Remote Access: ☒ - Winter Road

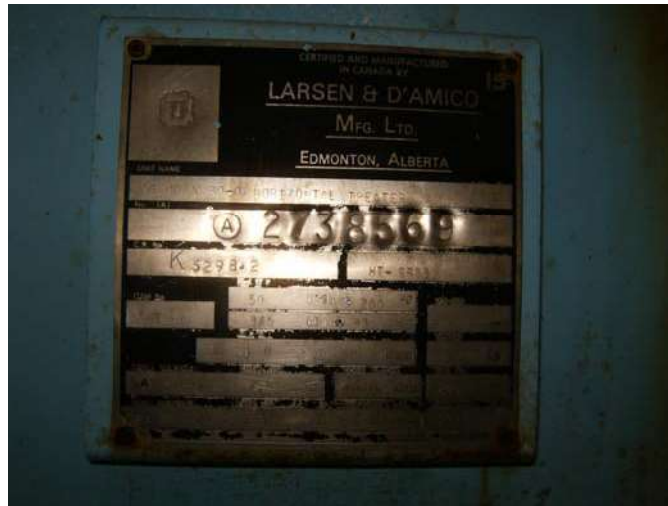
01 nameplate

| Item | N/A | Condition | Comment<br>(Check Status Bar or Press F1 for Help) | NCR | Action Item<br>Integrity | Action Item<br>Maintenance |
|---|---|---|---|---|---|---|
| Nameplate | <input type="checkbox"/> | Accept | Legible and firmly affixed | <input type="checkbox"/> | <input type="checkbox"/> | <input type="checkbox"/> |

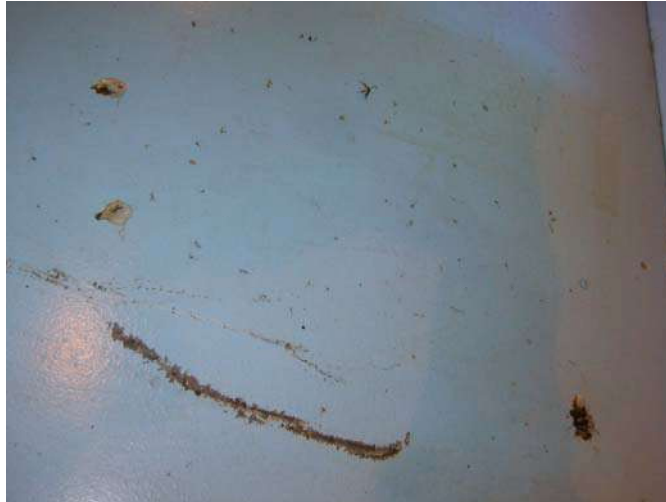
| Item | N/A | Condition | Comment<br>(Check Status Bar or Press F1 for Help) | NCR | Action Item<br>Integrity | Action Item<br>Maintenance |
|---|---|---|---|---|---|---|
| Metal Surfaces (Paint) | <input type="checkbox"/> | Accept | Chipped and flaking exposing base metal | <input type="checkbox"/> | <input type="checkbox"/> | <input checked="" type="checkbox"/> |

The coating is chipped exposing the base metal to minor surface corrosion throughout the Drum

04 coating deterioration

Clean and touch up the coating to aid in the protection against corrosion

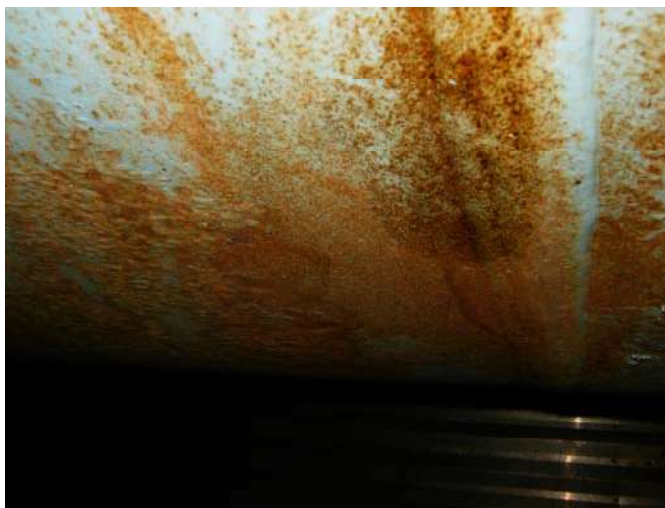
| Item | N/A | Condition | Comment<br>(Check Status Bar or Press F1 for Help) | NCR | Action Item<br>Integrity | Action Item<br>Maintenance |
|---|---|---|---|---|---|---|
| Shell Heads & Nozzles | <input type="checkbox"/> | Accept | Minor surface corrosion noted throughout | <input type="checkbox"/> | <input type="checkbox"/> | <input type="checkbox"/> |

05 surface corrosion

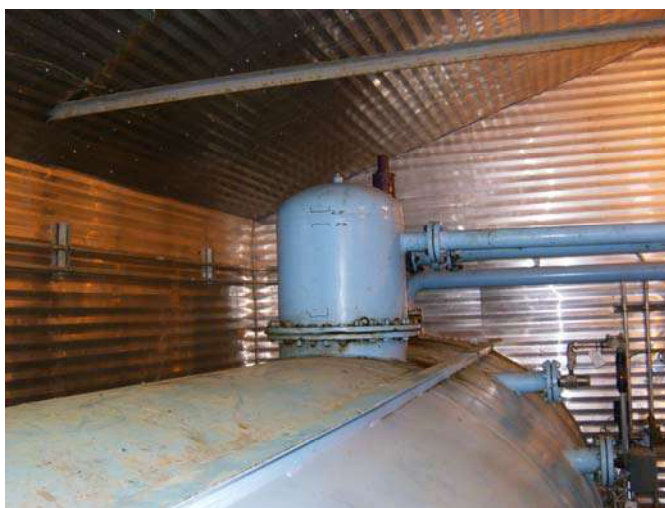
Dirt, dust and bird turds noted on the top section of the treater

06 dirt, dust & bird turds

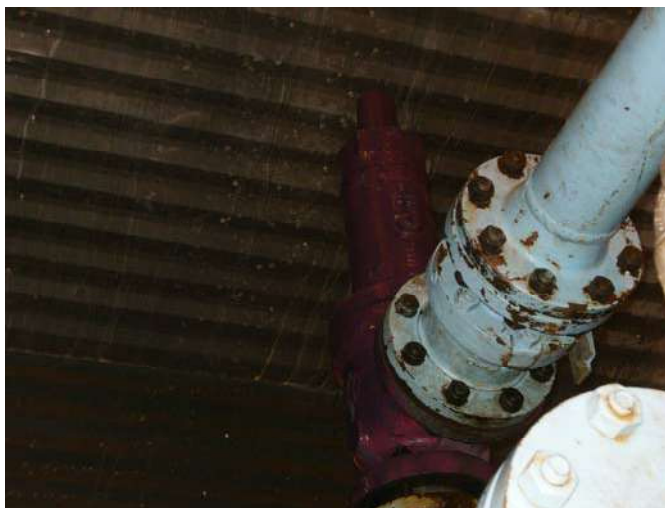
There is a valve on both sides of the PSV without carseals

07 PSV overview

Carseal the inlet and outlet PSV valves to ensure they are not accidentally closed

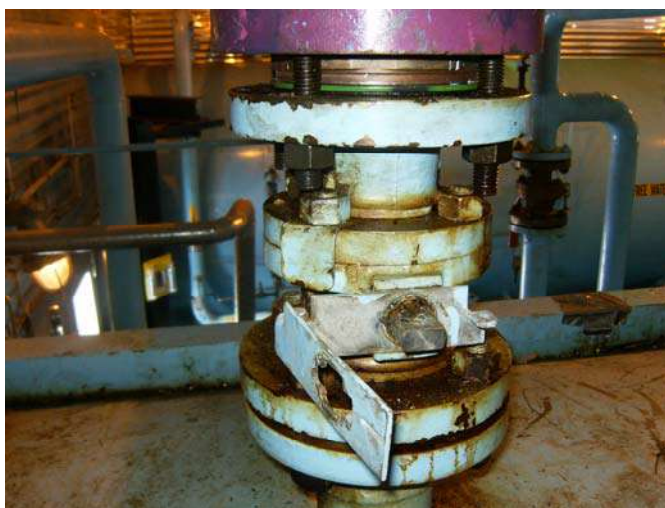
| Item | N/A | Condition | Comment<br>(Check Status Bar or Press F1 for Help) | NCR | Action Item<br>Integrity | Action Item<br>Maintenance |
|---|---|---|---|---|---|---|
| PSV | <input type="checkbox"/> | Reject | Carseal missing on discharge/ suction valves | <input type="checkbox"/> | <input type="checkbox"/> | <input checked="" type="checkbox"/> |

There is a valve on both sides of the PSV without carseals

08 missing carseal

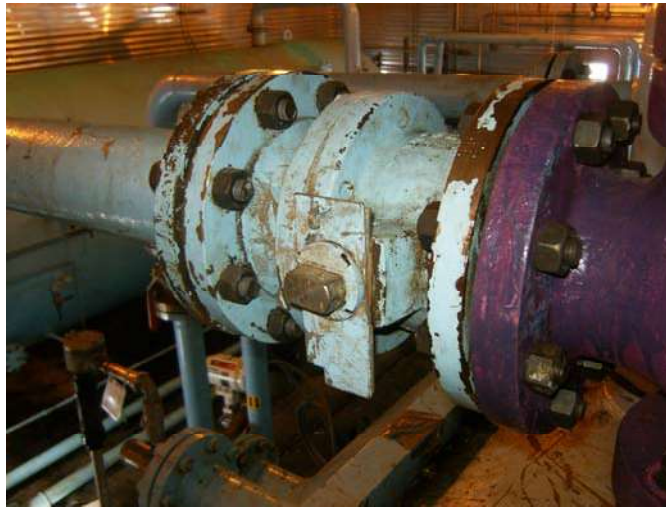
09 missing carseal

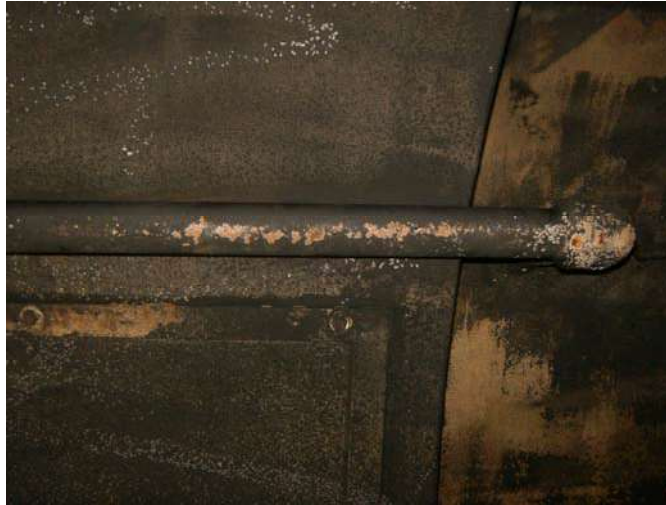
10 blisters & flash corrosion

Consider touch up coating repairs in the cold end  
Consider recoating the hot section of the treater  
Replace all anodes

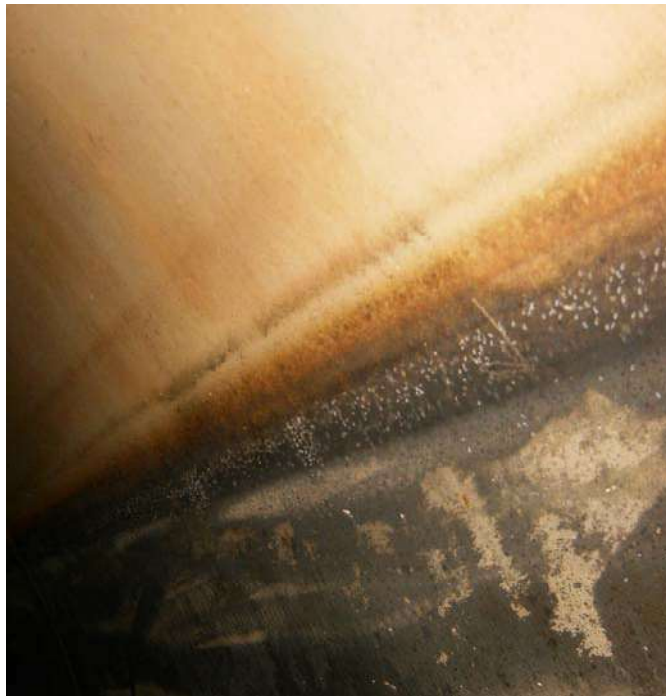
Blistering and coating failure noted in the liquid to vapour section, on the roof (12 o'clock) position, heads, shells and on the manway

11 blisters in liquid to vapour section

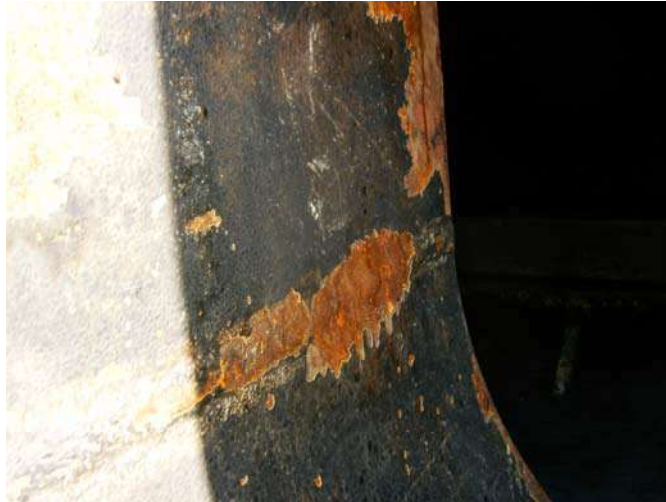
| Item | N/A | Condition | Comment<br>(Check Status Bar or Press F1 for Help) | NCR | Action Item<br>Integrity | Action Item<br>Maintenance |
|---|---|---|---|---|---|---|
| Manway | <input type="checkbox"/> | Accept | Coating deterioration in manway | <input type="checkbox"/> | <input type="checkbox"/> | <input type="checkbox"/> |

**13 coating deterioration on manway**

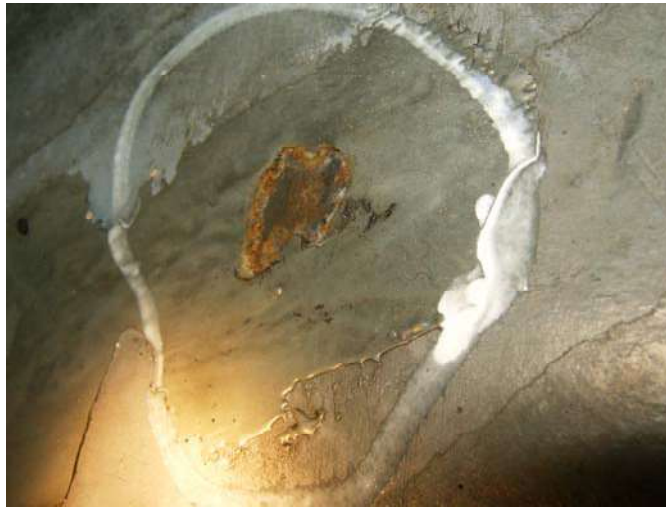
There is an existing coating repair that has deteriorated and flaked exposing the base metal

14 previous coating repair damage

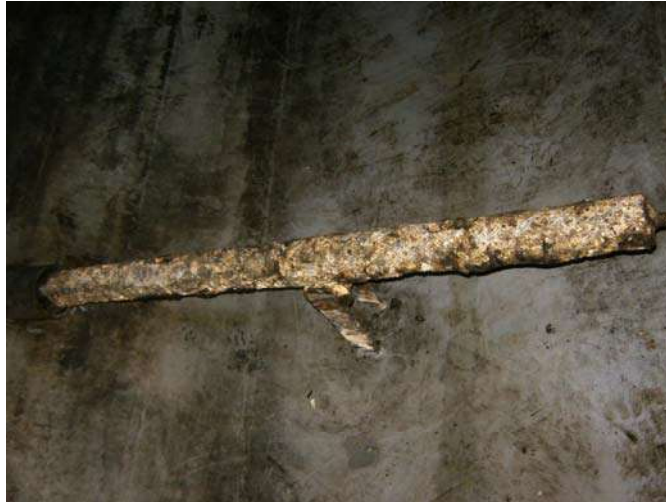
The anodes are eroded approximately 65%

15 eroded anode

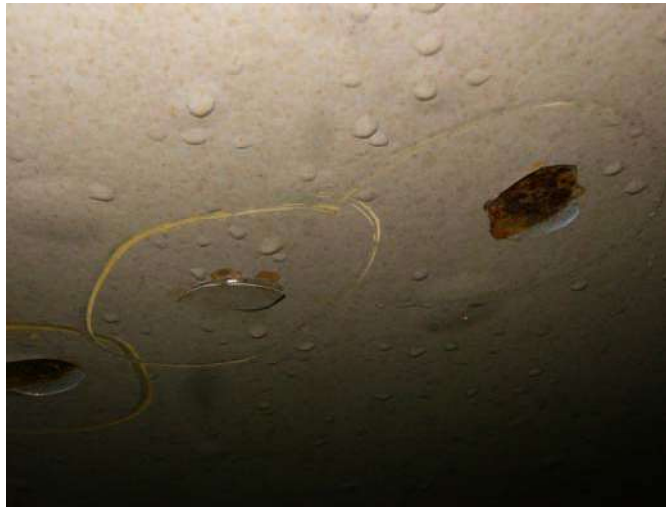
**16 roof coating failure**

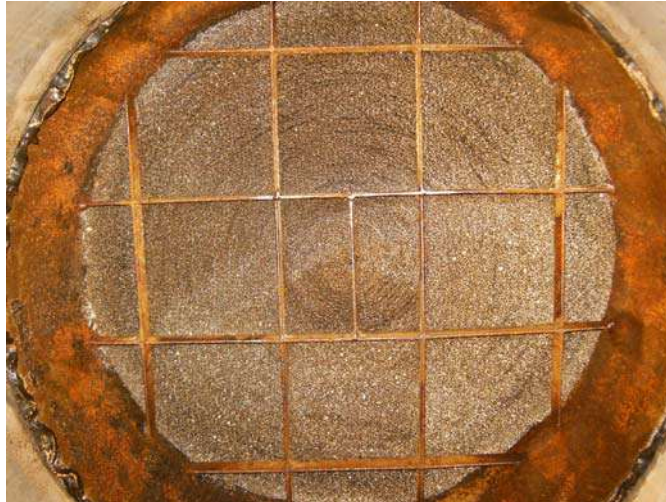
The demister pad was not removed because it is clean and free of any heavy product build-up

**19 demister overview**

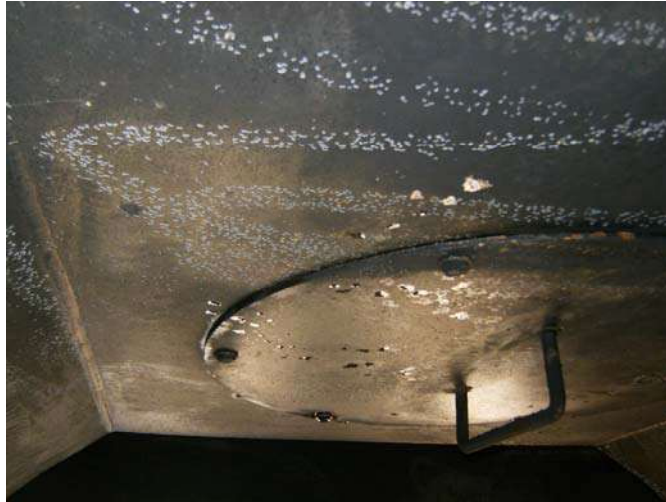
**21 popped blisters from wash**

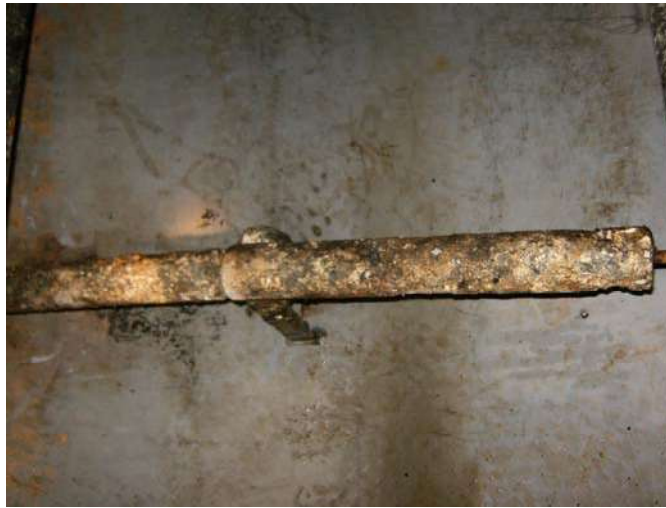
Anodes are approximately 60% eroded

**24 anode cold section**

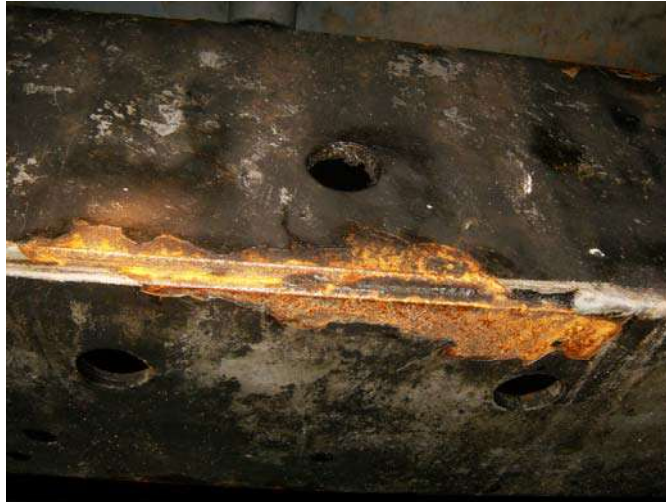
**25 flash corrosion on base metal**

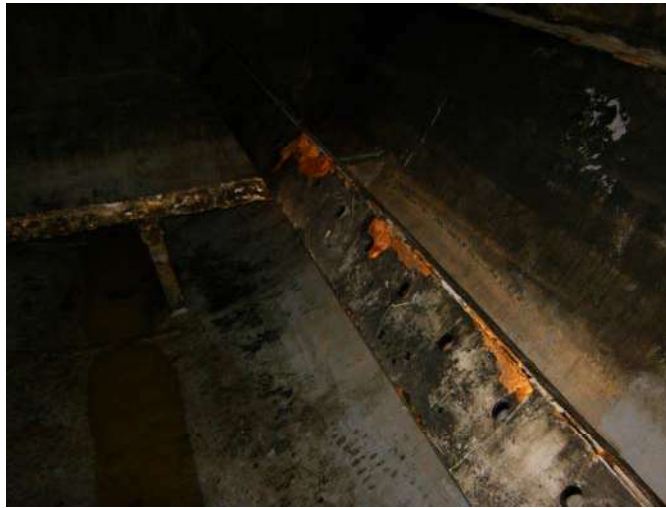
Coating deterioration noted on the attachment welds and structural steel, and on the manway.

**26 attachments coating deterioration**

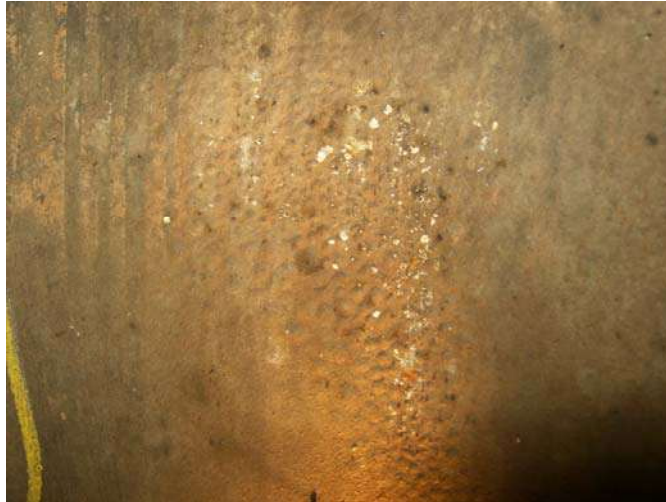
**27 blistering**

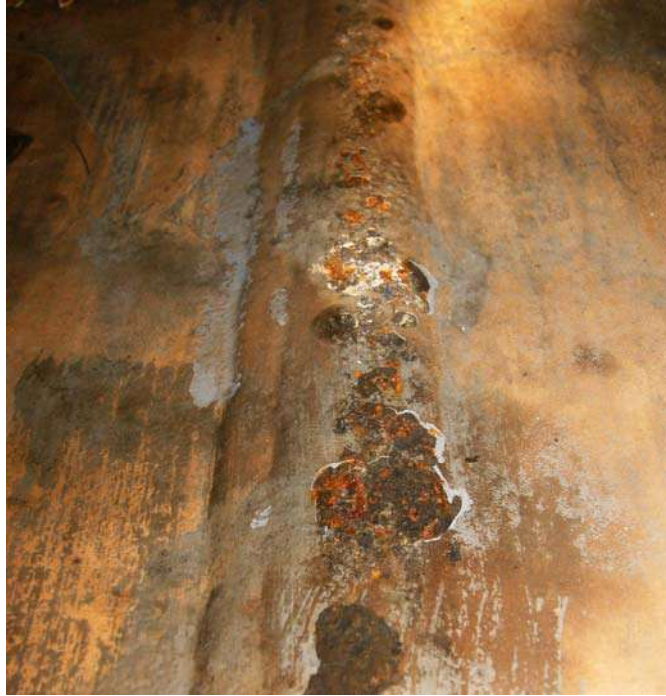
28 north head to shell circ seam

There is an 15" long section where the coating has failed on the North Head to Shell circumferential, exposing the base metal with flash corrosion noted - no pitting

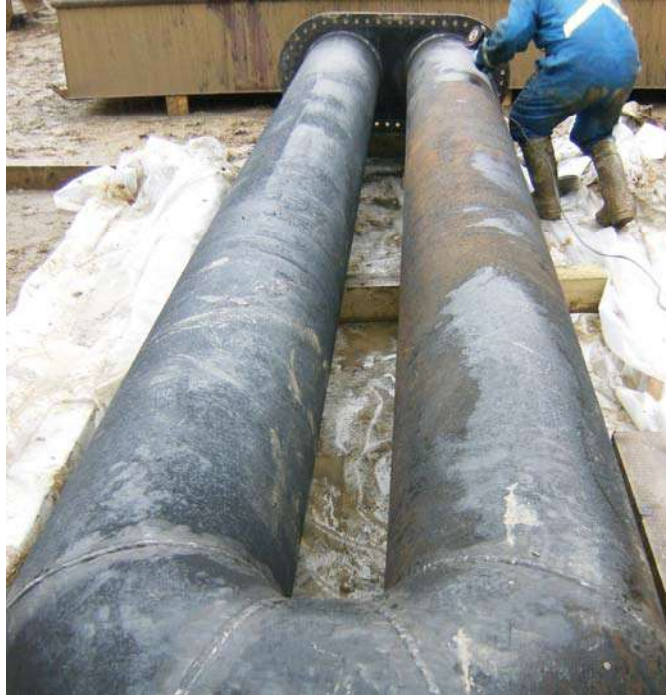
Minor pitting noted on the miter bend elbow, with a maximum depth recorded of 0.027"

30 firetube miter bend
