GENERAL INSPECTION FORM						
District: Northern Plains			Skid No. : 16718			
Facility: FireBird Oil Battery			Location (LSD) Surface: 14-01-98-08-W6M			
Vessel Name & Equipment Number: Free Water Knock Out						
Orientation: Horizontal <input checked="" type="checkbox"/> or Vertical <input type="checkbox"/>			Location (LSD) Downhole:			
Status: In Service <input checked="" type="checkbox"/> or Out of Service (blinded / fully isolated) <input type="checkbox"/>			Commissioning Inspection <input type="checkbox"/> or Regulatory Inspection <input checked="" type="checkbox"/>			
PRESSURE VESSEL NAMEPLATE DATA						
"A" or "G" or "S" (Sask.) or BC Registration Number.			CRN Number			
A 2706762			K-5656.2			
Vessel serial number: 91-6066-0			Size (diameter x length- estimate if necessary): 96 in X 30 ft S/S			
Shell thickness: 9.5 mm			Shell material: SA-516-70N			
Head thickness: 9.2 mm			Head material: SA-516-70N

Photo Table

GENERAL NDE REPORT

Job Description: To performed Mag Particle Inspection on Free Water KO A2706762 shell metal build up and replacement nozzle welds.

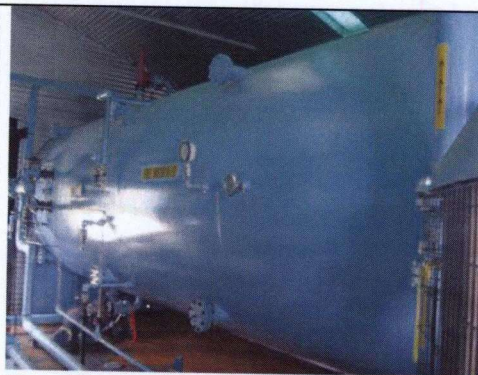
Vessel External Over View

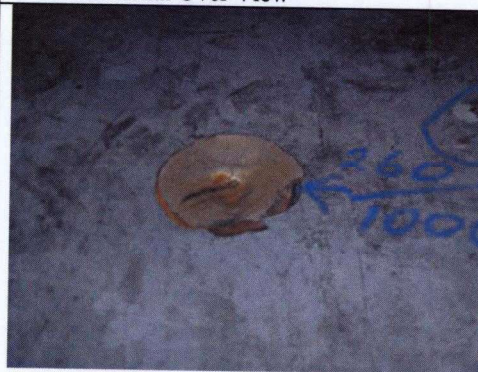
Other Observations					
<p>Recommendations: See repairs required. Summary: This vessel is in good condition, visual external and internal carried out – pitting detected to .140 inches deep on shell and 3 inch drain nozzle corroded to 70% wall loss. Repairs carried out by NATCO – shell build up and nozzle replaced.</p> <p style="text-align: right; color: blue; font-size: 1.2em;">MOC# 19498</p>					
1- Vessel is fit to return back into service. An internal inspection should be conducted within 3 years or sooner.

Lower Shell 260/1000 pitting

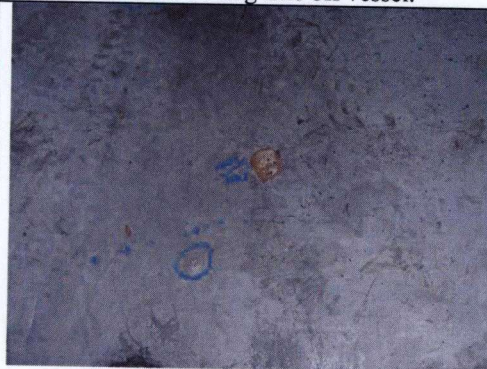
Lower shell 140/1000 pit and 130/1000 pit

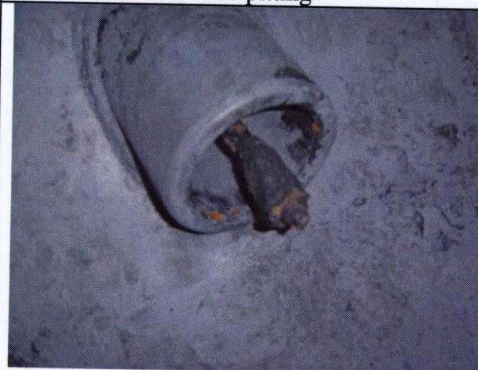
Consumed Anode

** MUST IMPLEMENT PLAN TO MONITOR ANODE CONSUMPTION
 IF ANODES CONSUMED THEN INTERNAL MAY NEED TO BE COMPLETED PRIOR TO YR 3
 KR.*

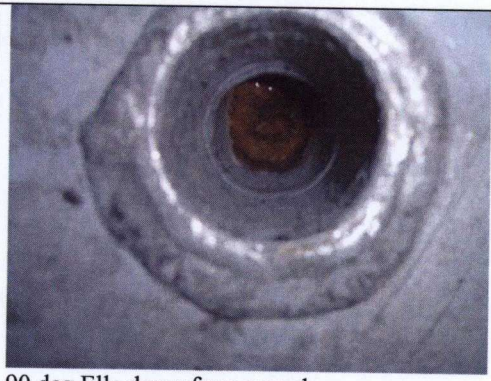
90 deg Elle down from vessel

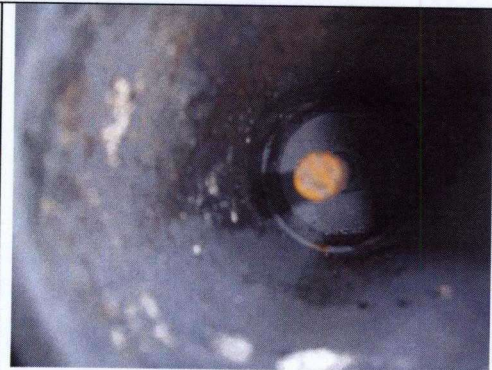
Consumed anode.

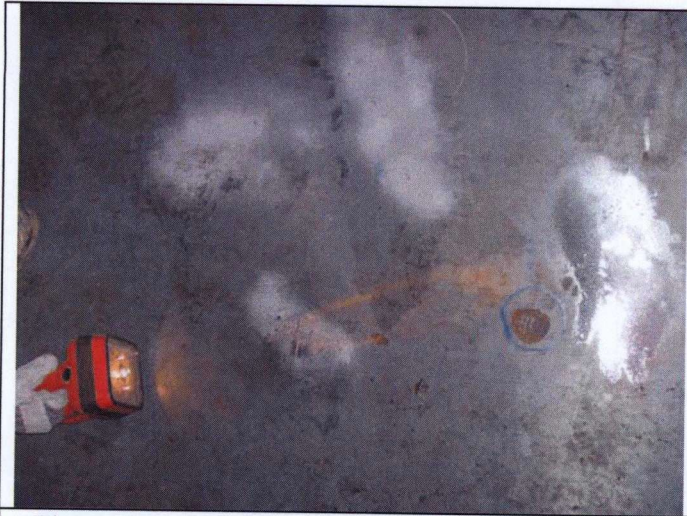
No cracking found during MT testing of shell and nozzle replacement weld repairs.

Five repairs tested, shell section 2 south of manway

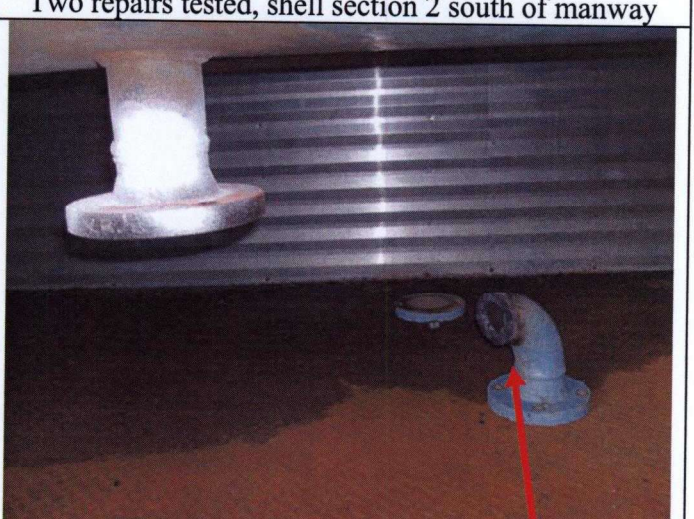
Flange Installation, After removed Nozzle

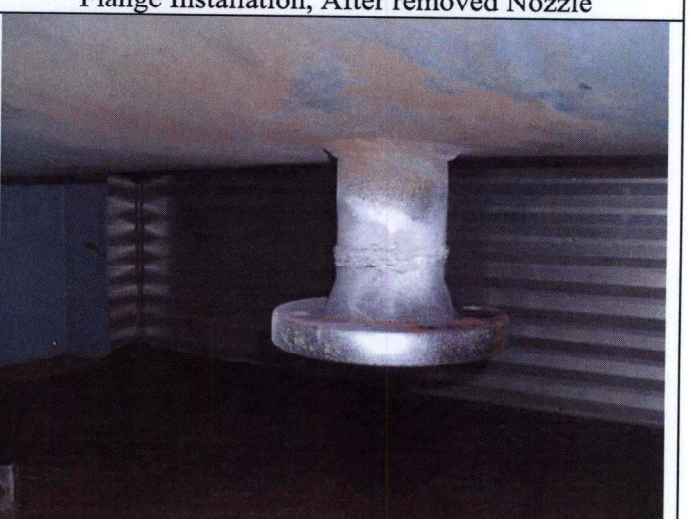
MT tested no cracking detected.
