GENERAL NDE REPORT

Tag# H-610\_06\_19  
2013\_MT-Report-a

Description: MPI Inspection on both Burner and Exhaust End in Saskatoon Reboiler Ser # 3830 (Tag# H-610) in Train #1.

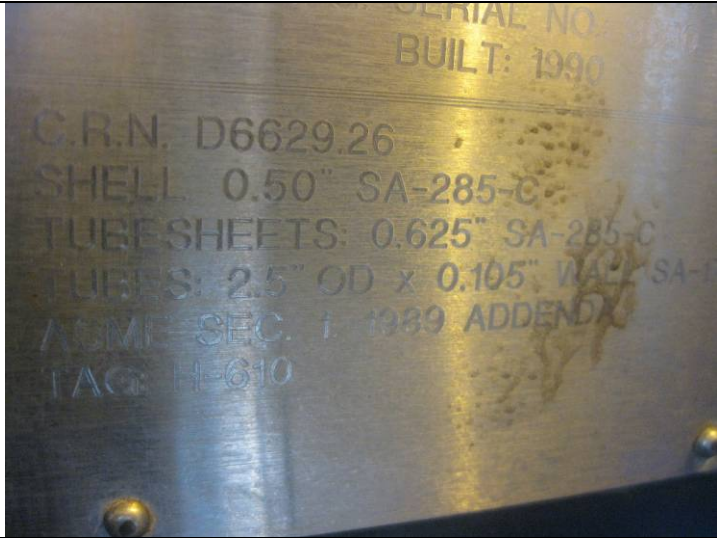
Data Plate (Ser # 3830) Tag # H-610

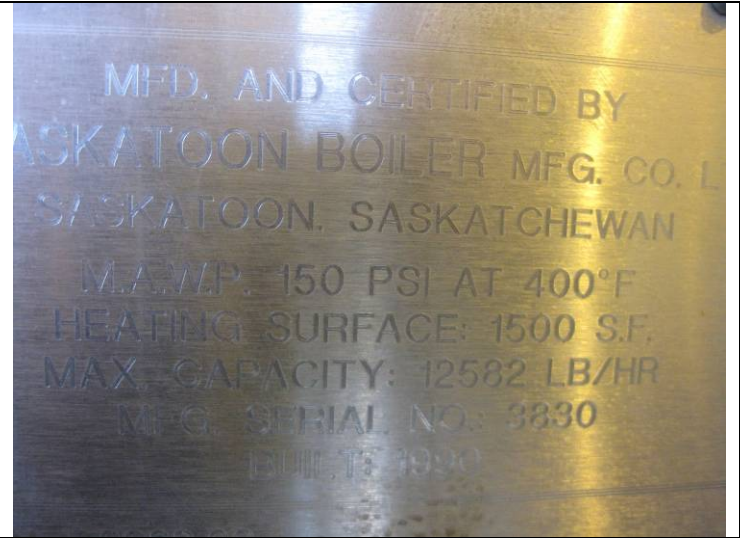
2<sup>ND</sup> Data Plate Tag # H-610 (Ser # 3830)

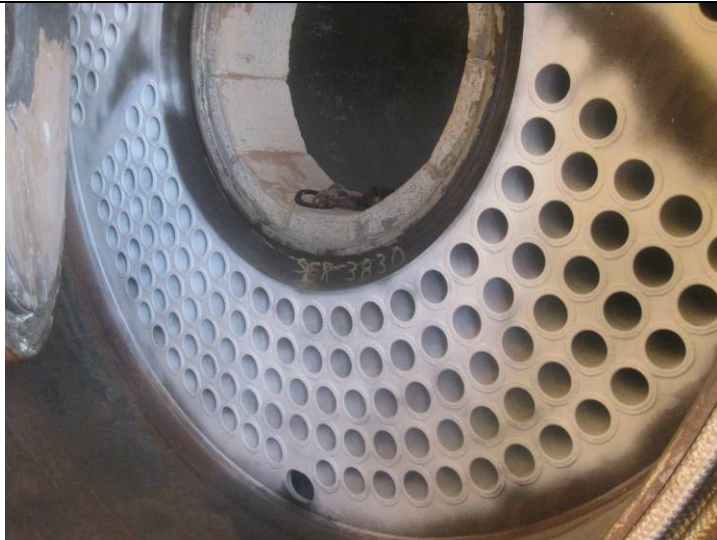
Results: (1) No cracks found at time of inspection

View of areas inspected in bottom of Burner End.

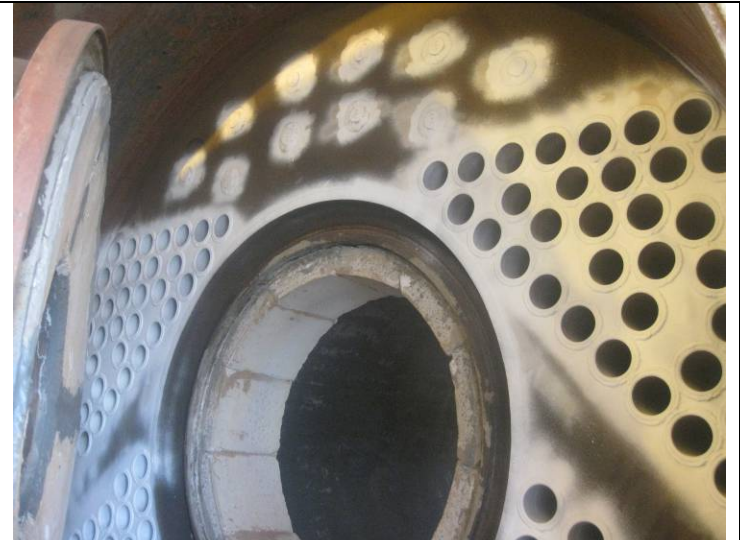
View of areas inspected in top of Burner End.

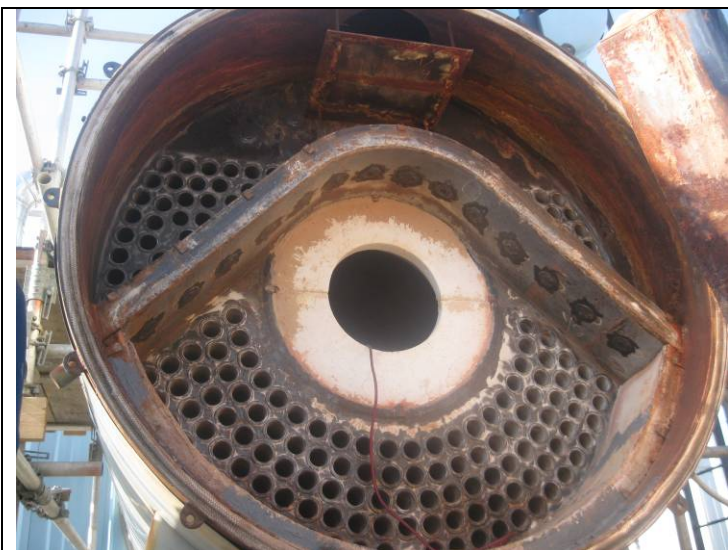
View of Exhaust End prior to MPI Inspection

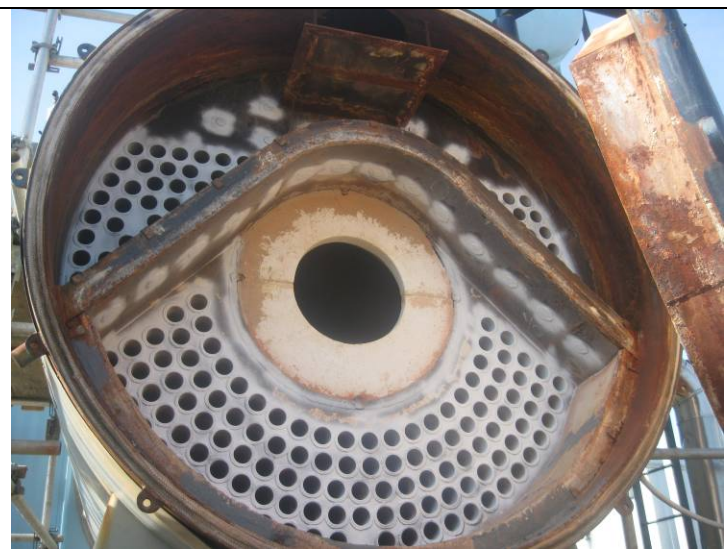
View of areas Inspected in Exhaust End
