Existing Equipment Integrity Assessment Report

Inspect Date: July 27, 2023	Client: Yoho Resources	District: Inga, BC	LSD: 10-19-087-23W6
Facility:	Client Ref #	IRM Ref #	P004
Equipment #:	Description: Accumulator	Jur# N/A	CRN: 0H15682.213
MFR: Enerflex	Mfr S/N: E00224402920	Mfr Date: 2016	Status: Operating

Vessel External Inspection

SN.E00224402920 - UT - 001 - RC

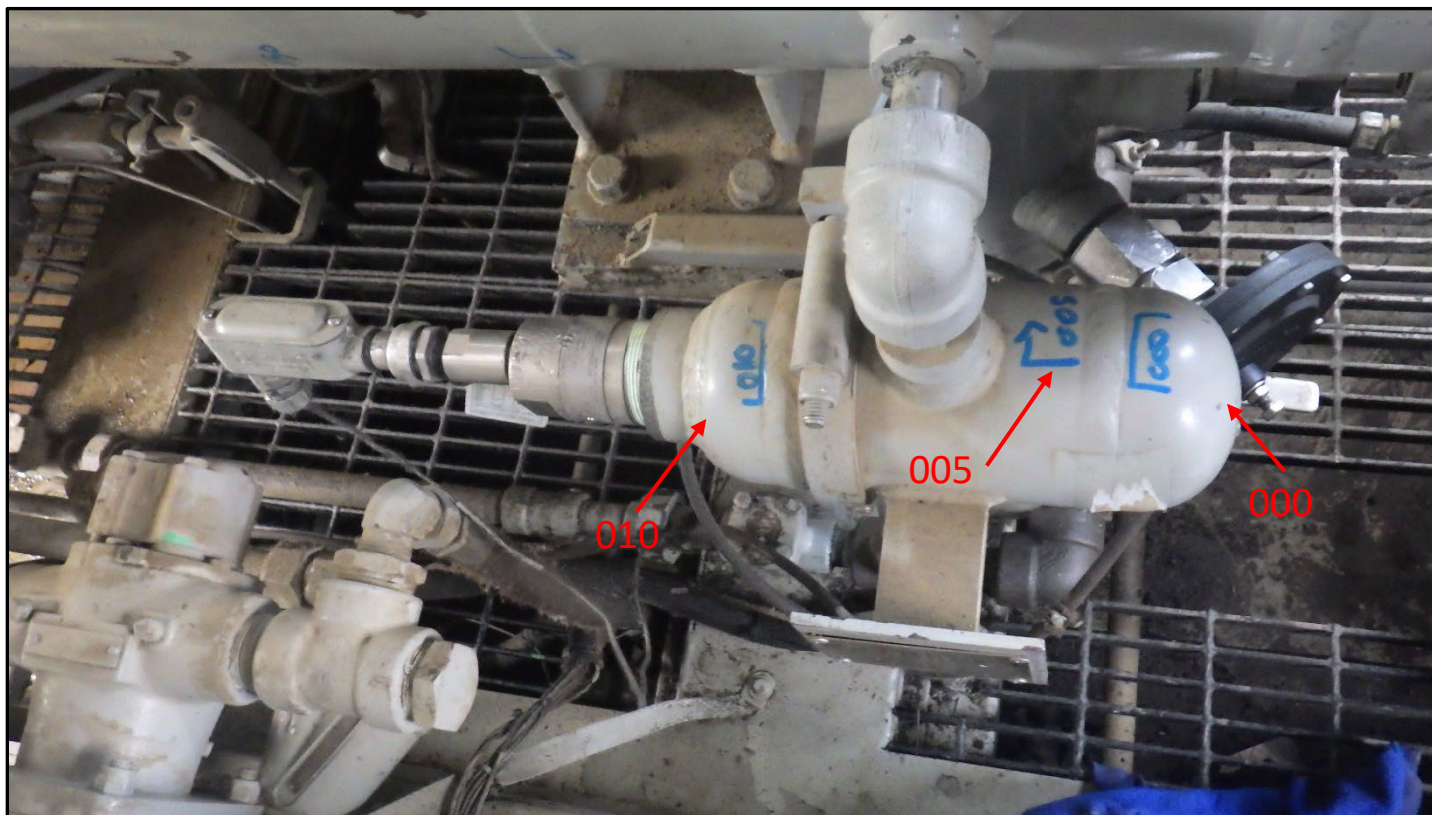
TML Locations

Band ID	Location	Direction	Material	Nominal (in)	CA (in)		Baseline (in)	Previous (in)	Current (in)	% Wall Loss	Tmin (in)	STCR (mpy)	LTCR (mpy)	Years Remaining	
000*	East Head	T - B	Carbon Steel	0.337	0.125	Year:	2016		2023						Acceptable
						Min:	0.337		0.308	8.61%	0.212	0.00	4.14	20	
						Avg:			0.312						
Comments:															
005*	Shell	360° Circ	Carbon Steel	0.337	0.125	Year:	2016		2023						Acceptable
						Min:	0.337		0.333	1.19%	0.212	0.00	0.57	20	
						Avg:			0.343						
Comments:															
010*	West Head	T - B	Carbon Steel	0.337	0.125	Year:	2016		2023						Acceptable
						Min:	0.337		0.348	0.00%	0.212	0.00	0.00	20	
						Avg:			0.356						
Comments:															
						Year:									#DIV/0!
						Min:				#DIV/0!	0.000	#DIV/0!	#DIV/0!	#DIV/0!	
						Avg:									
Comments:															
						Year:									#DIV/0!
						Min:				#DIV/0!	0.000	#DIV/0!	#DIV/0!	#DIV/0!	
						Avg:
