# Existing Equipment Integrity Assessment Report

BPV-066733

Inspect Date: July 27, 2023	Client: Yoho Resources	District: Inga, BC	LSD: 10-19-087-23W6
Facility:	Client Ref #	IRM Ref #	P004
Equipment #: BPV-066733	Description: 3rd Stage Aerial Cooler	Jur# A0552590	CRN: T1804.213
MFR: Air-X-Changers	Mfr S/N: 055572.5	Mfr Date: 2005	Status: Operating

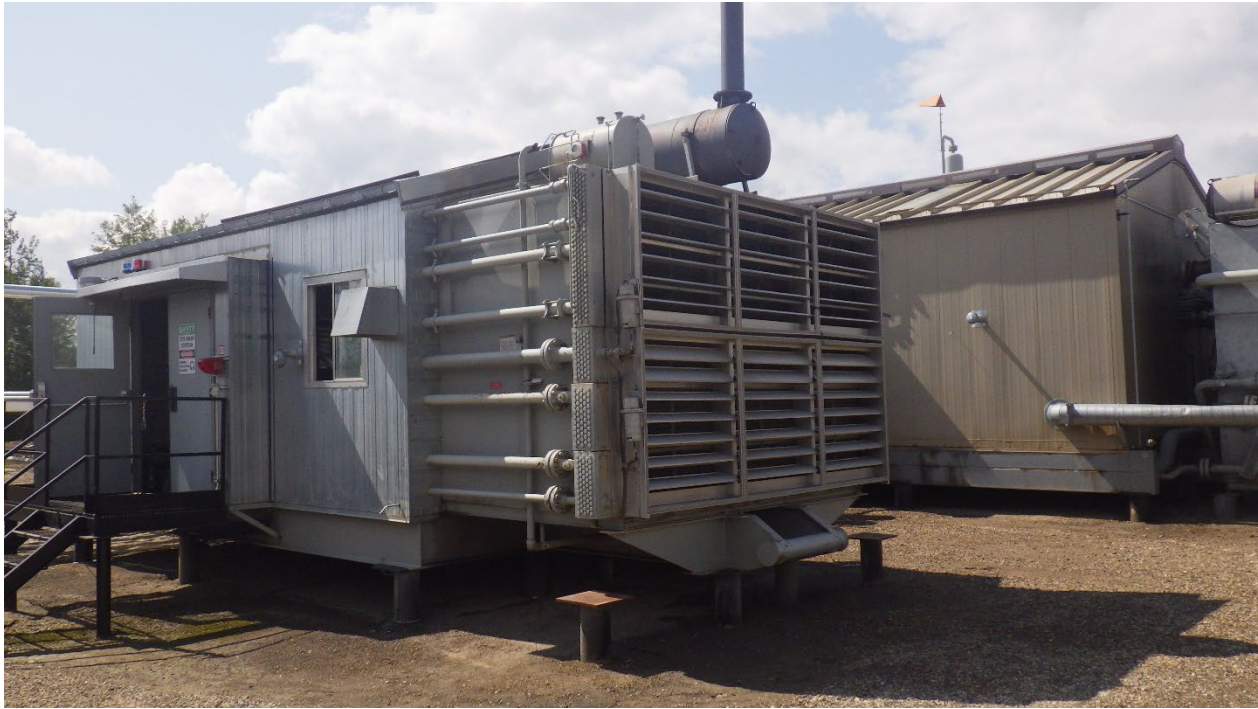
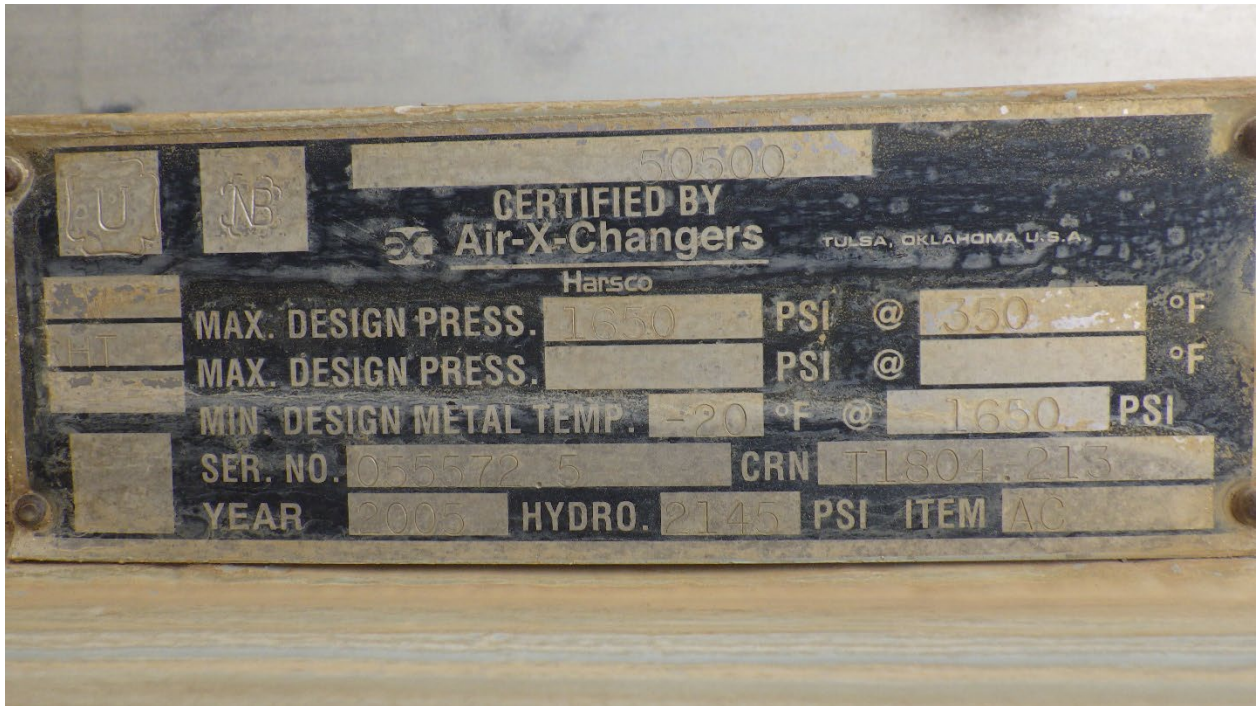
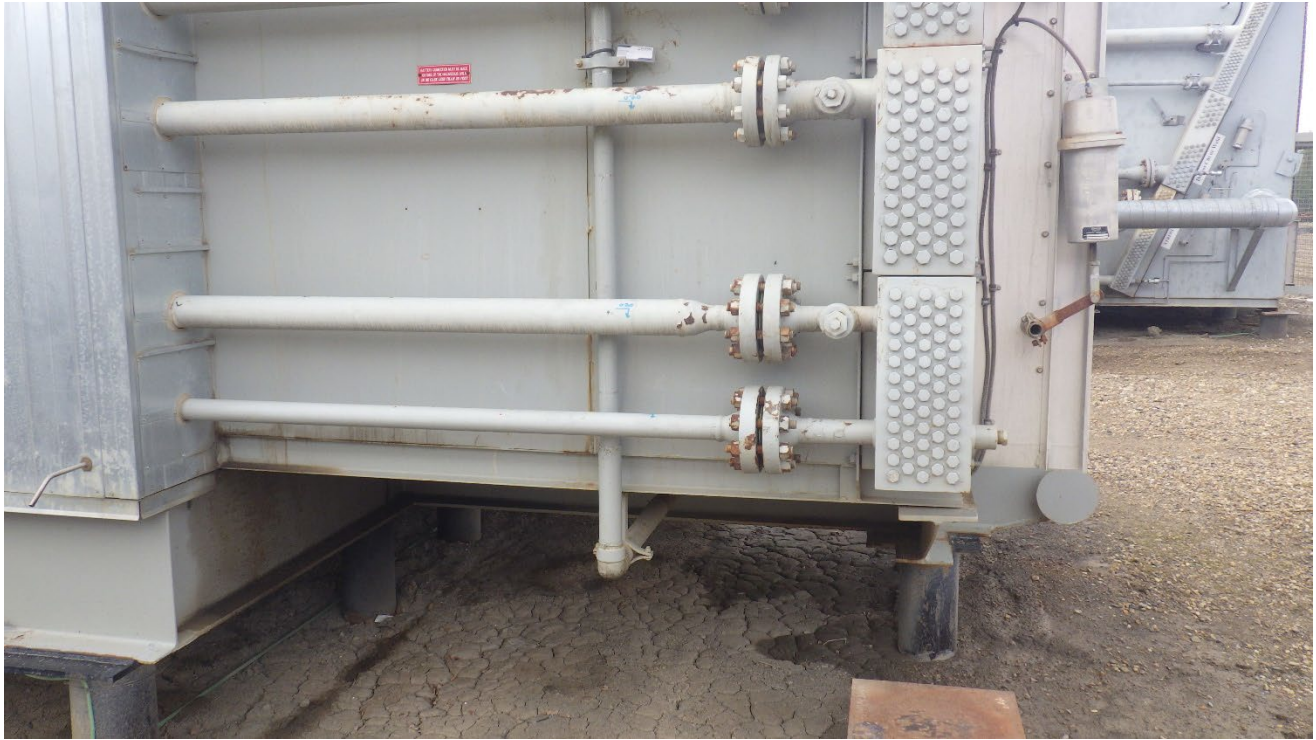
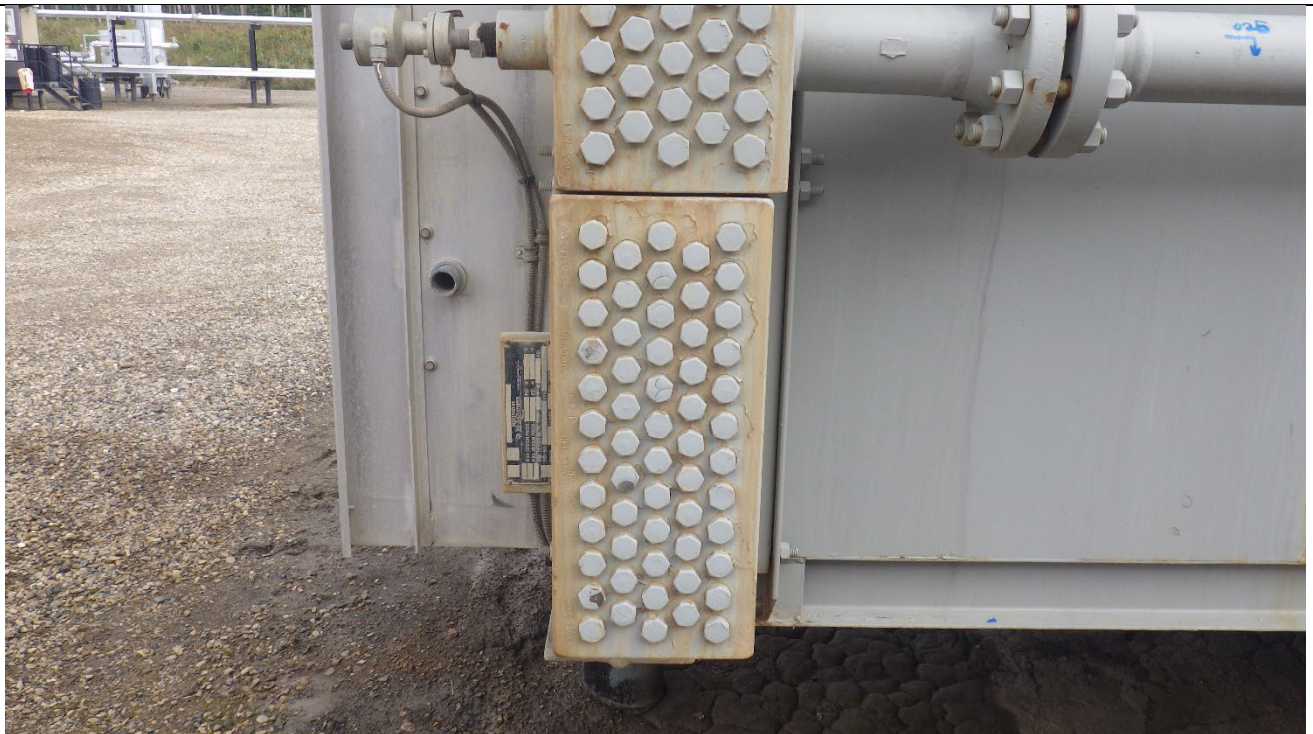
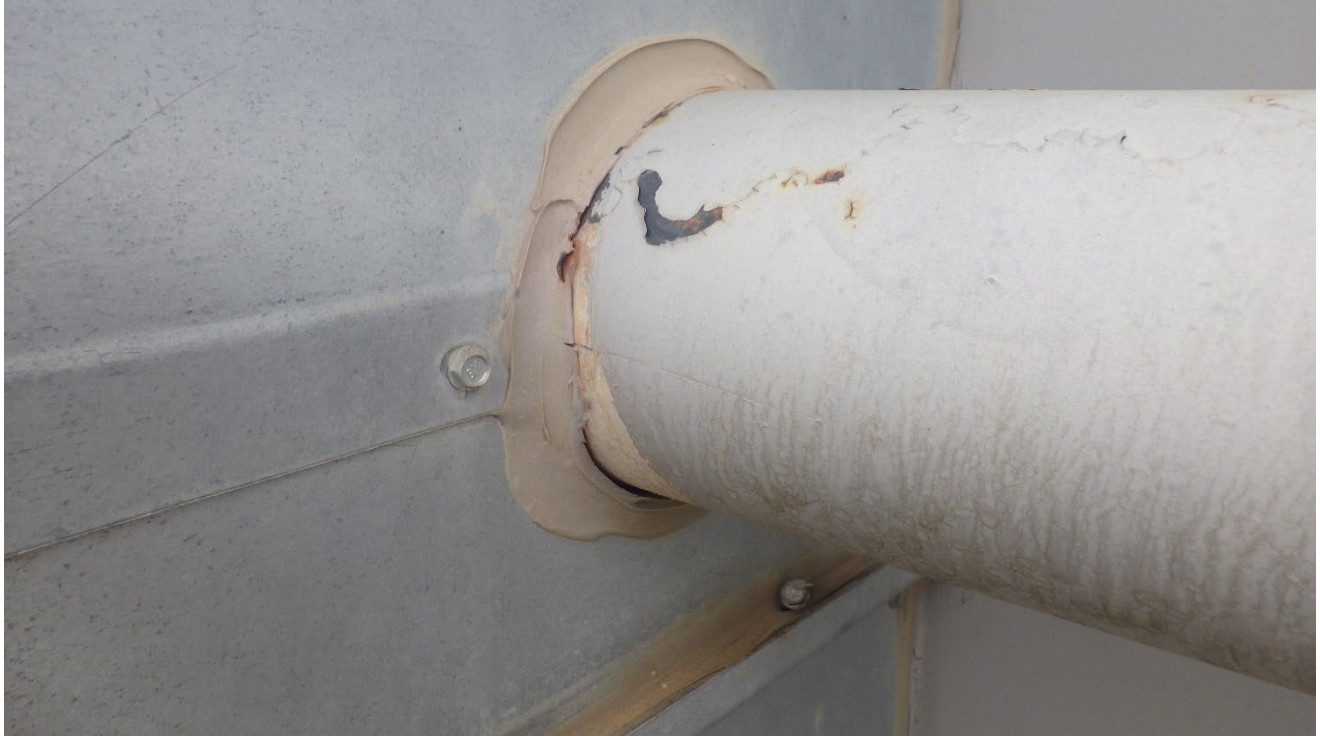
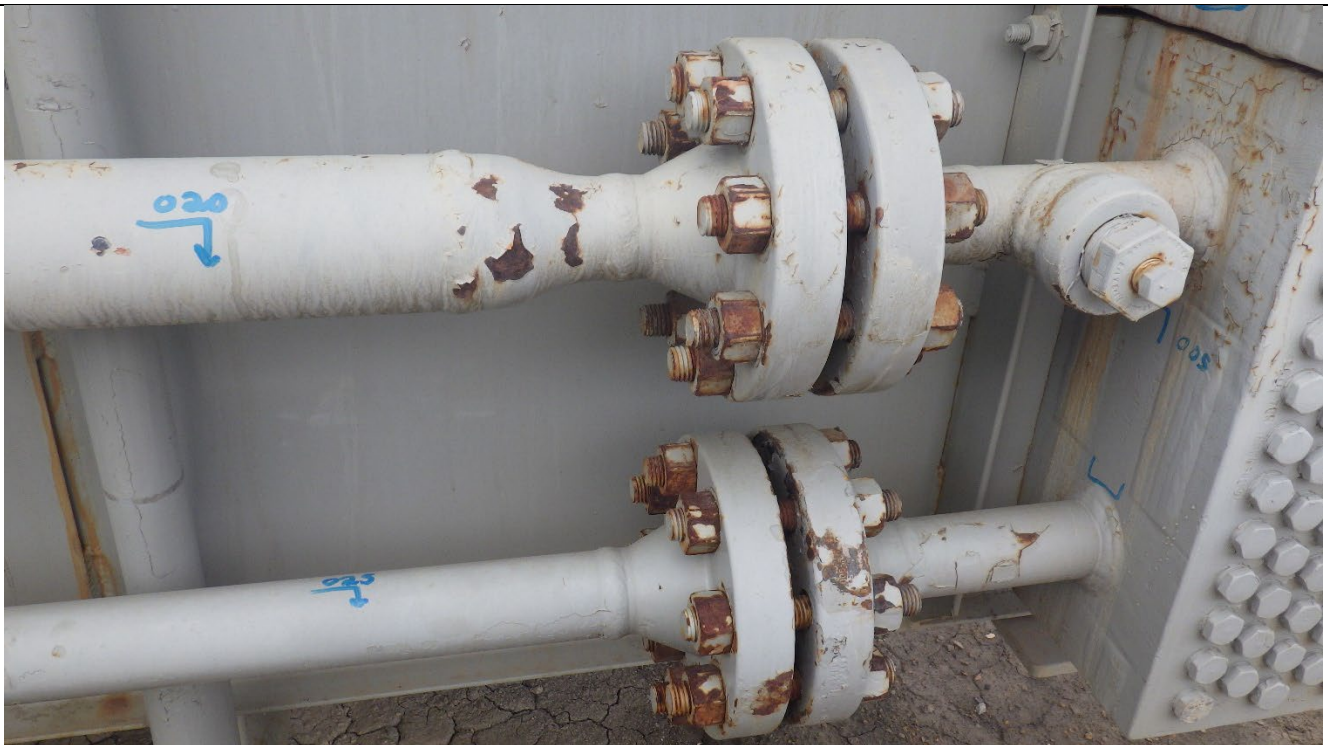
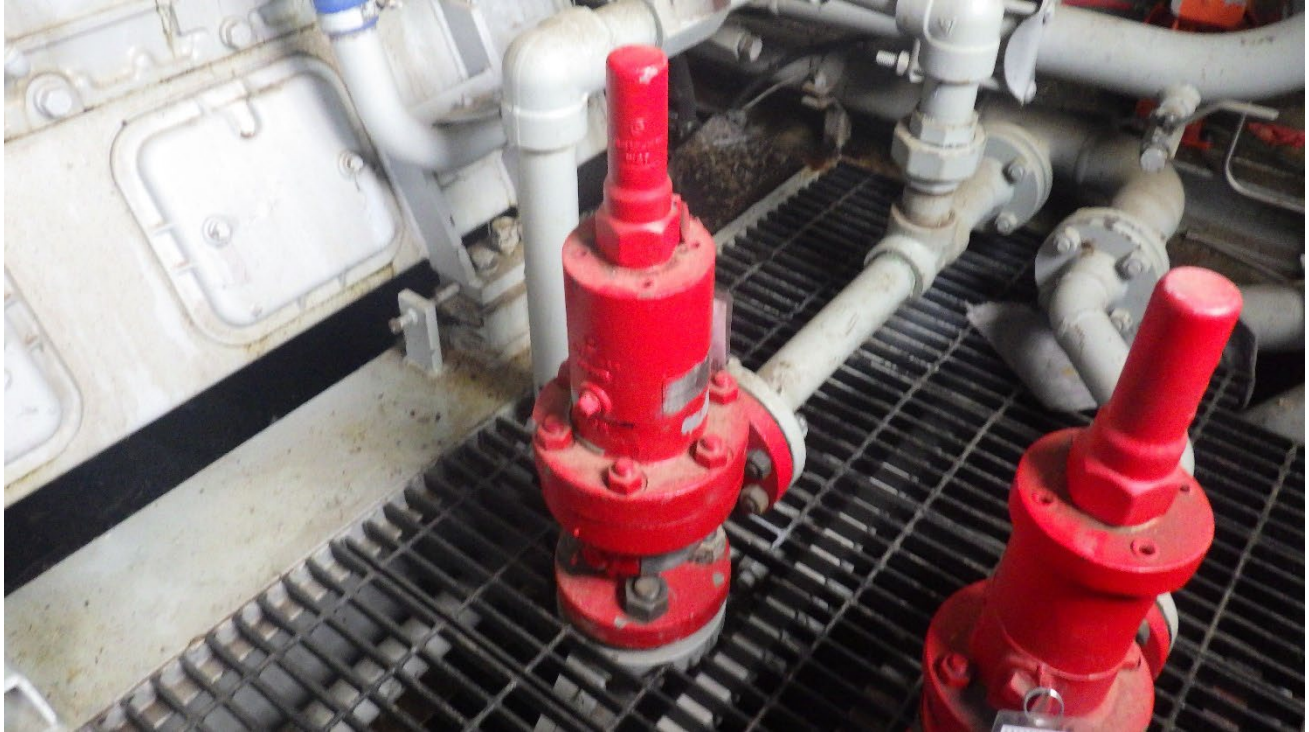
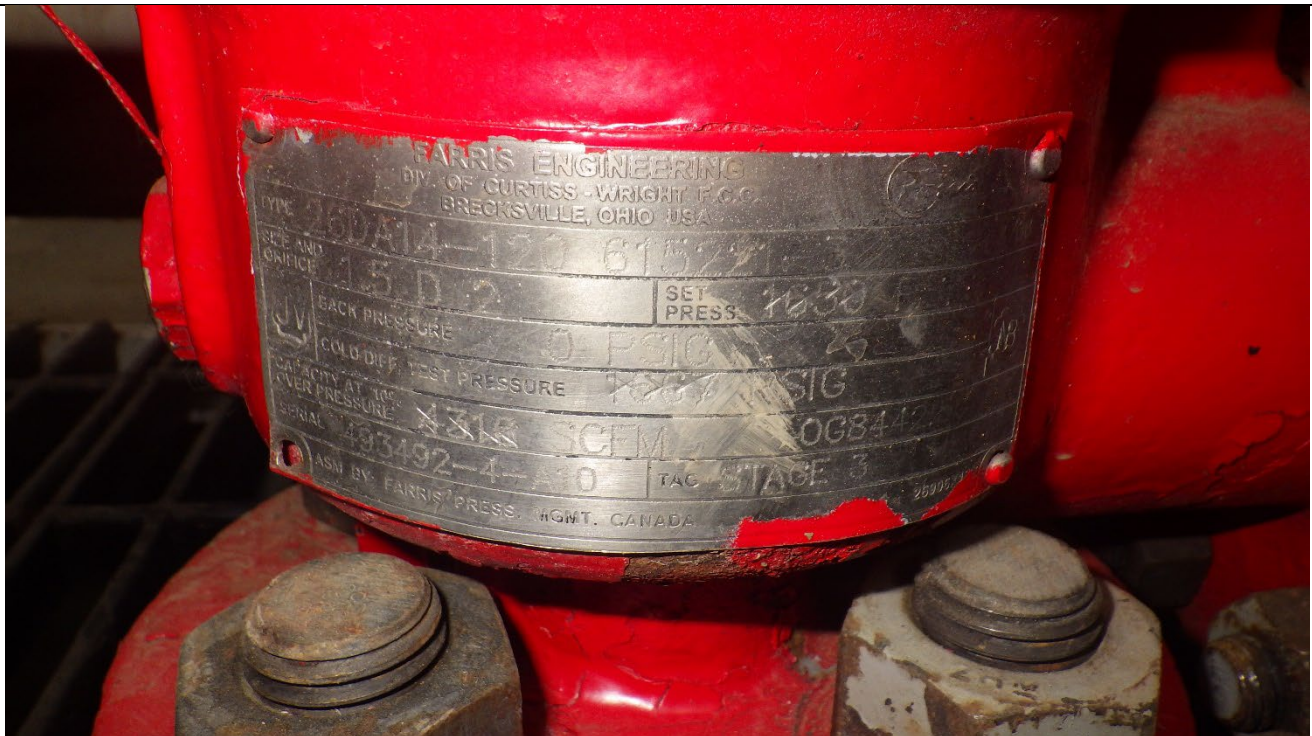
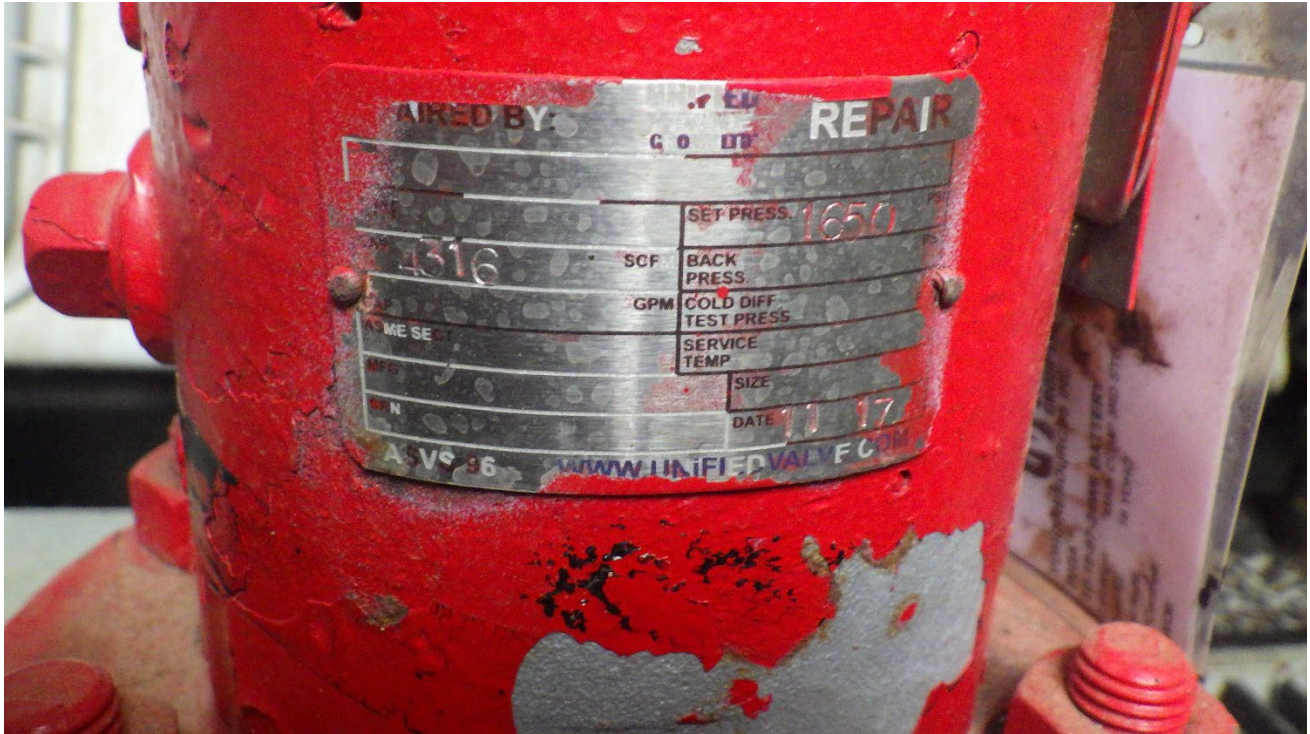
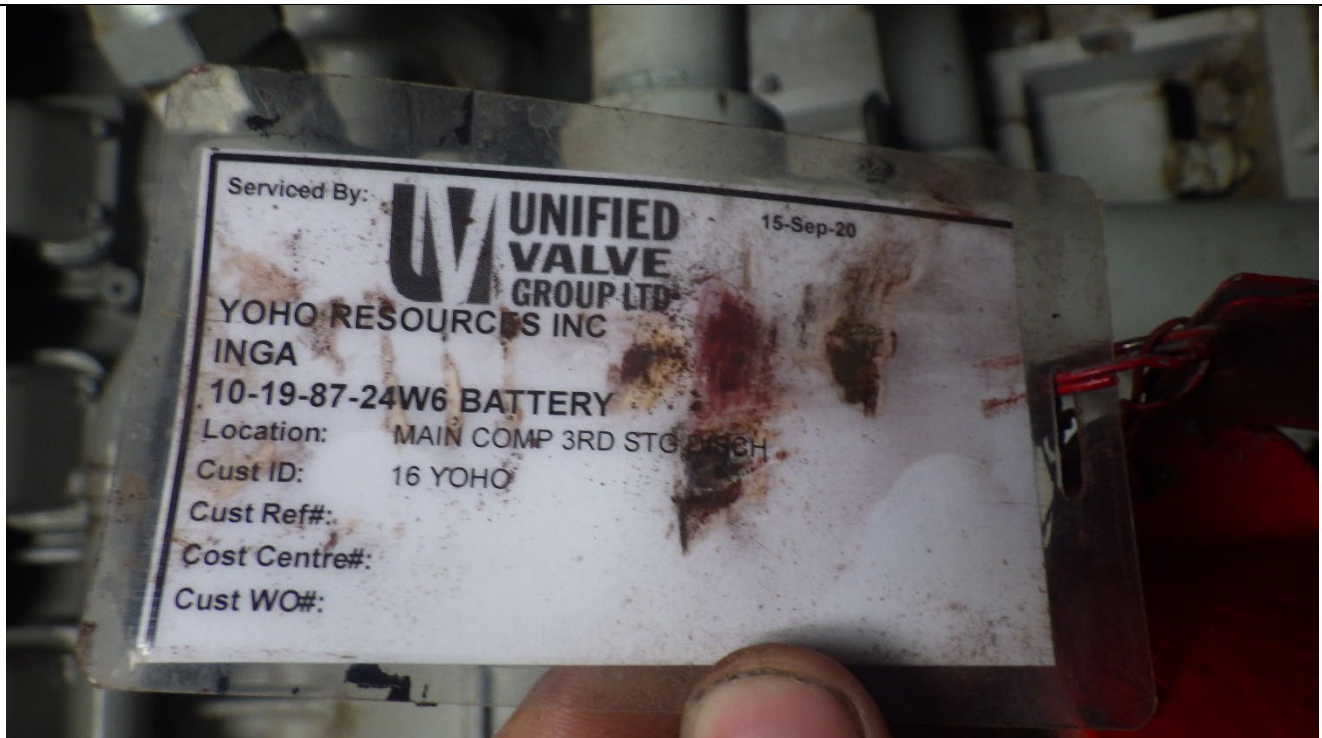
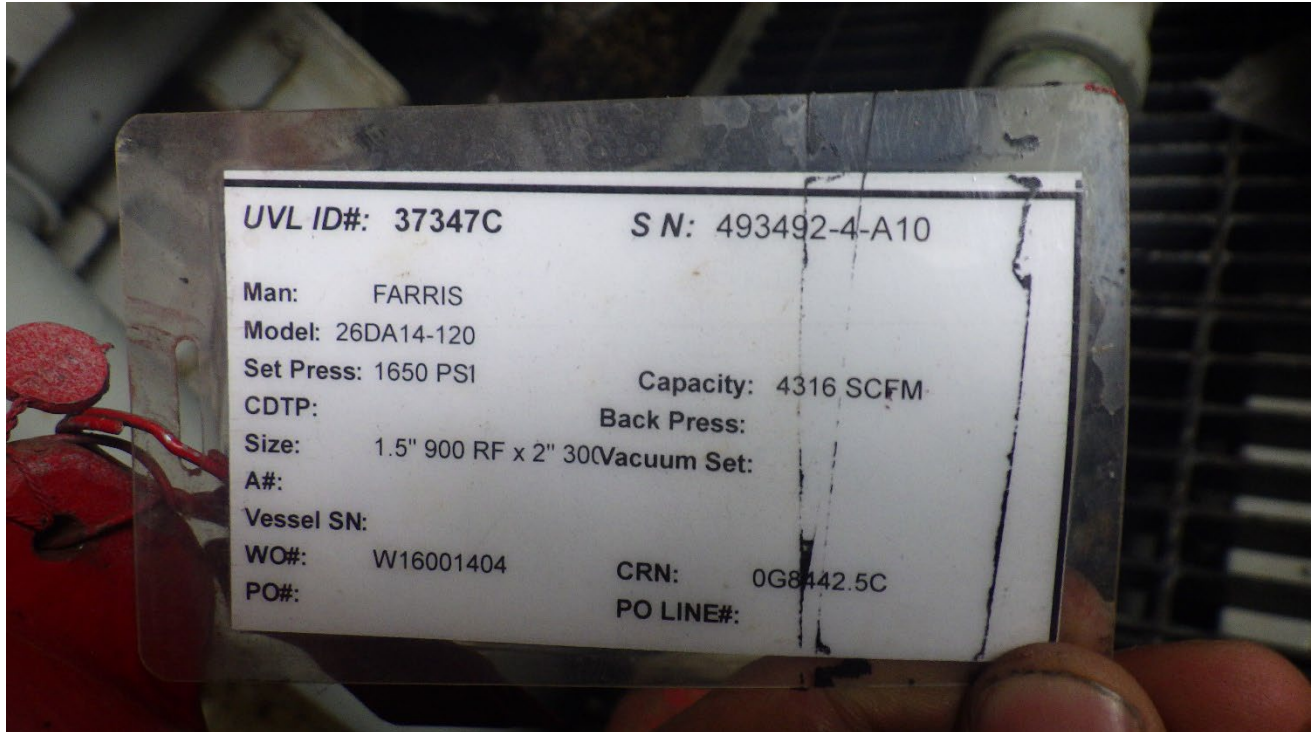
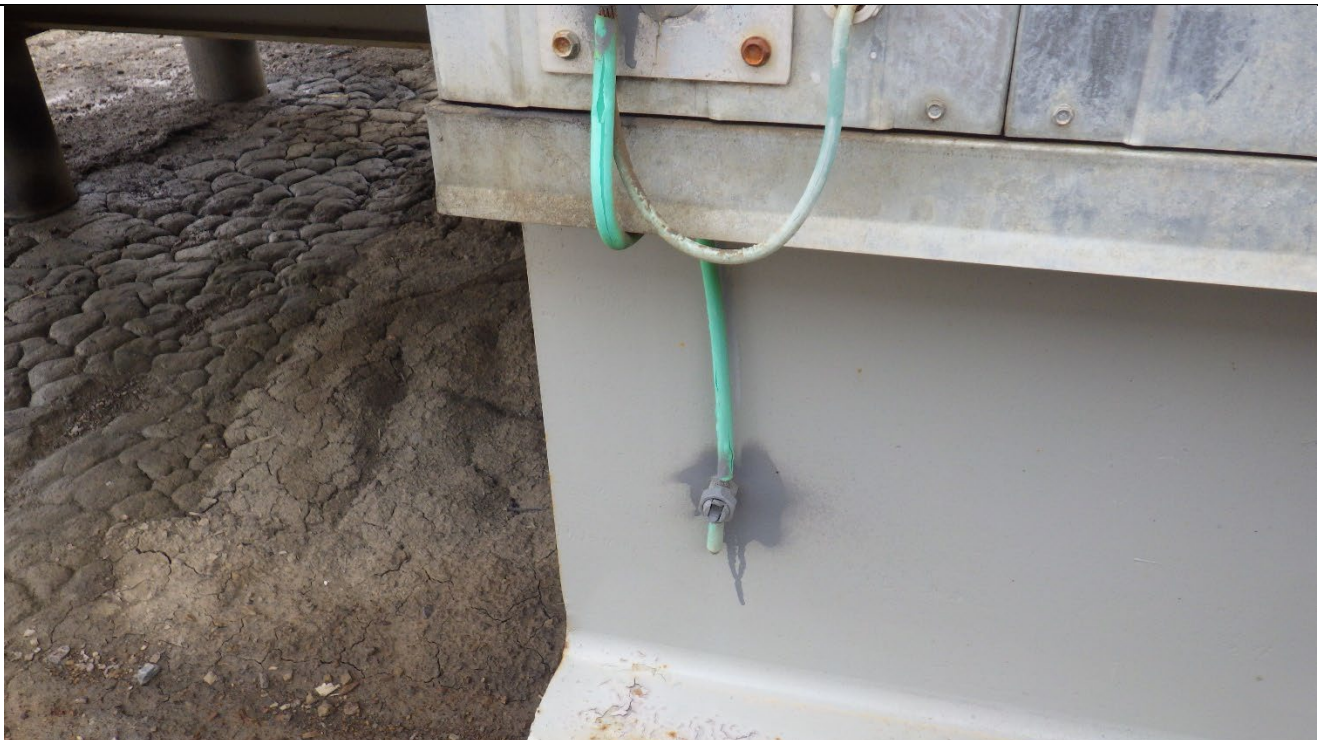
<b>Comments:</b>				
1. The caulking at the piping to building interfaces have failed.				
<input checked="" type="checkbox"/> In Service <input type="checkbox"/> Idle <input type="checkbox"/> Blinded/Disconnected	Signature

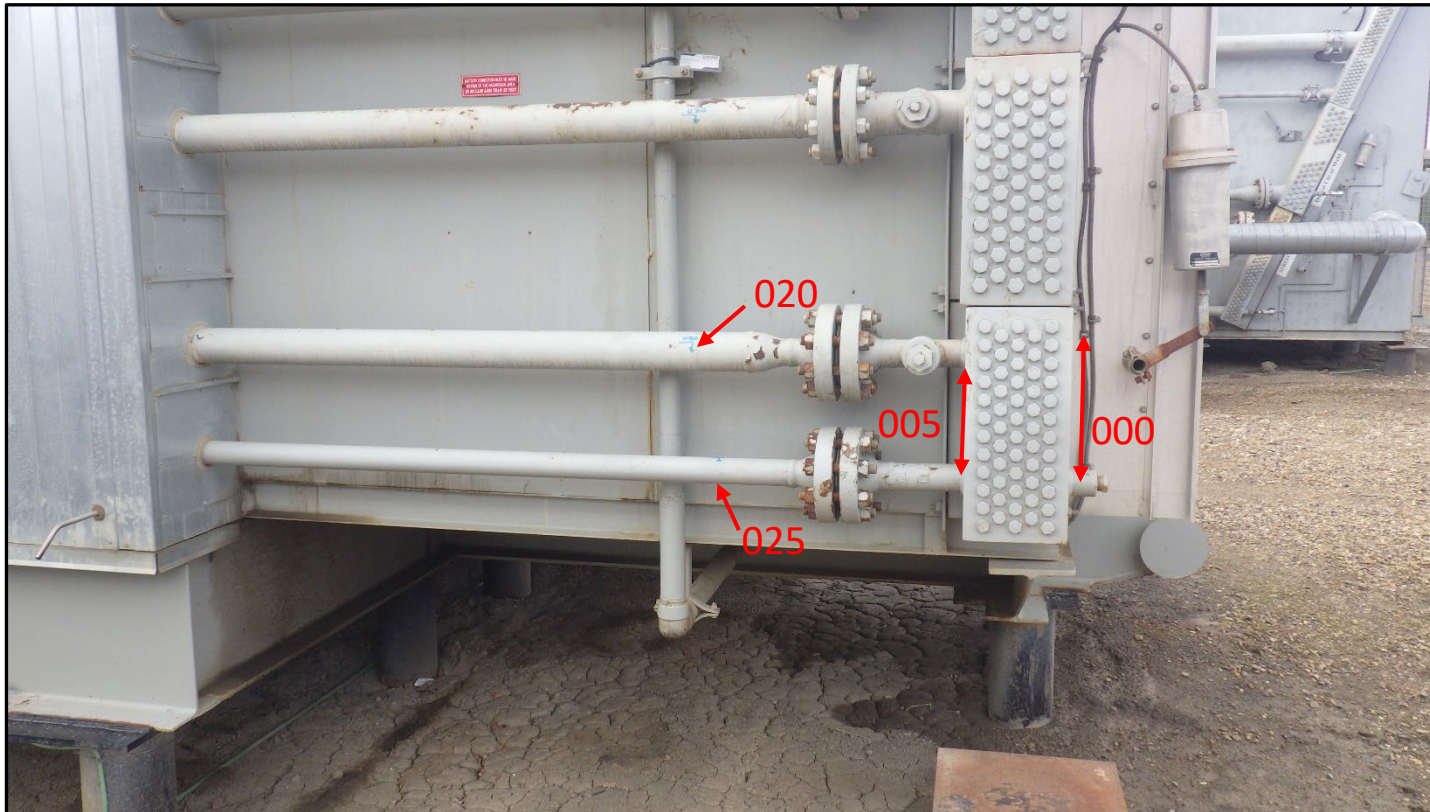
## TML Locations

Band ID	Location	Direction	Material	Nominal (in)	CA (in)		Baseline (in)	Previous (in)	Current (in)	% Wall Loss	Tmin (in)	STCR (mpy)	LTCR (mpy)	Years Remaining	
000*	EHB - North Face	T - B	SA516 - 70N	1.000	0.063	Year: Min: Avg:	2005 1.000		2023 1.010 1.012	0.00%	0.937	0.00	0.00	20	Acceptable
	Comments: 0.063" used for C.A.														
005*	EHB - South Face	T - B	SA516 - 70N	1.000	0.063	Year: Min: Avg:	2005 1.000		2023 1.017 1.019	0.00%	0.937	0.00	0.00	20	Acceptable
	Comments: 0.063" used for C.A.														
010*	WHB - South Face	T - B	SA516 - 70N	1.000	0.063	Year: Min: Avg:	2005 1.000		2023 1.012 1.016	0.00%	0.937	0.00	0.00	20	Acceptable
	Comments: 0.063" used for C.A.														
015*	WHB - North Face	T - B	SA516 - 70N	1.000	0.063	Year: Min: Avg:	2005 1.000		2023 1.012 1.016	0.00%	0.937	0.00	0.00	20	Acceptable
	Comments: 0.063" used for C.A.														
						Year: Min: Avg:				#DIV/0!	0.000	#DIV/0!	#DIV/0!	#DIV/0!	#DIV/0!
