Nameplate / PRD Audit Form						
Equipment Nameplate						
Tag / Eqpt #:		Built:	March 1980			
Asset #:		MWP:	517 kPa @ 93°C	MDMT:		
Vessel Name:	Free Water Knockout #2		RT:	RT-2	JE:	100%
Reg. No.:	A0161444		C.A.:	NIL		
S/N:	LM-1671		Dia. Shell	96" I.D.	Dia. Boot:	
NB #:		Dia. Accumulator		Dia. Gas Dome:	No Access	
CRN:	C-8805.2		Heat Treatment	Unknown		
	Nominal	Material		Nominal	Material	
Shell 1:	7.93 mm	SA-285-C	Head 1:	12.70 mm	SA-285-C	
Shell 2:			Head 2:	15 mm	SA-285-C	
Manufacturer:	C.E. Natco Limited					
PRD Information						
PRD S/N:		Model of PRD:				
Tag #:		Colour of PRD:	Blue			
Set Pressure:		Inlet / Outlet Size:	3" / 3"			
Capacity:		Connection Type:	Threaded			
Date of Last Service:		Code Stamp:				
Asset #:		Block Valve Exists:	No			
CRN:		PRD Location	Vessel			
Manufacturer:						
PRD Inspection						
			Yes	No	N/A	
Was the MAWP of the vessel greater or equal to the PRD set pressure?			<input type="checkbox"/>	<input type="checkbox"/>	<input type="checkbox"/>

- An API-510 external inspection was completed on the Free Water Knockout #2.
- The vessel was inspected to meet regulatory requirements.
- Partial access was available to the vessel for external visual in

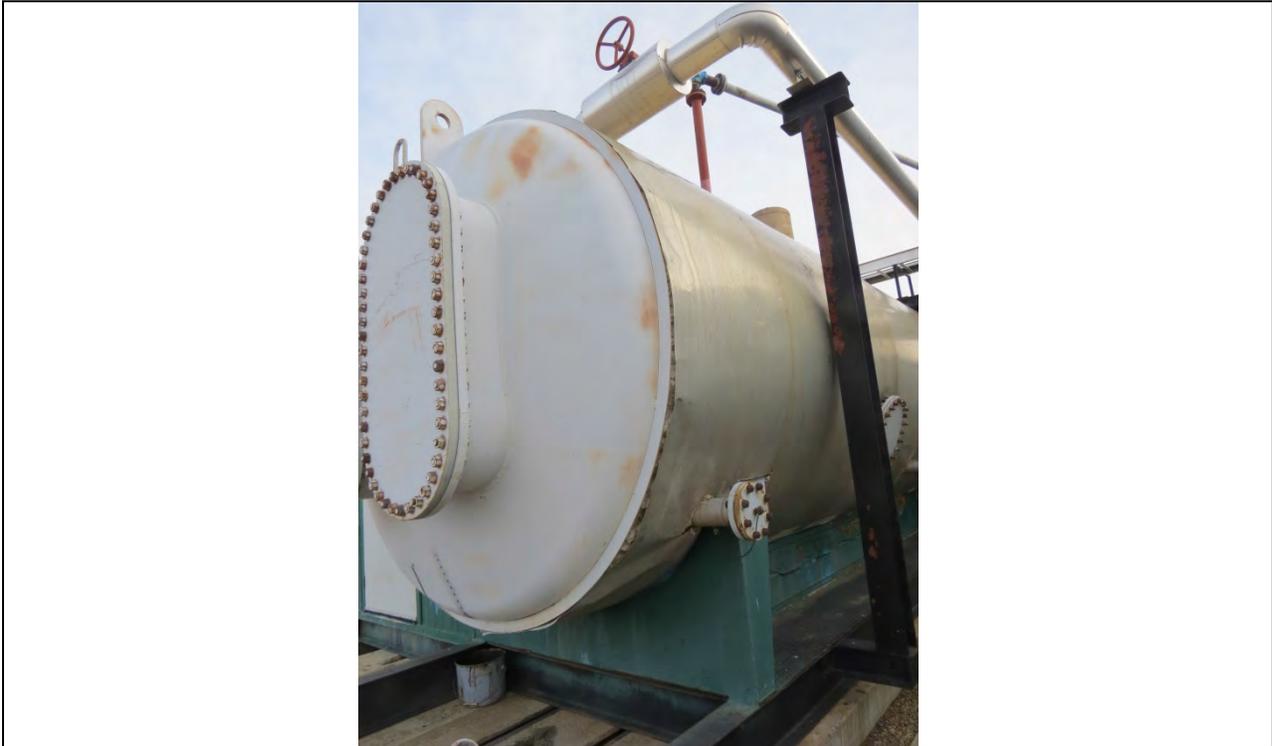
- The vessel was insulated. [The cladding was not sealed against the west insulation ring around the circumference of the vessel. The cladding was no longer properly sealed against the nozzles, manway and building walls. The cladding was deteriorated on the top east head.](#) No indications of external corrosion under insulation were visible.

*Insulation not sealed on west head*

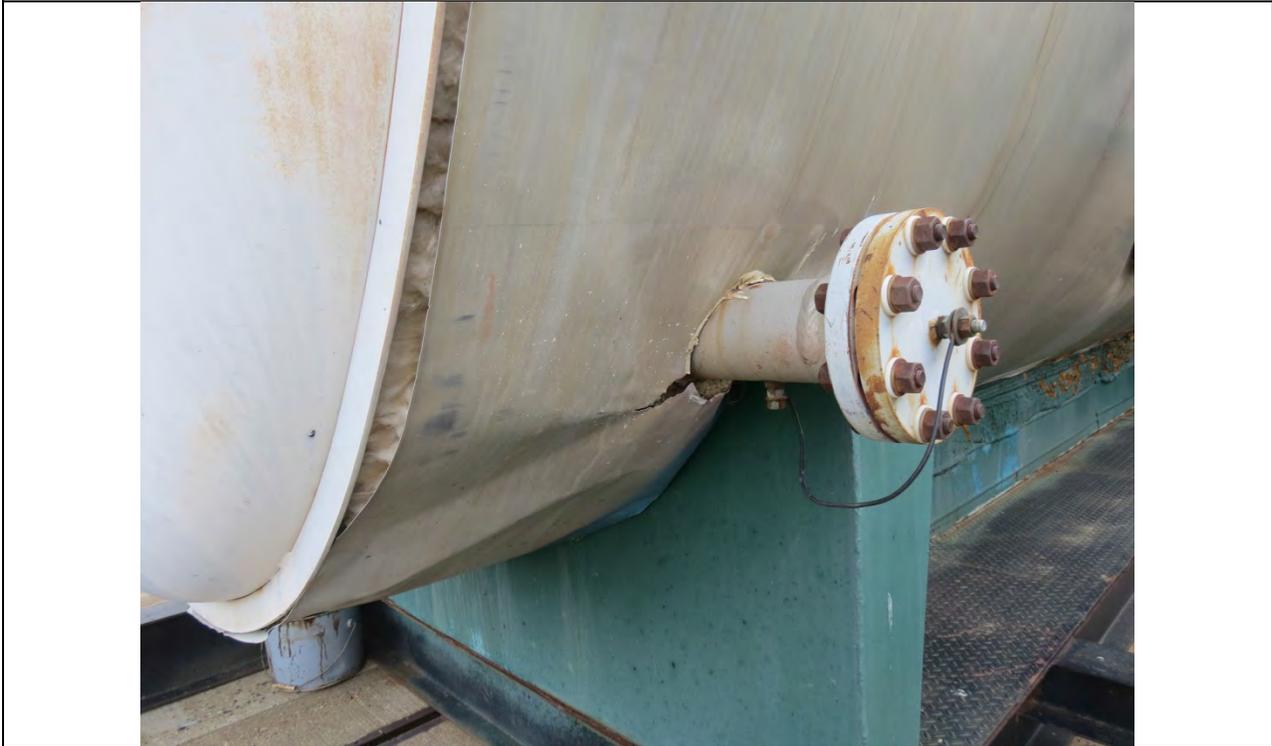
*Insulation not sealed on west anode nozzle*

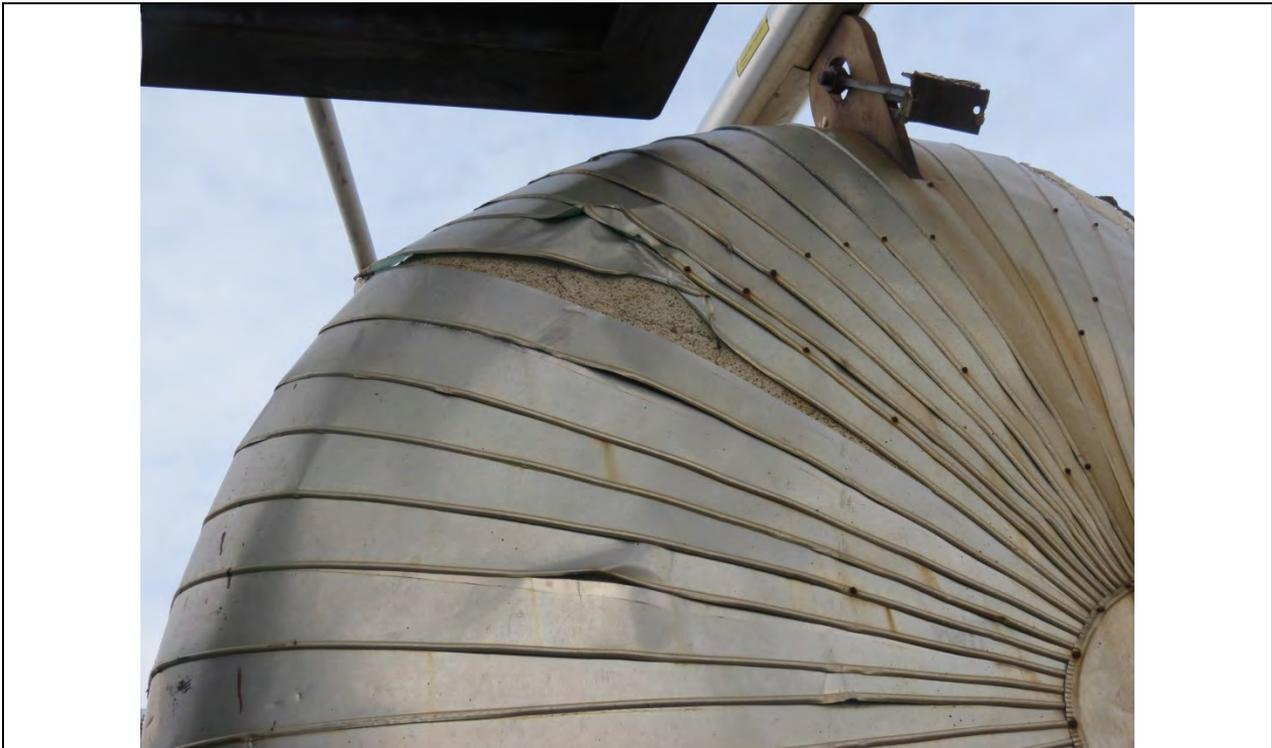
*Missing cladding on top east head*

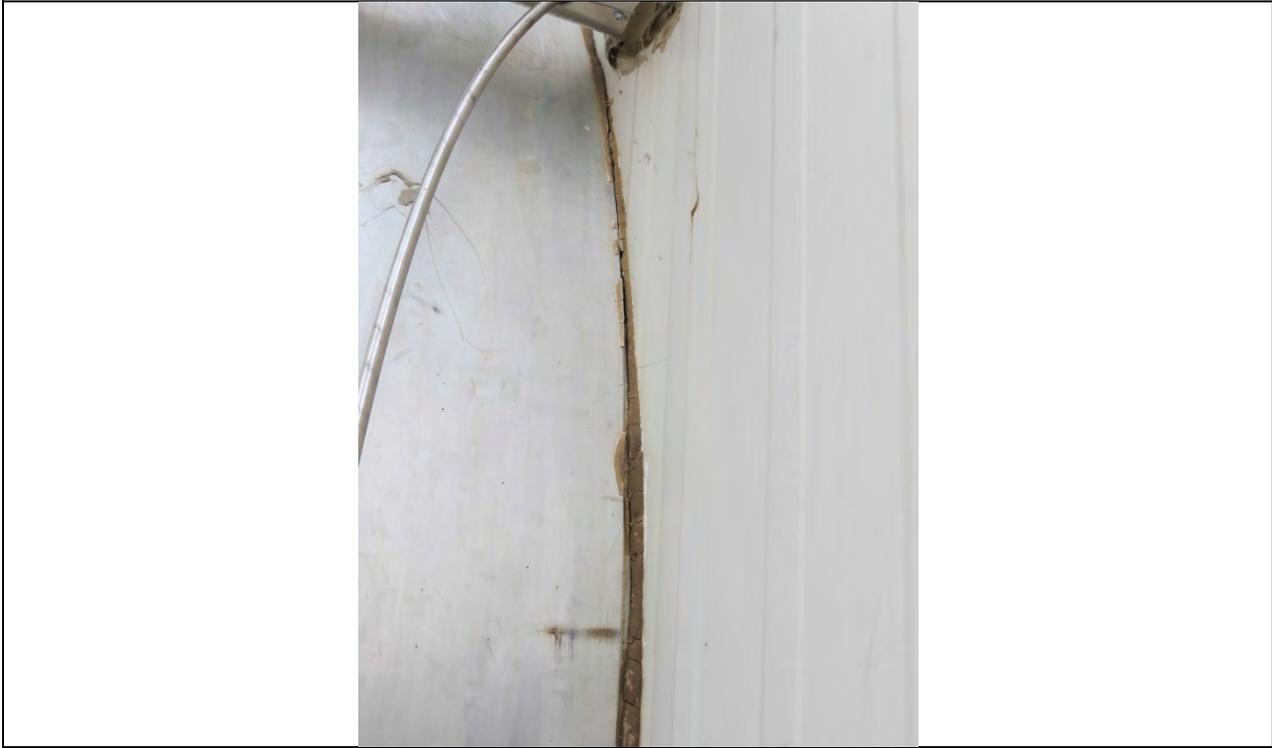
*Vessel not sealed against east building wall*

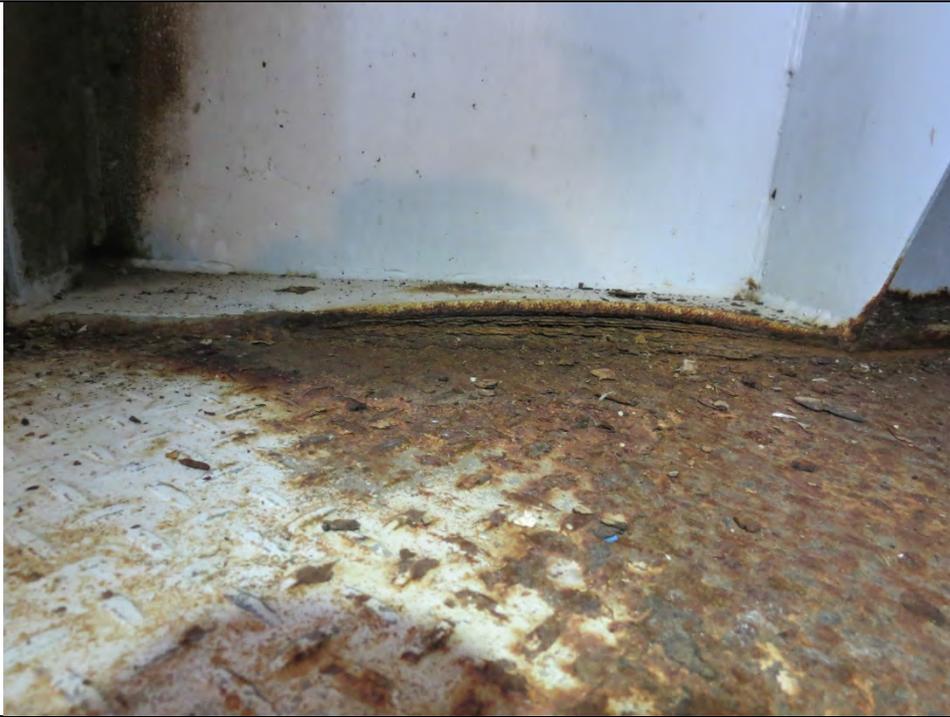
- Access to the inside of the vessel was also available through a flanged opening in the end of the vessel.
- The vessel was supported by support saddles. [There was crevice corrosion occurring between the saddle supports base and the building floor. The corrosion appears to be wrapping the base of the supports and was corroding the anchor welds as well.](#)

*Close view of crevice corrosion on east saddle support*

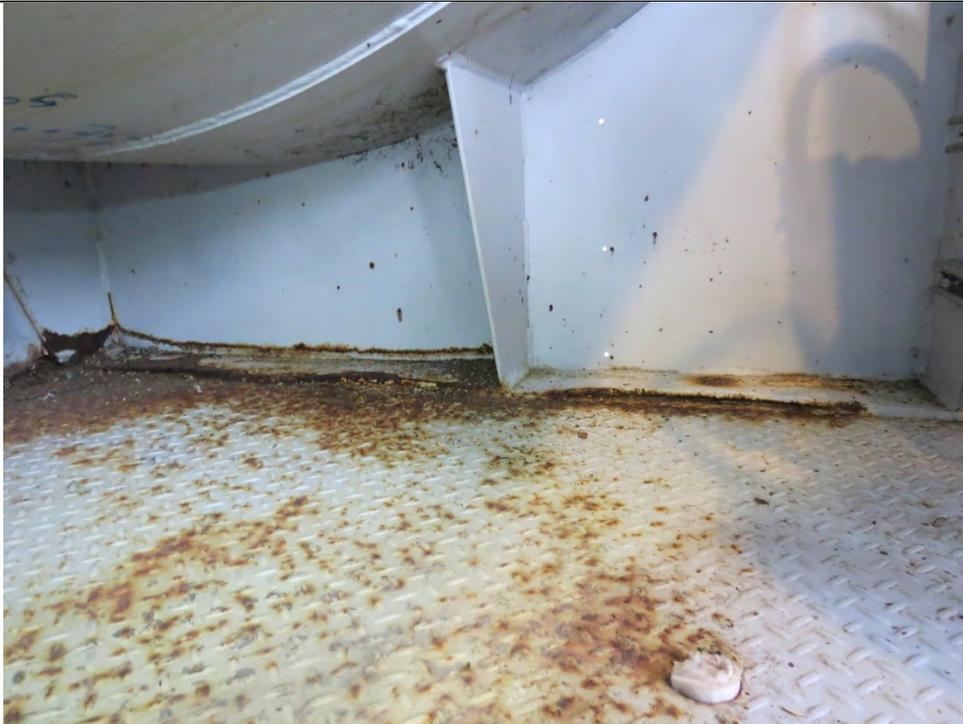
*Crevice corrosion on west saddle support*

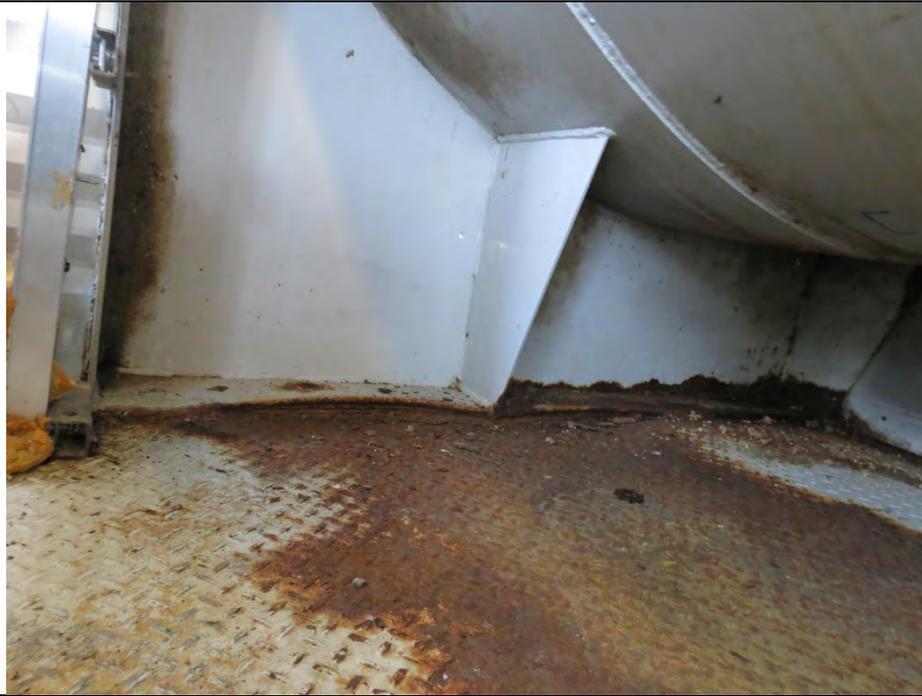
*Crevice corrosion on east saddle support*

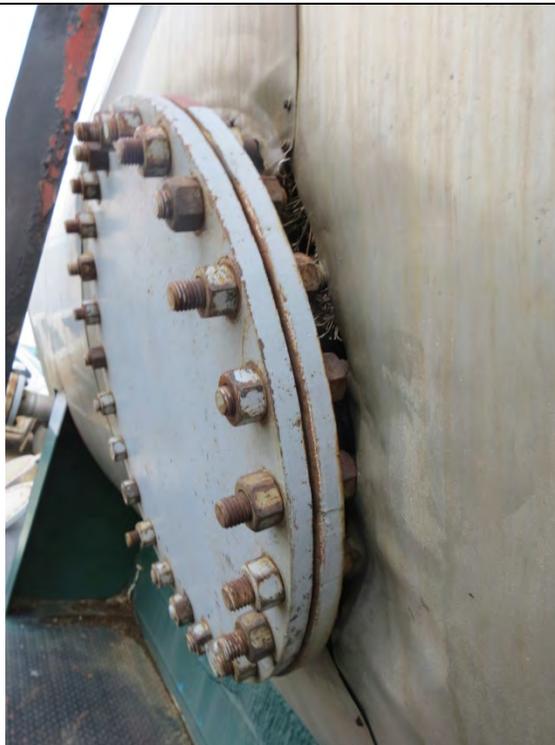
*Insulation not sealed against manway*

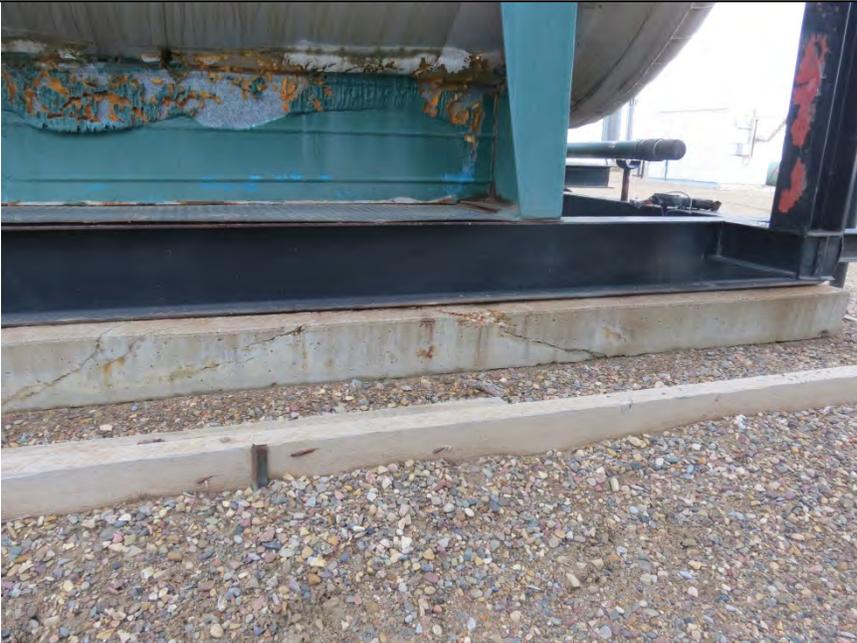
- The vessel sat on a concrete and steel foundation and floor. The foundation and floor appeared to be in good condition. The vessel appeared to sit level and did not appear to lean. [There were cracks on the south east side of the concrete foundation.](#)

*Cracking in concrete foundation*

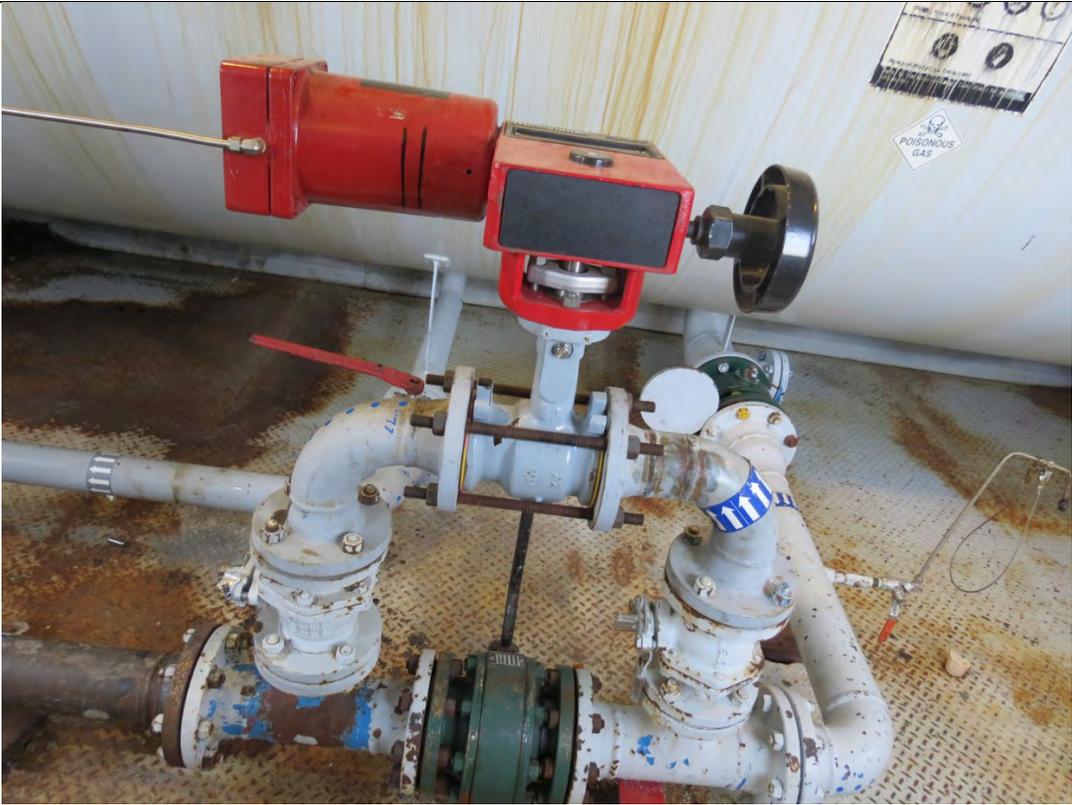
- All threaded connections appeared to be in good condition. No signs of cross-threading were visible.
- [A slow leak was noted from the west flange of the control valve located on the produced water outlet piping.](#)

*General view of control valve with leaking flange connection*

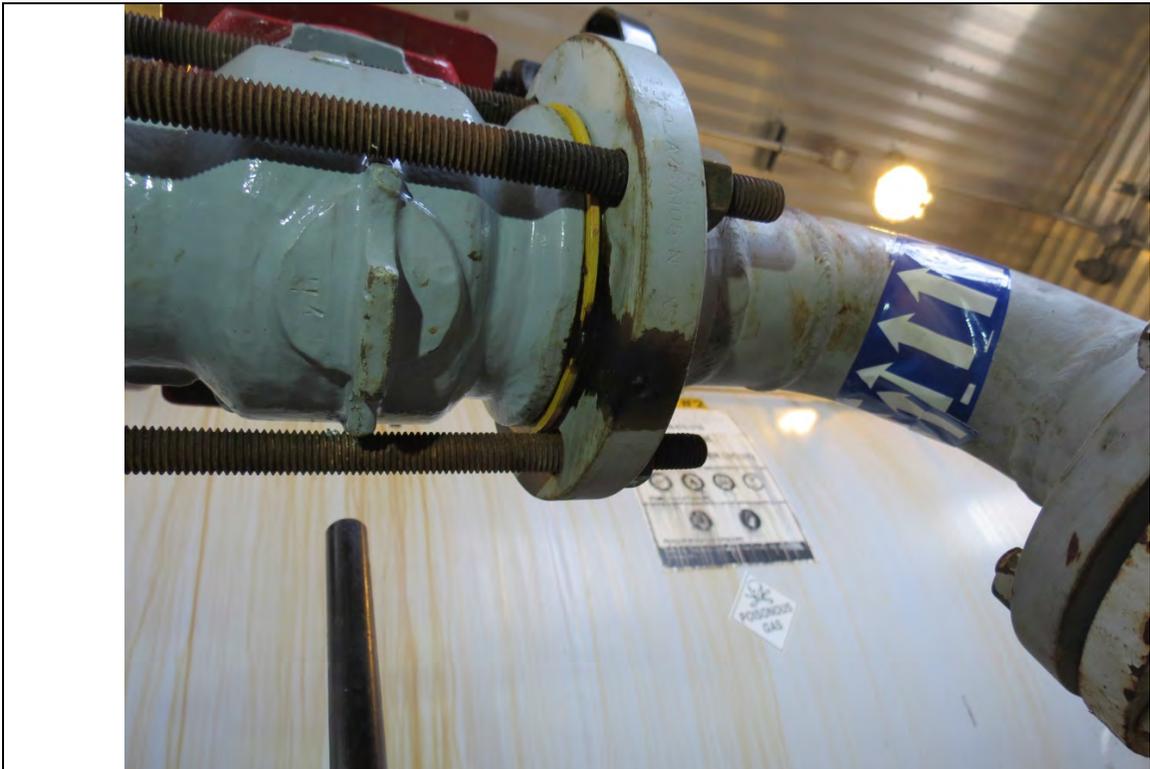
*West flange connection leak on produced water control valve*

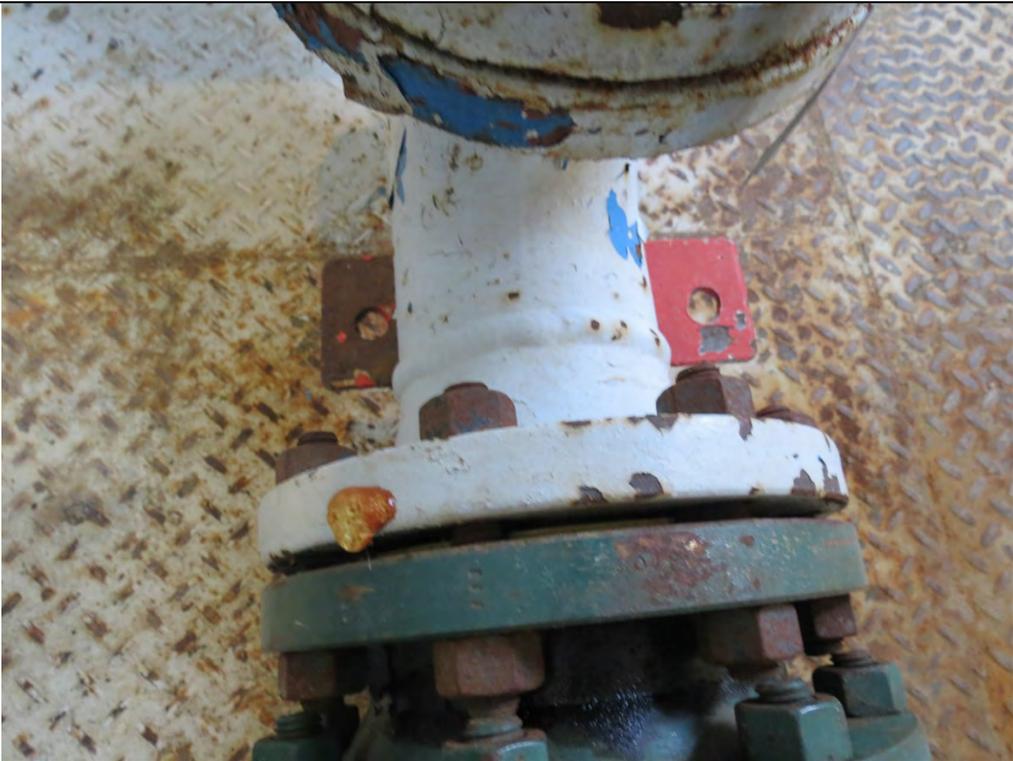
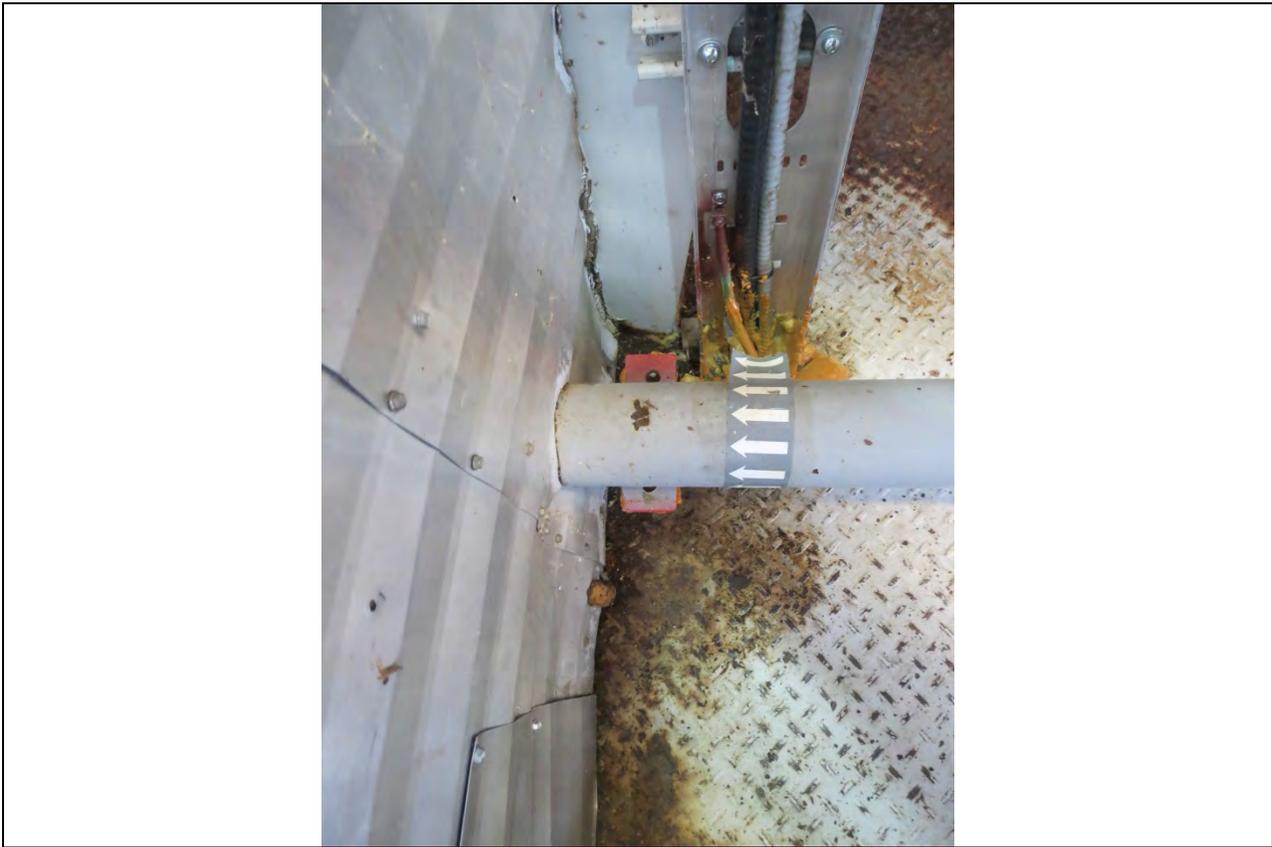
- [There were no piping support U-bolts installed on the pipe shoes located inside the building.](#)
- All flange bolting was in place and appeared to be properly engaged.

*Example of missing pipe clamps on various piping*

*Example of missing pipe clamps on various piping(2)*
