UNIT 372896 INSPECTION

Unit # 372896

Engine G3408 TA Serial # GNB01920

Compressor Serial # TDSH355L0093KZ

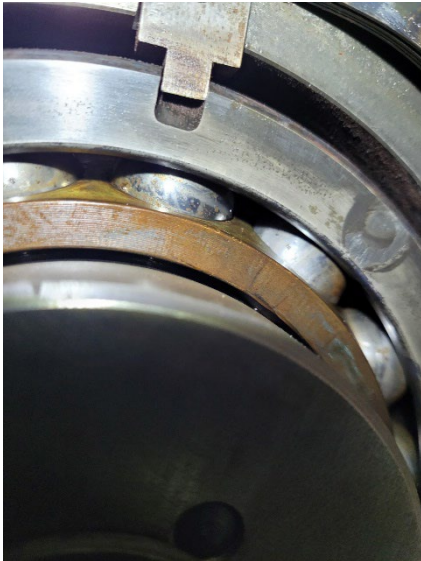
-Input shaft end play is 0.025" (appears excessive)

-Driven rotor end play is 0.008"

-The bearing on the driven rotor is covered in rust spots

- Rebuild compressor (suspect rotors are damaged due to the excessive end play)
- Clean up and test all end devices
- Replace liner packs as needed
- Have plate exchanger rebuilt

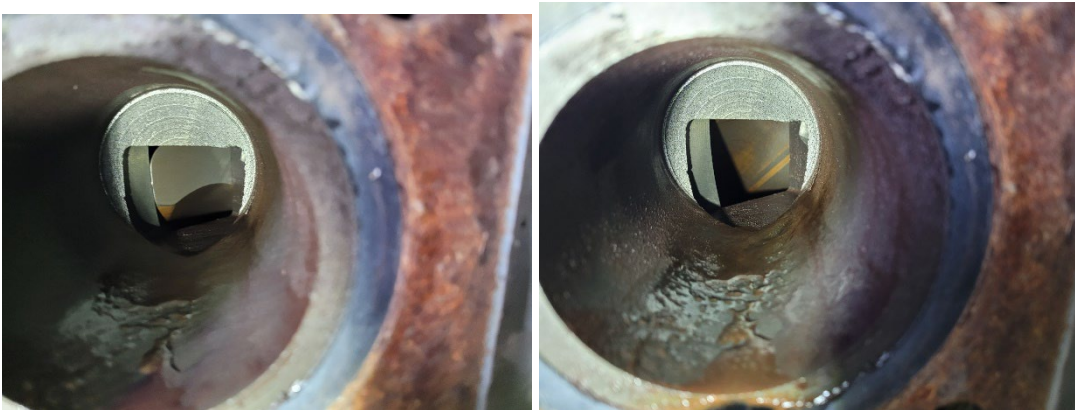
-The driven rotor appears to mostly free of rust

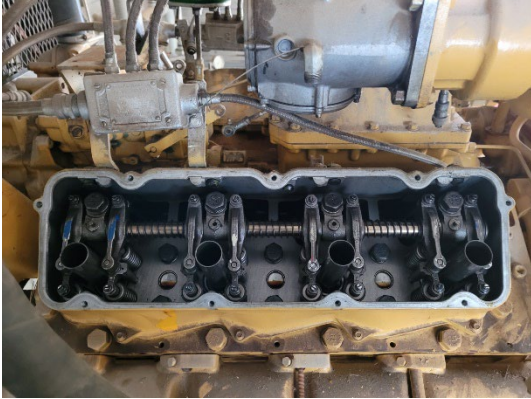
-The interior of the engine appears to be rust free

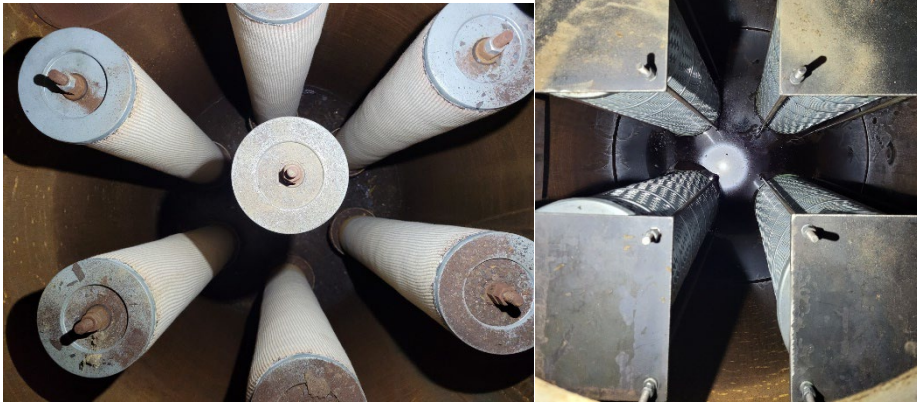
Suction and coalescer vessels

-Appear to be complete with minimal rust
