Inspections Performed for: FMC Technologies Completion – Grand Junction

Inspection Report for: LH-0010 Line Heater

LH-0010 Line Heater

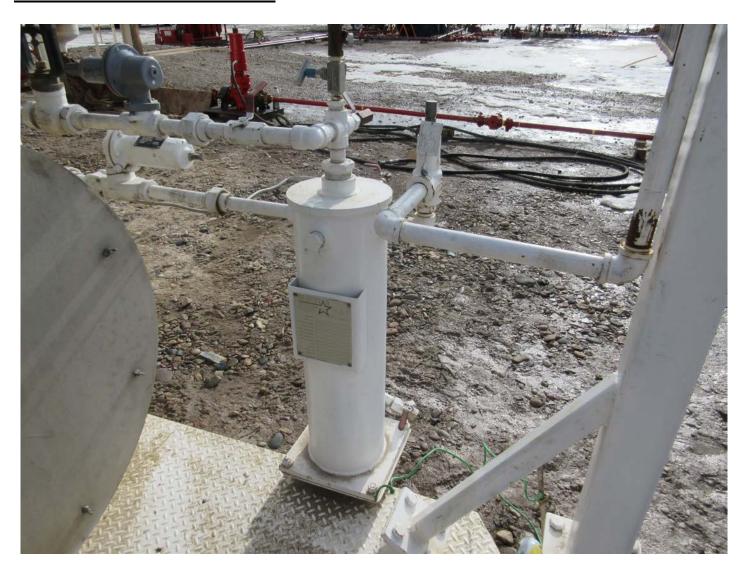
LH-0010-FGS-2 Fuel Gas Scrubber

Condition of Nameplate and/or Bracket: Nameplate is intact and legible. The nameplate bracket is securely attached.

Condition of Paint and/or Insulation: The paint is in acceptable condition with minor localized chipping and peeling.

Condition of Welds; Head and Shell Metal Surfaces: All (exposed) metal surfaces are painted. There is no distortion or indication of corrosion beneath the paint coating. The pressure boundary welds have no visual weld defects. Paint has minor chipping.

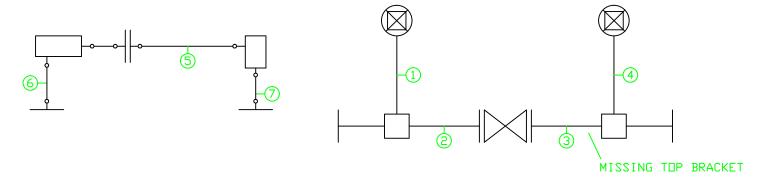
#1.01- STR-F 0.772 D5	#2. 04- STR-R 0. 779 D5	#4. 03- STR-BK 0. 748 D5	#6. 02- STR-L 0. 749 D5
#1.02- STR-L 0.726 D5	#3. 01- STR-T 0. 766 D5	#4. 04- STR-R 0. 740 D5	#6.03- STR-BK 0.761 D5
#1.03- STR-BK 0.718 D5	#3. 02- STR-L 0. 745 D5	#5. 01- STR-T 0. 715 D5	#6. 04- STR-R O. 743 D5
#1.04- STR-R 0.731 D5	#3. 03- STR-BTM 0. 743 D5	#5. 02- STR-F 0. 714 D5	#7. 01- STR-F 0. 818 D5
#2.01- STR-T 0.783 D5	#3. 04- STR-R 0. 747 D5	#5. 03- STR-BTM 0. 704 D5	#7. 02- STR-L 0. 829 D5
#2.02- STR-L 0.757 D5	#4. 01- STR-F 0. 751 D5	#5. 04- STR-BK 0. 727 D5	#7. 03- STR-BK 0. 819 D5
#2.03- STR-BTM 0.715 D5	#4. 02- STR-L 0. 752 D5	#6.01- STR-F 0.740 D5	#7. 04- STR-R 0. 831 D5

Caution TML Logic: TML Corrosion Rate > 15.0 MPY .OR. TML Remaining Life < 3.00 Years. There are 1 Caution TMLs in this Eq/Circ ID.
