| <b>Inspection Report for:</b> LH-0033 | |

**FMC Technologies Completion LH-0033 Line Heater**

## API 510 PRESSURE VESSEL EXTERNAL INSPECTION

**Reason for Inspection:** Initial API-510 Stream Inspection

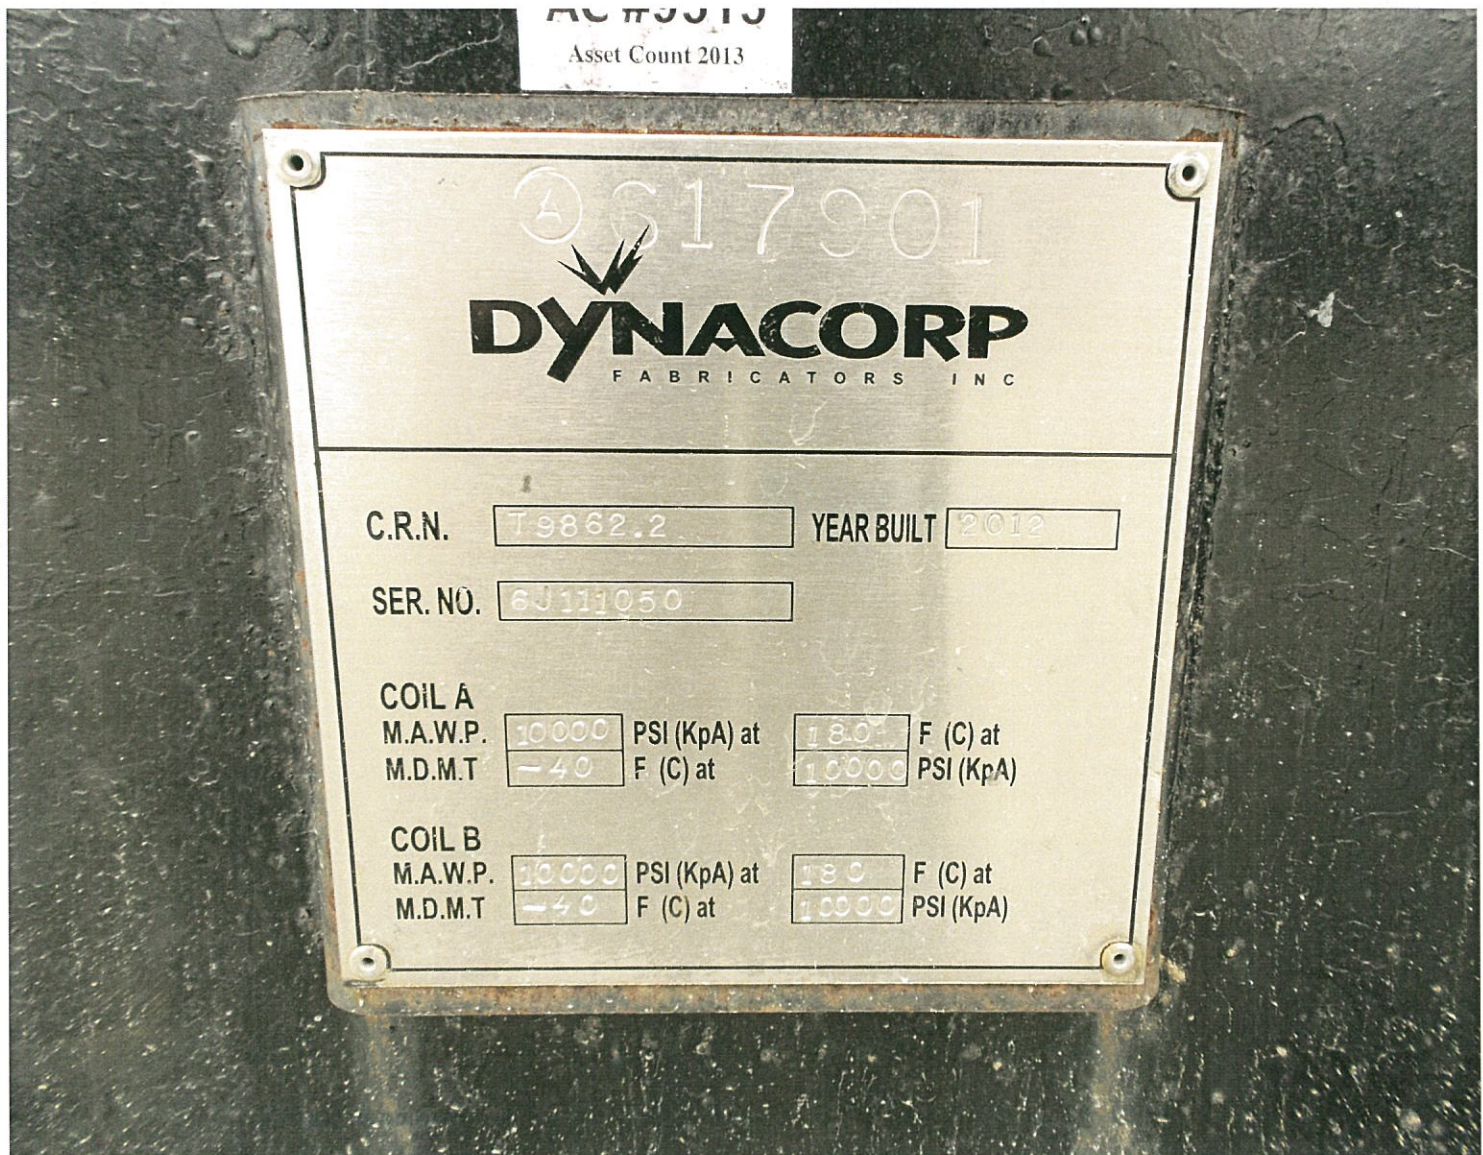
**Nameplate Coils # 1 and Coils # 2**

**Condition of Nameplate and/or Bracket:** Nameplate is intact and legible. The nameplate bracket is securely attached. Nameplate is in new condition with no surface corrosion present.

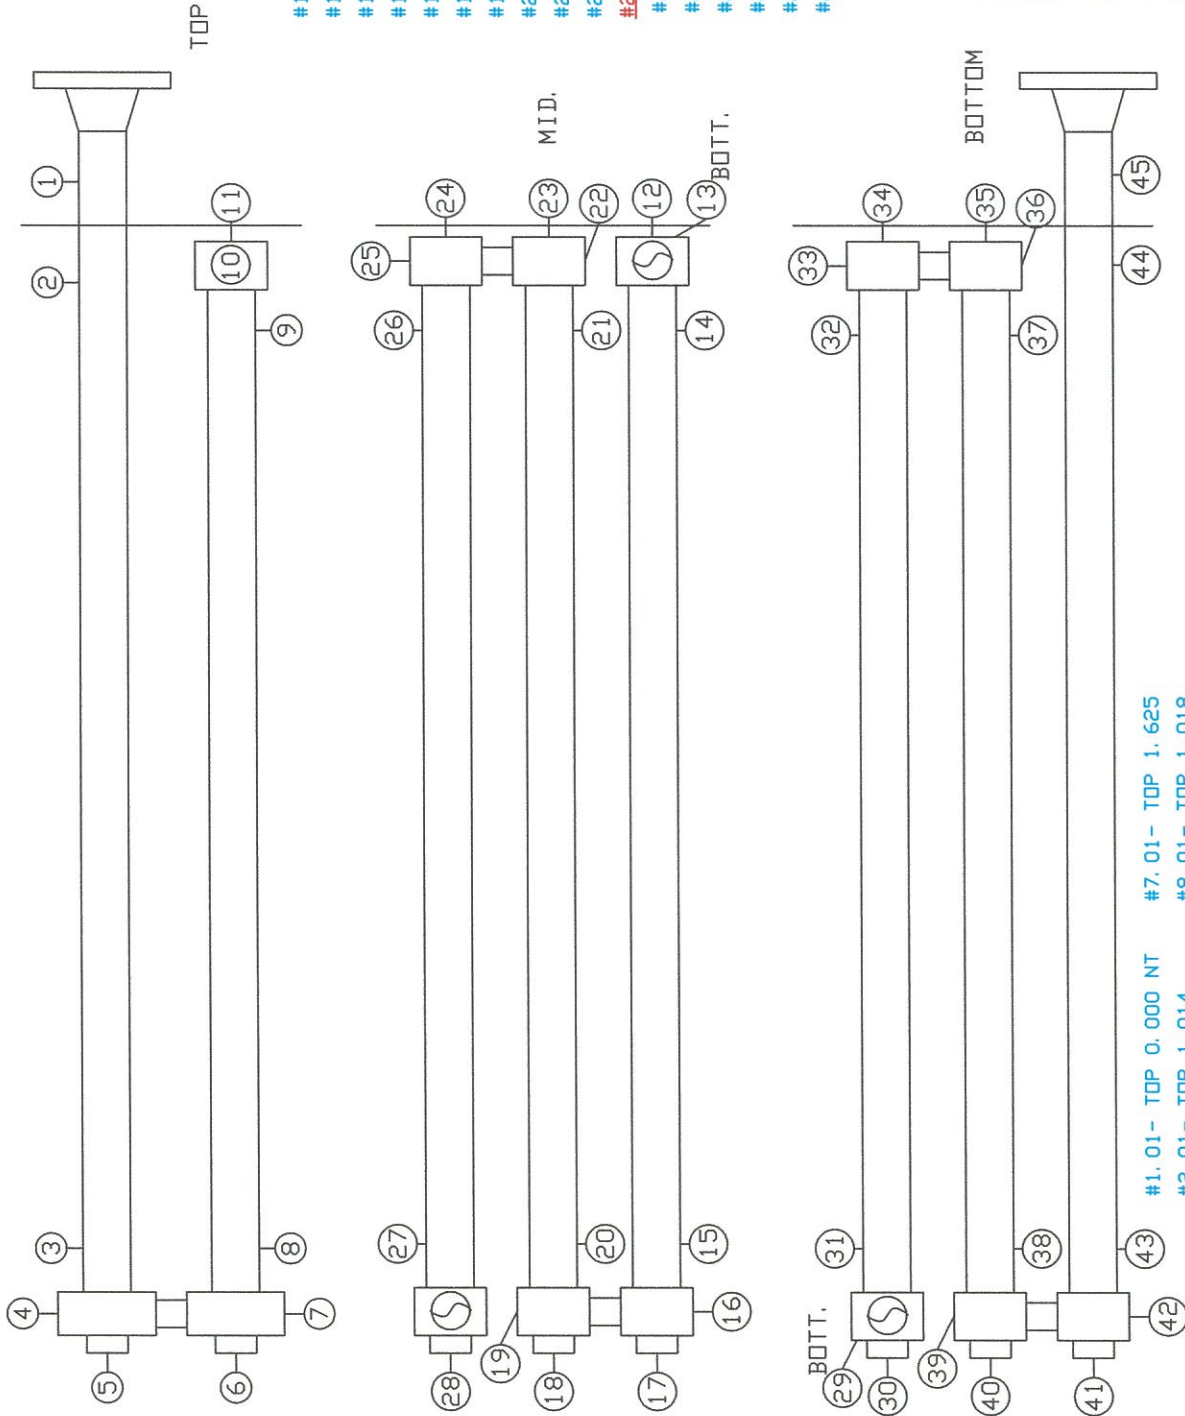
DESC: COIL A ON LH-0033 LINE HTR; SN: 6J111050  
DWG#: LH0033-C1-1.01-45.01

- #13.01- MID 1.104 #30.01- BTM 1.629
- #14.01- MID 1.026 #31.01- BTM 1.025
- #15.01- MID 0.997 #32.01- BTM 1.003
- #16.01- MID 1.618 #33.01- BTM 1.637
- #17.01- MID 2.496 #34.01- BTM 2.511
- #18.01- MID 1.617 #35.01- BTM 1.663
- #19.01- MID 0.000 NT #36.01- BTM 2.535
- #20.01- MID 0.997 #37.01- BTM 1.007
- #21.01- MID 1.008 #38.01- BTM 1.062
- #22.01- MID 1.674 #39.01- BTM 0.000 NT
- ~~#23.01- MID 2.476~~ #40.01- BTM 1.742
- #24.01- MID 1.612 #41.01- BTM 2.520
- #25.01- MID 2.490 #42.01- BTM 1.648
- #26.01- MID 1.000 #43.01- BTM 0.996
- #27.01- MID 1.023 #44.01- BTM 1.982
- #28.01- MID 2.490 #45.01- BTM 1.034
- #29.01- BTM 0.000 NT

Group Description:  
RCR = 7.2 MPY  
Rem. Life (from last survey 08/27/2013) = 32.6 yrs

0 C.A. Status: No  
Total Caution TMLs = 1

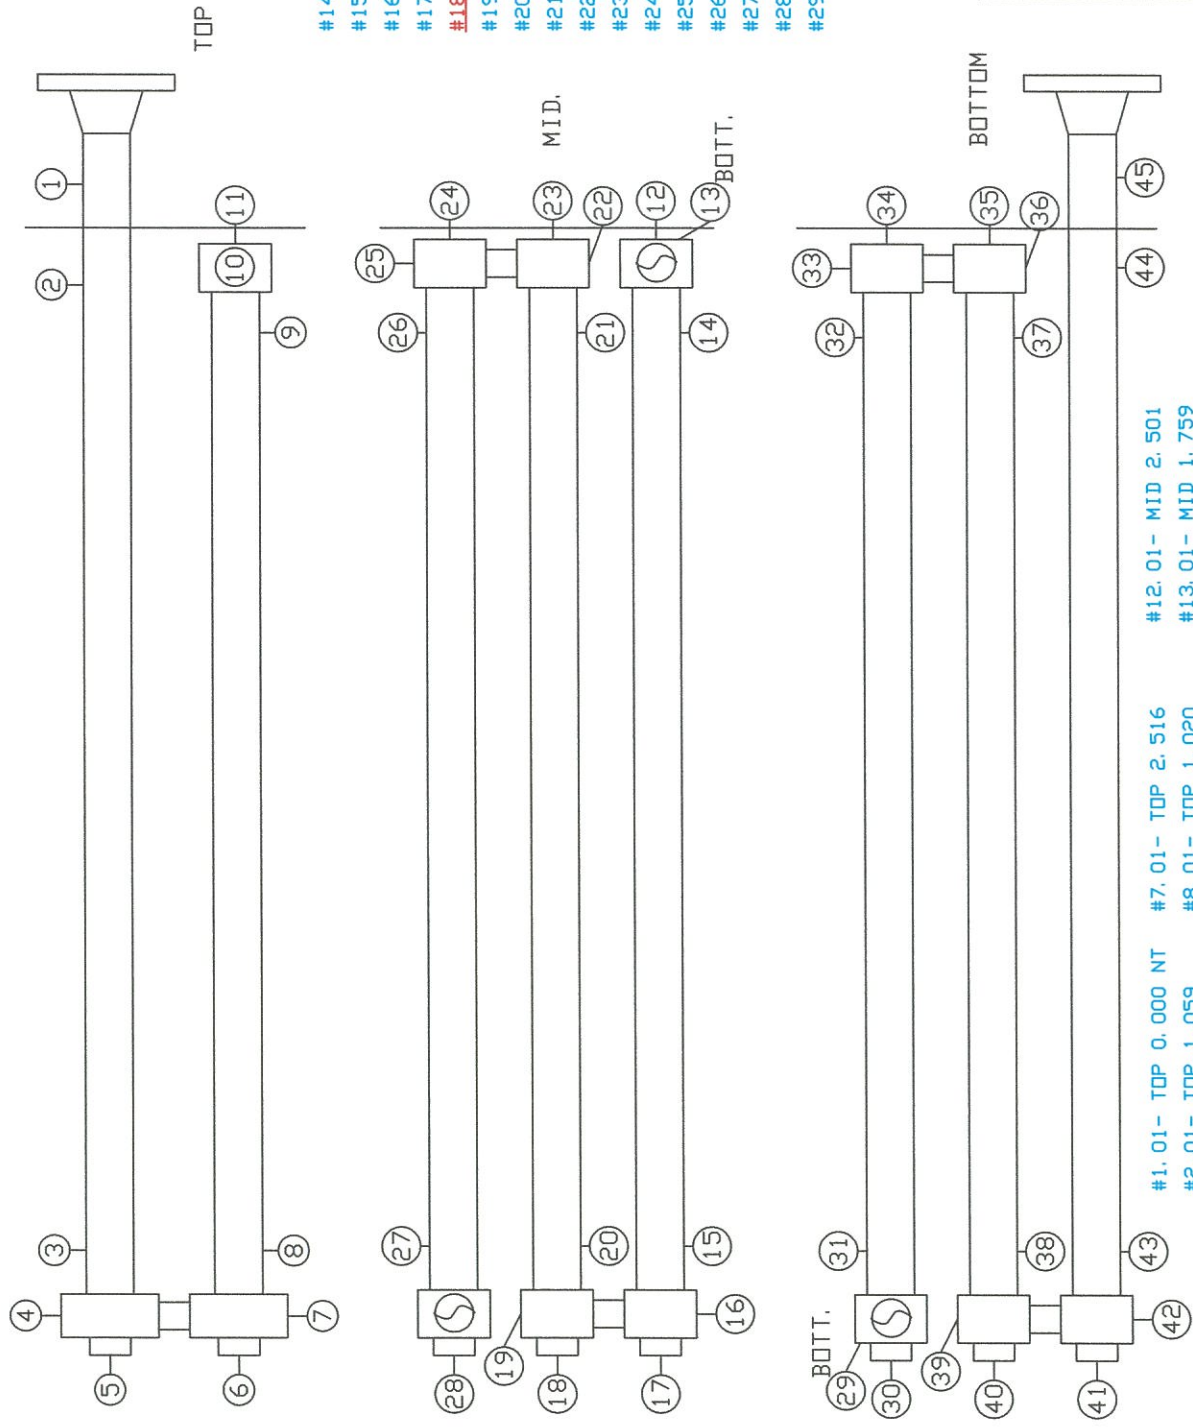
| #14.01- MID 1.014 | #30.01- BTM 2.503 |
| #15.01- MID 0.983 | #31.01- BTM 1.002 |
| #16.01- MID 2.523 | #32.01- BTM 0.996 |
| #17.01- MID 1.623 | #33.01- BTM 2.494 |
| #18.01- MID 2.459 | #34.01- BTM 1.895 |
