<b>Inspections Performed for:</b> FMC Technologies Completion	
<b>Inspection Report for:</b> LH-0033 – Coil 1	
<b>Remaining Life:</b> 4.1 YRS	<b>Date of this Report:</b> 09/11/2018
<b>Average Corrosion Rate:</b> 129.4 MPY	<b>Next UT:</b> 09/11/2019 <b>Next VT:</b> 09/11/2019
<b>Manufacturer:</b> DynaCorp Fabricators	<b>Mfg Serial #:</b> 6J111050
<b>Date Built:</b> 2012	<b>National Board #:</b> None
<b>Alberta registration #:</b> 617901	<b>Canadian Registration #:</b> T9862.2

**FMC Technologies Completion LH-0033 Line Heater**

<b>Inspections Performed for:</b> FMC Technologies Completion	
<b>Inspection Report for:</b> LH-0033 – Coil 2	
<b>Remaining Life:</b> 20+ YRS	<b>Date of this Report:</b> 09/11/2018
<b>Average Corrosion Rate:</b> 17.3 MPY	<b>Next UT:</b> 09/11/2019 <b>Next VT:</b> 09/11/2019
<b>Manufacturer:</b> DynaCorp Fabricators	<b>Mfg Serial #:</b> 6J111050
<b>Date Built:</b> 2012	<b>National Board #:</b> None
<b>Alberta registration #:</b> 617901	<b>Canadian Registration #:</b> T9862.2

<b>Inspections Performed for:</b> FMC Technologies Completion – PA District	
<b>Inspection Report for:</b> LH-0033 Fuel Gas Scrubber	
<b>Remaining Life:</b> 17.9 YRS	<b>Date of this Repo

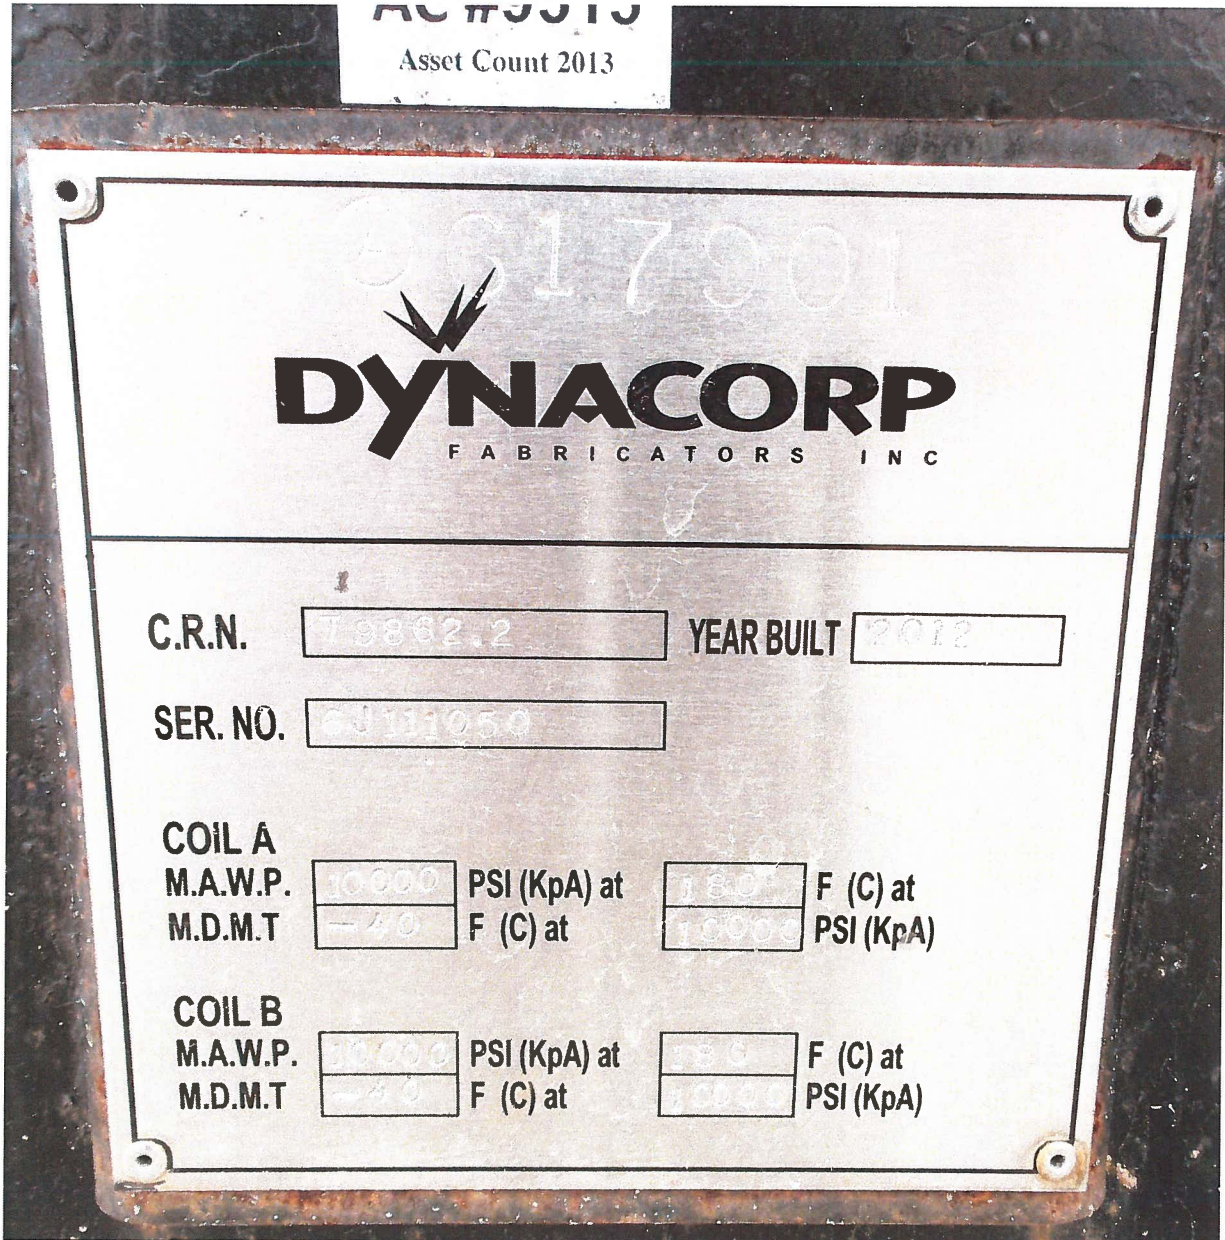
**Nameplate Coils # 1 and Coils # 2**

**Condition of Nameplate and/or Bracket:** Nameplate is missing. May require an authorized inspector to install one.

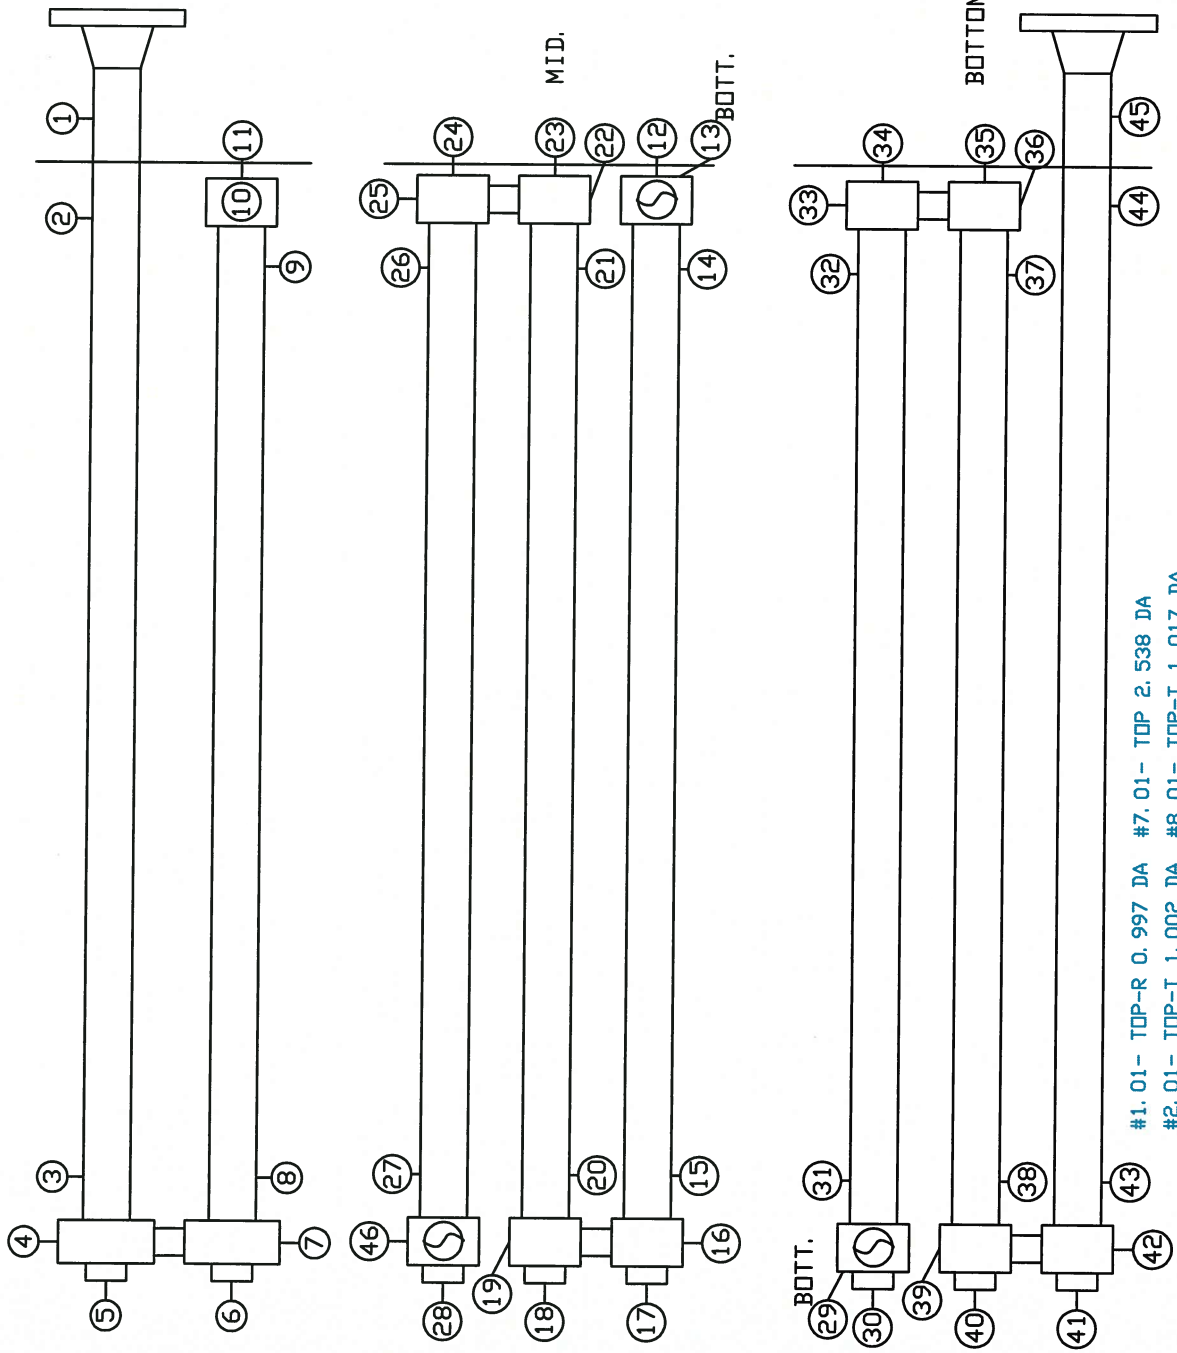
**DESC: COIL A ON LH-0033 LINE HTR; SN: 6J111050**  
**DWG#: LH0033-C1-1.01-46.01**

- DA-501
- #13.01- MID 0.000 NT #30.01- BTM 1.639 DA
  - #14.01- MID-T 1.018 DA #31.01- BTM 0.994 DA
  - #15.01- MID-R 0.965 DA #32.01- BTM-L 0.993 DA
  - #16.01- MID 1.634 DA #33.01- BTM 0.000 NT
  - #17.01- MID 2.513 DA #34.01- BTM 2.486 DA
  - #18.01- MID 1.663 DA #35.01- BTM 1.659 DA
  - #19.01- MID 0.000 NT #36.01- BTM 0.000 NT
  - #20.01- MID-L 1.038 DA #37.01- BTM 0.000 NT
  - #21.01- MID-L 1.009 DA **#38.01- BTM 0.000 NI**
  - #22.01- MID 0.000 NT #39.01- BTM 0.000 NT
  - #23.01- MID 2.507 DA #40.01- BTM 2.573 DA
  - #24.01- MID 1.603 DA **#41.01- BTM 1.622 DA**
  - #25.01- MID 2.539 DA #42.01- BTM 2.525 DA
  - #26.01- MID-T 0.984 DA #43.01- BTM-R 1.020 DA
  - #27.01- MID-L 1.019 DA **#44.01- BTM-T 0.985 DA**
  - #28.01- MID 1.661 DC** #45.01- BTM-L 1.009 DA
  - #29.01- BTM 2.552 DA #46.01- BTM 0.000 NT

- #1.01- TOP-R 0.997 DA #7.01- TOP 2.538 DA
- #2.01- TOP-T 1.002 DA #8.01- TOP-T 1.017 DA
- #3.01- TOP 1.031 DA #9.01- TOP-T 1.009 DA
- #4.01- TOP 1.668 DA** #10.01- TOP 1.637 DA
- #5.01- TOP 2.519 DC #11.01- TOP 0.000 NT
- #6.01- TOP 1.653 DA** #12.01- MID 0.000 NT

Representative Corrosion Rate = 129.4 MPY

Predicted Eq/Circ ID Retirement date is 10/10/2022

Recommended Eq/Circ UT/RT Inspection Date is 09/11/2019  
UT/RT Inspection Interval is 1.00 years.

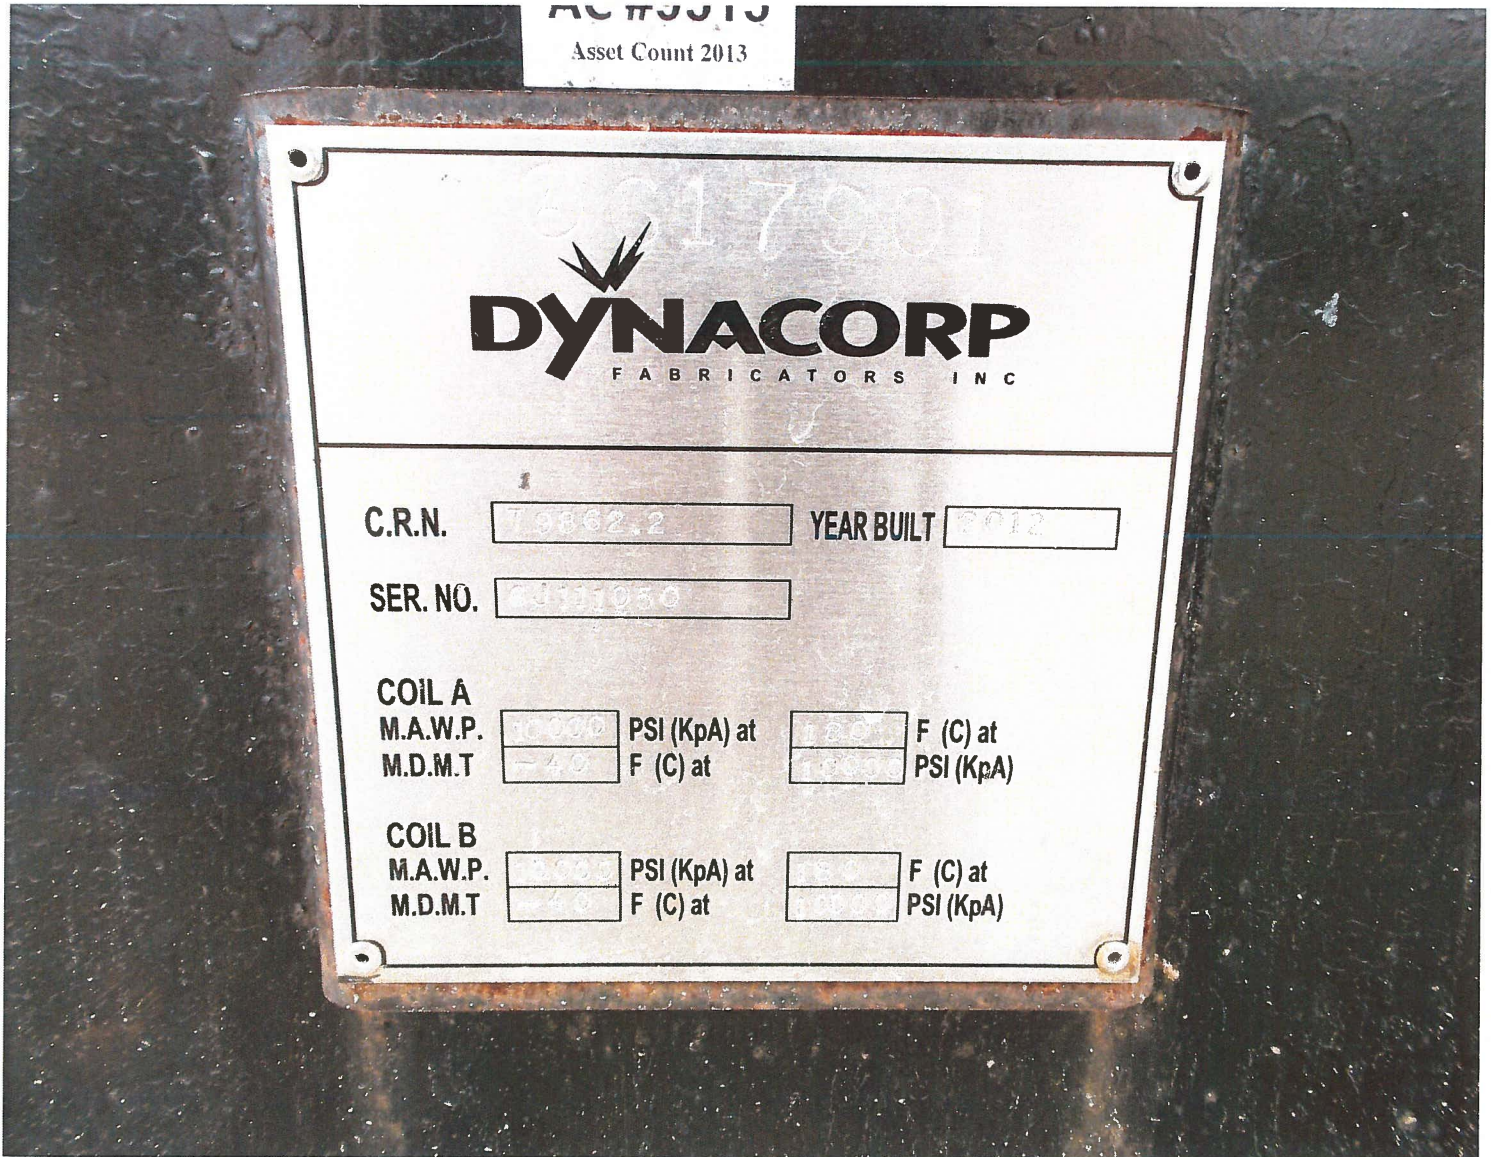
**Nameplate Coils # 1 and Coils # 2**

**Condition of Nameplate and/or Bracket:** Nameplate is missing. May require an authorized inspector in install a replacement nameplate.

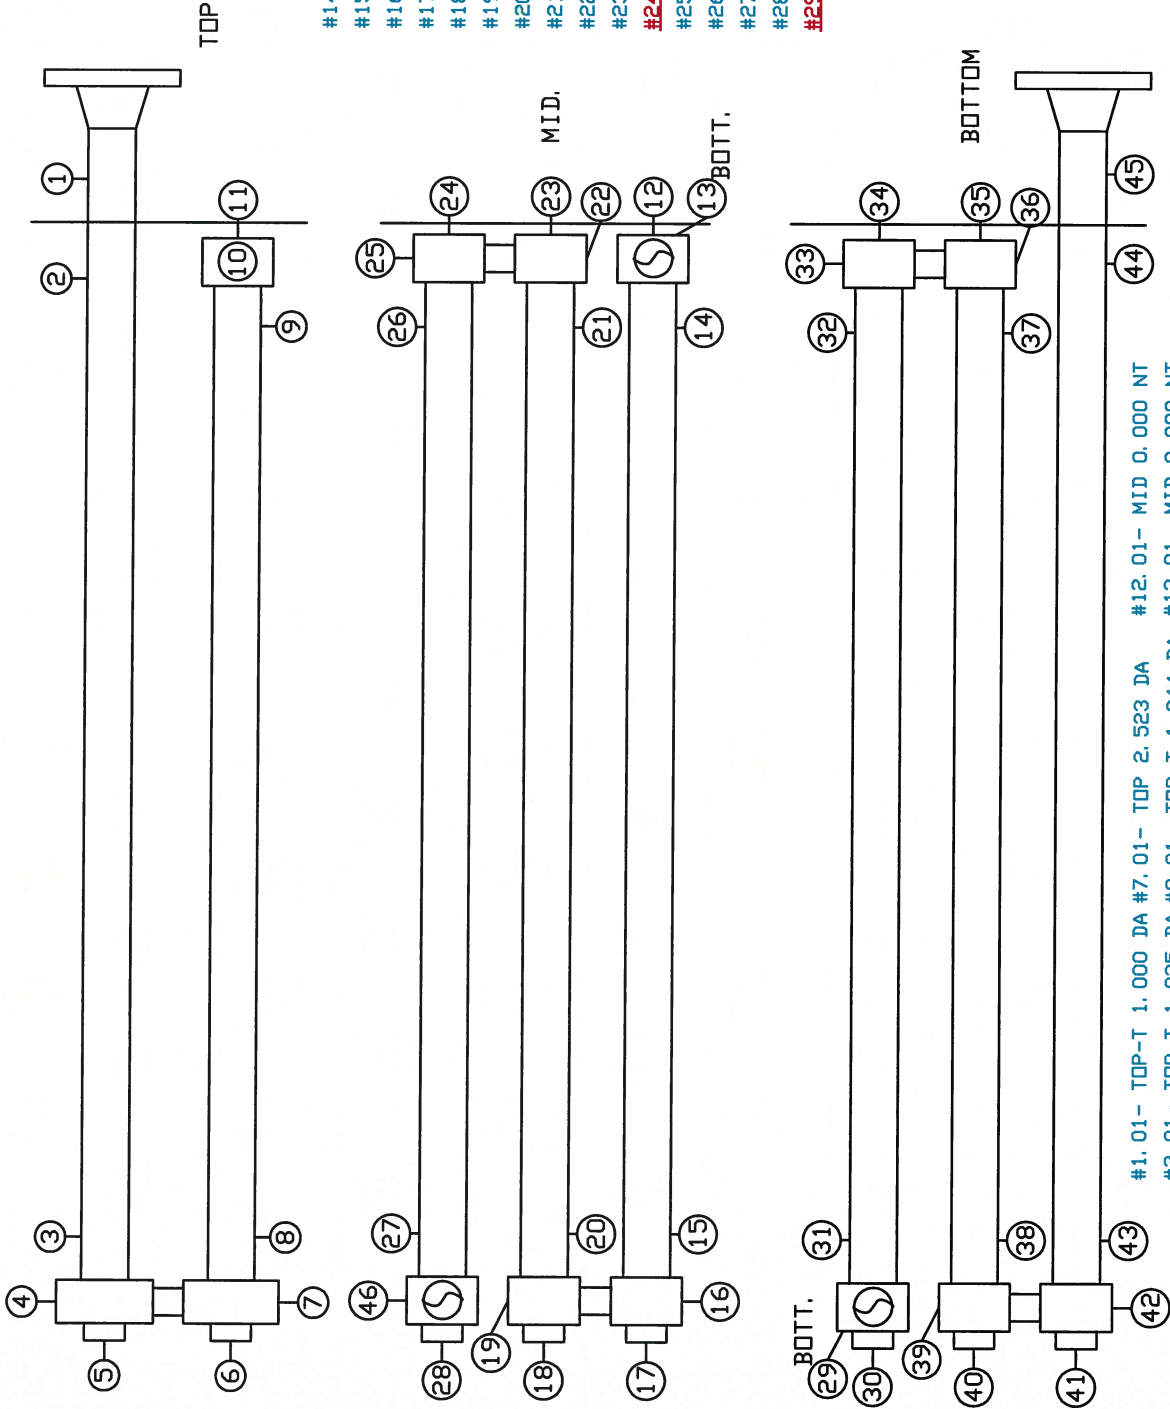
- #14. 01- MID-L 1. 029 DA #30. 01- BTM 2. 483 DA
- #15. 01- MID-L 1. 012 DA #31. 01- BTM-R 1. 046 DA
- #16. 01- MID 2. 543 DA #32. 01- BTM-T 1. 000 DA
- #17. 01- MID 1. 668 DA #33. 01- BTM 2. 567 DA
- #18. 01- MID 2. 534 DA ~~#34. 01- BTM 1. 648 DA~~
- #19. 01- MID 0. 000 NT #35. 01- BTM 2. 520 DA
- #20. 01- MID-T 1. 036 DA #36. 01- BTM 0. 000 NT
- #21. 01- MID-R 1. 018 DA #37. 01- BTM 0. 000 NT
- #22. 01- MID 0. 000 NT ~~#38. 01- BTM 0. 000 NT~~
- #23. 01- MID 1. 620 DA #39. 01- BTM 0. 000 NT
- ~~#24. 01- MID 2. 509 DA~~ #40. 01- BTM 2. 505 DA
- #25. 01- MID 1. 657 DA ~~#41. 01- BTM 1. 652 DA~~
- #26. 01- MID-T 0. 985 DA #42. 01- BTM 2. 557 DA
- #27. 01- MID-T 1. 046 DA #43. 01- BTM-L 1. 027 DA
- #28. 01- MID 2. 515 DA #44. 01- BTM-T 1. 038 DA
- ~~#29. 01- BTM 1. 621 DA~~ #45. 01- BTM 0. 000 NT
- #46. 01- BTM 0. 000 NT

Representative Corrosion Rate is the Maximum of:  
(A) -- Average Corrosion Rate x 1.00 : 7.4 MPY  
(B) -- Average Max 25.0% of TMLs, Min of 2 : 29.1 MPY  
(C) -- Formula Corrosion Rate (Sigma = 1.28) : 8.8 MPY  
(D) -- Default Corrosion Rate : 0.1 MPY  
Representative Corrosion Rate = 29.1 MPY

Recommended Eq/Circ UT/RT Inspection Date is 09/11/2019  
UT/RT Inspection Interval is 1.00 years.

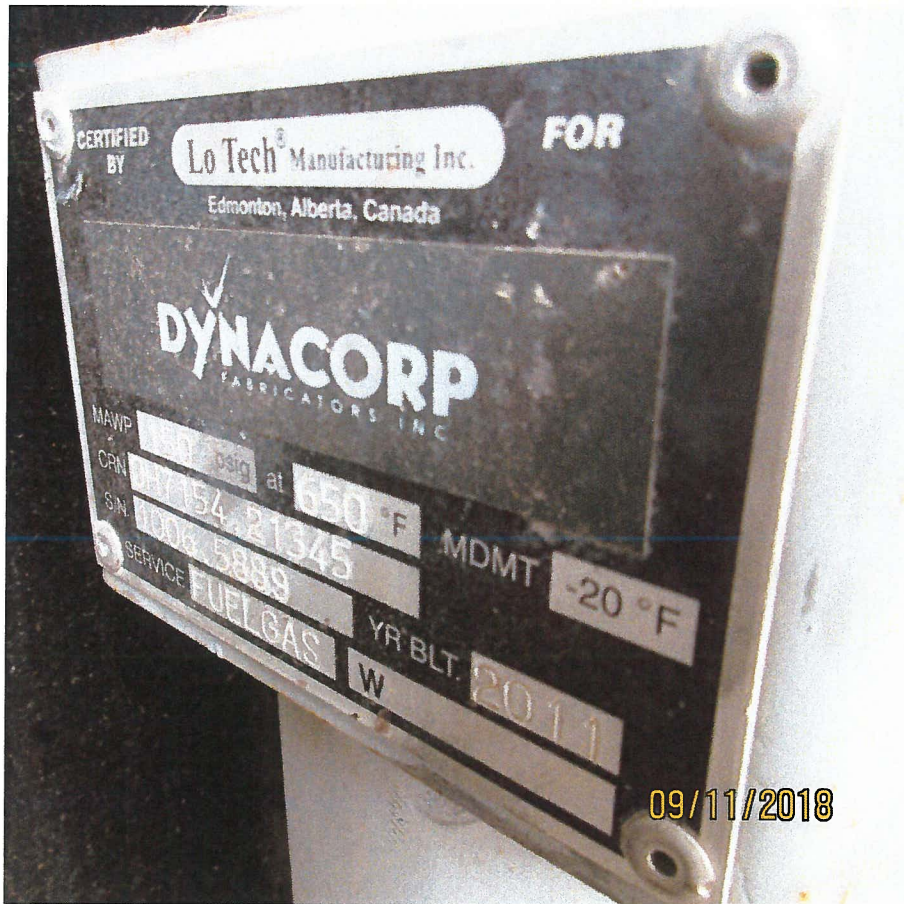
**Condition of Nameplate and/or Bracket:** Nameplate is intact and legible. The nameplate bracket is securely attached.

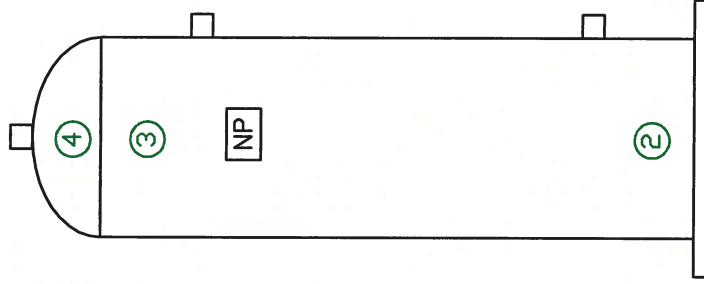
FH2E-D

- #2. 01- SH BTM - F 0. 279 FH
- #2. 02- SH BTM - L 0. 274 FH
- #2. 03- SH BTM - BK 0. 273 FH
- #2. 04- SH BTM - R 0. 280 FH
- #3. 01- SH TOP - F 0. 282 FH
- #3. 02- SH TOP - L 0. 292 FH
- #3. 03- SH TOP - BK 0. 283 FH
- #3. 04- SH TOP - R 0. 284 FH
- #4. 01- HD TOP - F 0. 284 FH
- #4. 02- HD TOP - L 0. 279 FH
- #4. 03- HD TOP - BK 0. 281 FH
- #4. 04- HD TOP - R 0. 281 FH

Representative Corrosion Rate is the Maximum of:  
(A) -- Average Corrosion Rate x 1.00 : 1.9 MPY  
(B) -- Average Max 25.0% of TMLs, Min of 2 : 3.4 MPY  
(C) -- Formula Corrosion Rate (Sigma = 1.28) : 2.6 MPY  
(D) -- Default Corrosion Rate : 0.1 MPY  
Representative Corrosion Rate = 3.4 MPY

Recommended Eq/Circ UT/RT Inspection Date is 09/11/2019  
UT/RT Inspection Interval is 1.00 years.
