<b>Inspections Performed for:</b> FMC Technologies Completion – PA District	
<b>Inspection Report for:</b> LH0035-C1 Line Heater	<b>Date Last Inspected:</b> 09/11/2018
<b>Remaining Life:</b> 10.2 YRS	<b>Next UT:</b> 09/11/2021 <b>Next VT:</b> 09/11/2021
<b>Representative Corrosion Rate:</b> 52.7 MPY	<b>Mfg Serial #:</b> 4049-01
<b>Manufacturer:</b> Coral Oilfield Services Inc.	<b>Alberta Registration #:</b> 626745
<b>Year Built:</b> 2013	<b>Canadian Registration #:</b> V6716.21

**FMC Technologies Completion LH0035-C1 (Coil 1)**

# API 510 PRESSURE VESSEL EXTERNAL INSPECTION REPORT

**FMC Technologies Completion LH0035-C2 (Coil 2)**

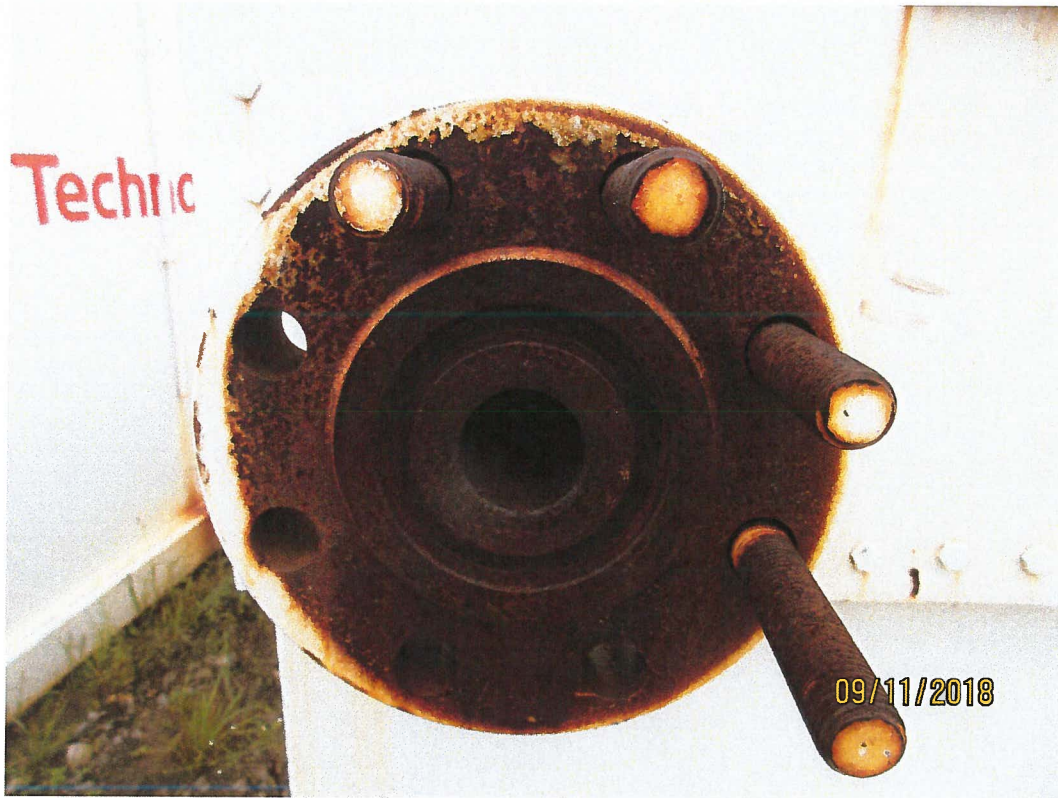
**Condition of Nozzles, Flanges, Repads, and Weepholes:** Nozzles and flanges are in good condition. Valves are removed. The outlet flanges are open and will require cleaning before reassembly. They are moderately corroded on the surface. (See attached photo)

Clean oxidation from around exposed flanges before reassembly

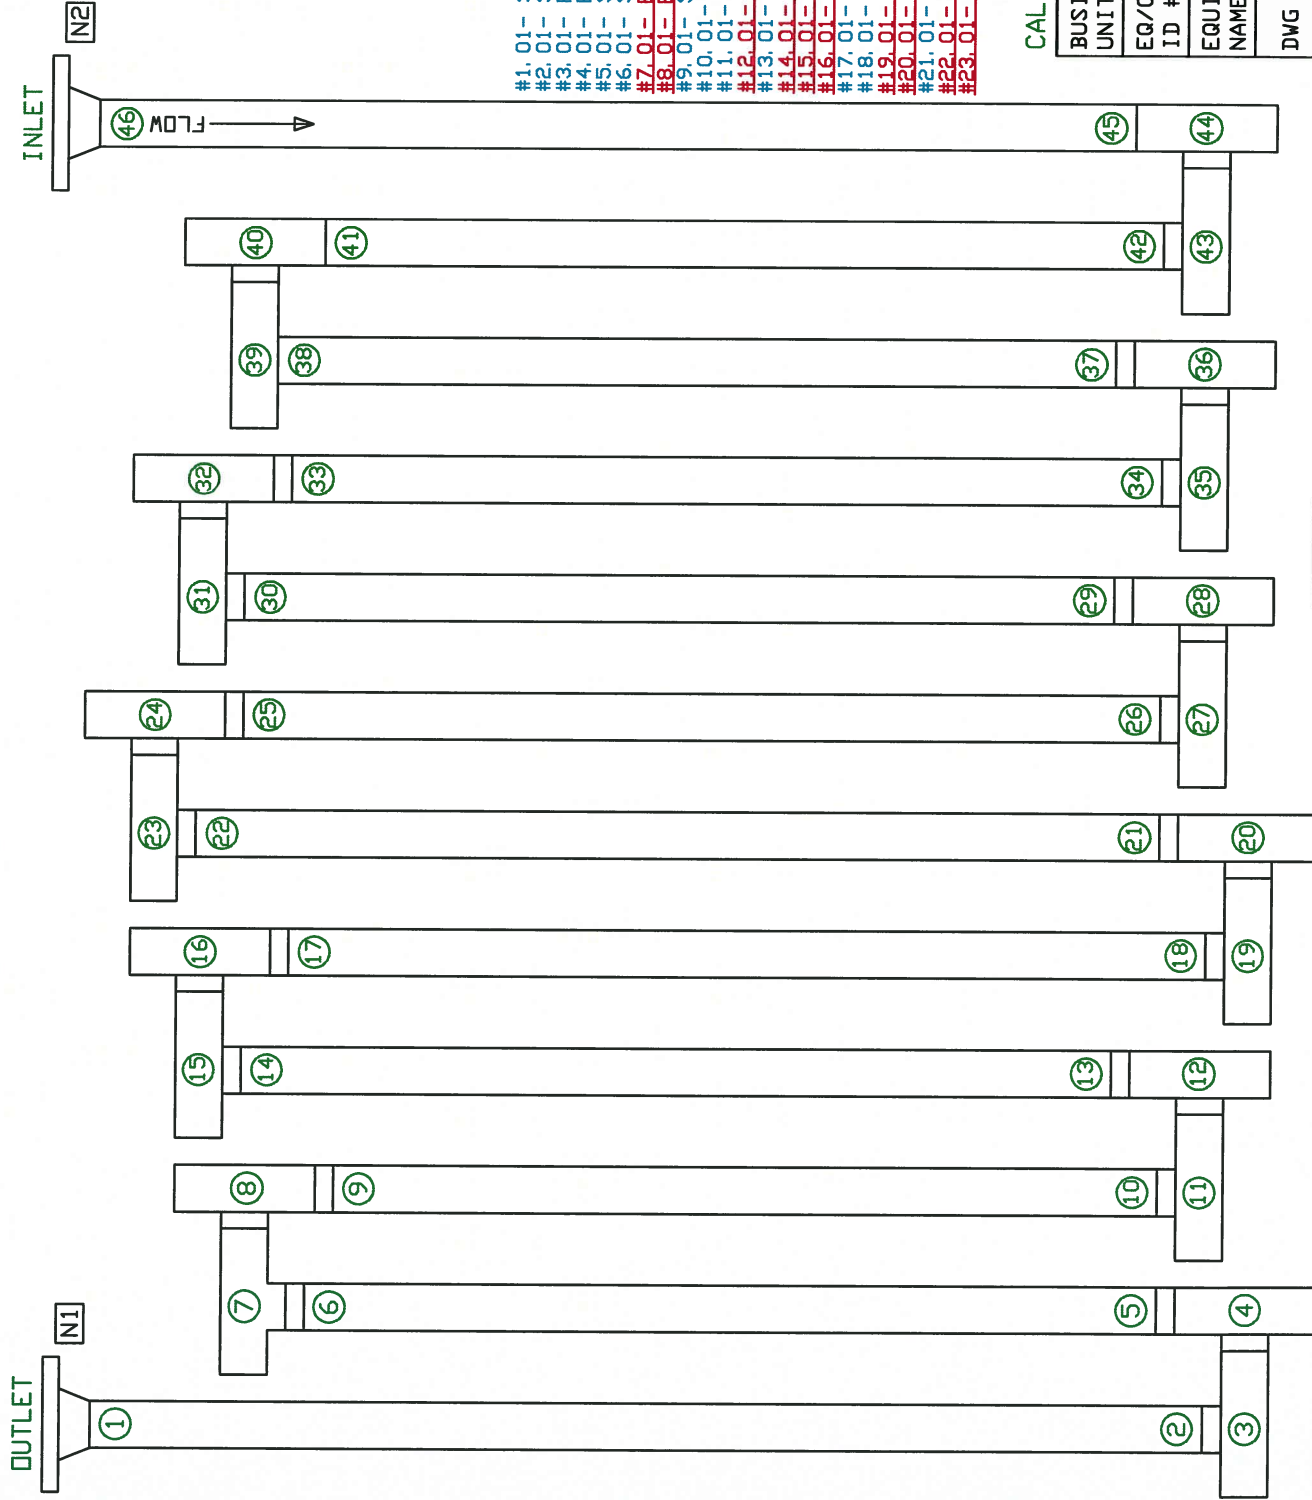
DESC: COIL 1 ON LINE HEATER  
DWG#: LH0035-C1-1.01-46.01

- #1. 01- STR-L 1.021 DA
- #2. 01- STR-B 1.014 DA
- #3. 01- END-L 1.241 DA
- #4. 01- END-BK 1.303 DA
- #5. 01- STR-L 1.027 DA
- #6. 01- STR-L 0.968 DA
- #7. 01- END-L 1.272 DA

- #8. 01- END-F 1.284 DA
- #9. 01- STR-R 1.027 DA
- #10. 01- STR-R 0.971 DA
- #11. 01- END-L 1.275 DA
- #12. 01- END-BK 1.297 DA
- #13. 01- STR-BT 1.003 DA
- #14. 01- STR-B 1.009 DA

- #15. 01- END-B 1.296 DA
- #16. 01- END-F 1.239 DA
- #17. 01- STR-T 0.994 DA
- #18. 01- STR-L 1.013 DA
- #19. 01- END-R 1.212 DA
- #20. 01- END-BK 1.256 DA

- #21. 01- STRBT 1.021 DA
- #22. 01- STR-LT 0.998 DA
- #23. 01- END-R 1.254 DA
- #24. 01- END-F 1.253 DA
- #25. 01- STR-B 1.002 DA
- #26. 01- STR-T 0.913 DA

- #27. 01- STR-R 1.274 DA
- #28. 01- END-BK 1.244 DA
- #29. 01- STR-L 1.003 DA
- #30. 01- STR-L 1.017 DA
- #31. 01- END-B 1.284 DA
- #32. 01- END-F 1.283 DA

- #33. 01- STR-L 1.017 DA
- #34. 01- STR-R 0.990 DA
- #35. 01- END-L 1.268 DA
- #36. 01- END-BK 1.281 DA
- #37. 01- STR-T 1.006 DA
- #38. 01- STR-T 0.986 DA

- #39. 01- END-F 1.243 DA
- #40. 01- END-F 1.249 DA
- #41. 01- STR-T 1.016 DA
- #42. 01- STR-R 0.975 DA
- #43. 01- END-L 1.259 DA
- #44. 01- END-L 1.267 DA
- #45. 01- STR-R 0.973 DA

- #46. 01- STR-L 0.986 DA

4 READINGS TAKEN AROUND  
THE CIRCUMFERENCE  
RECORDED THE LOWEST.

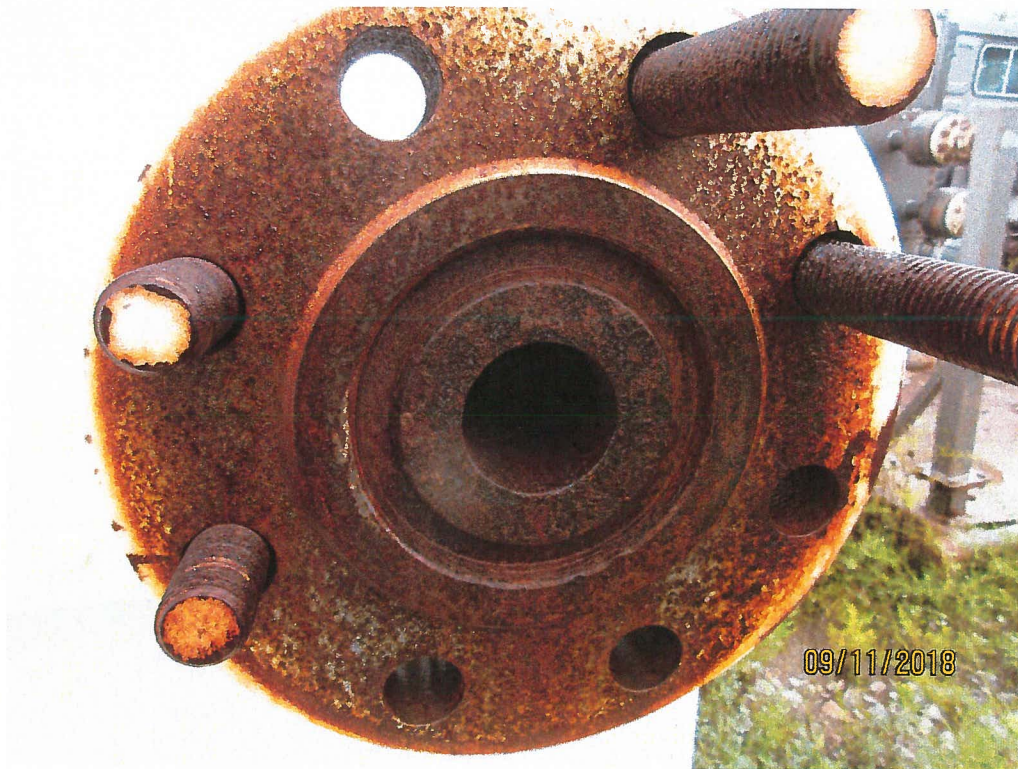
**Condition of Nozzles, Flanges, Repads, and Weepholes:** Nozzles and flanges are in good condition. Valve has been removed. The outlet flange is open. Exposed flange will require cleaning before use due to surface rust. (See attached photo)

Clean rust and oxidation off exposed flanges before reassembly.

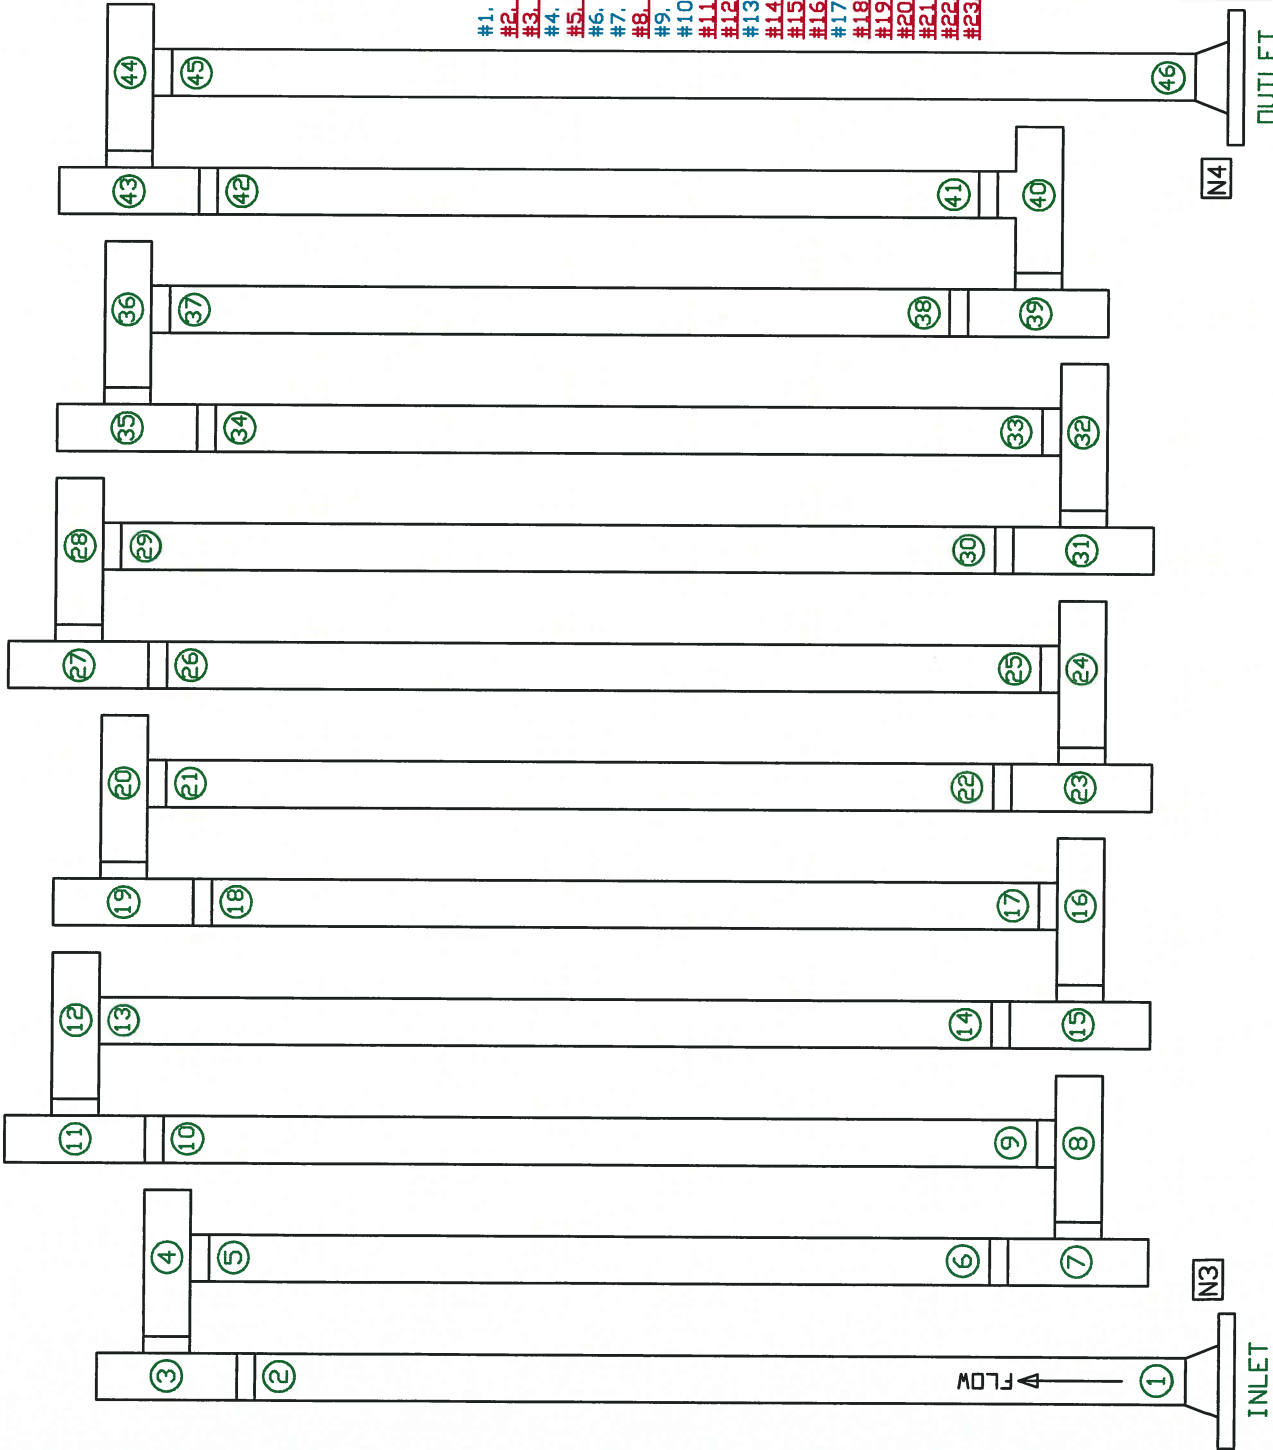
- #1. 01- STR-R 1.011 DA  
#2. 01- STR-L 1.003 DA  
#3. 01- END-L 1.196 DA  
#4. 01- END-B 1.280 DA  
#5. 01- STR-T 0.993 DA  
#6. 01- STR-B 1.028 DA  
#7. 01- END-L 1.258 DA

#8. 01- END-F 1.260 DA  
#9. 01- STR-B 0.968 DA  
#10. 01- STR-T 1.005 DA  
#11. 01- END-L 1.282 DA  
#12. 01- END-B 1.224 DA  
#13. 01- STR-B 0.980 DA  
#14. 01- STR-T 0.999 DA

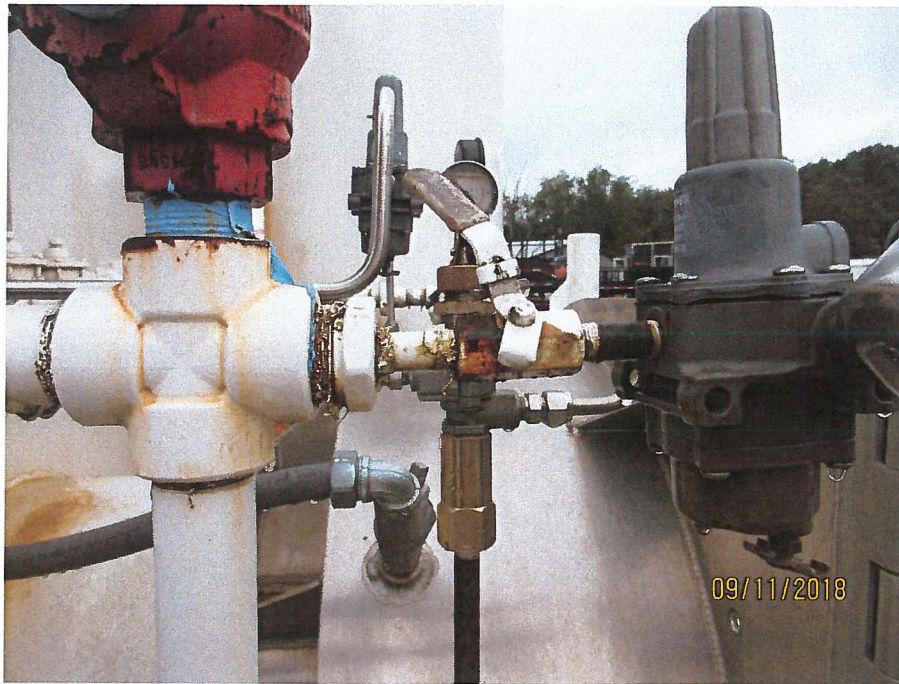
**Condition of Nozzles, Flanges, Repads, and Weepholes:** All threaded connections. There is no evidence of leaks at any of the threaded connections. Pressure regulator ¼" piping is bent upwards at the tee above the Scrubber. (See photo next page).

Replace ¼" piping at regulator above the Scrubber before placing in service.

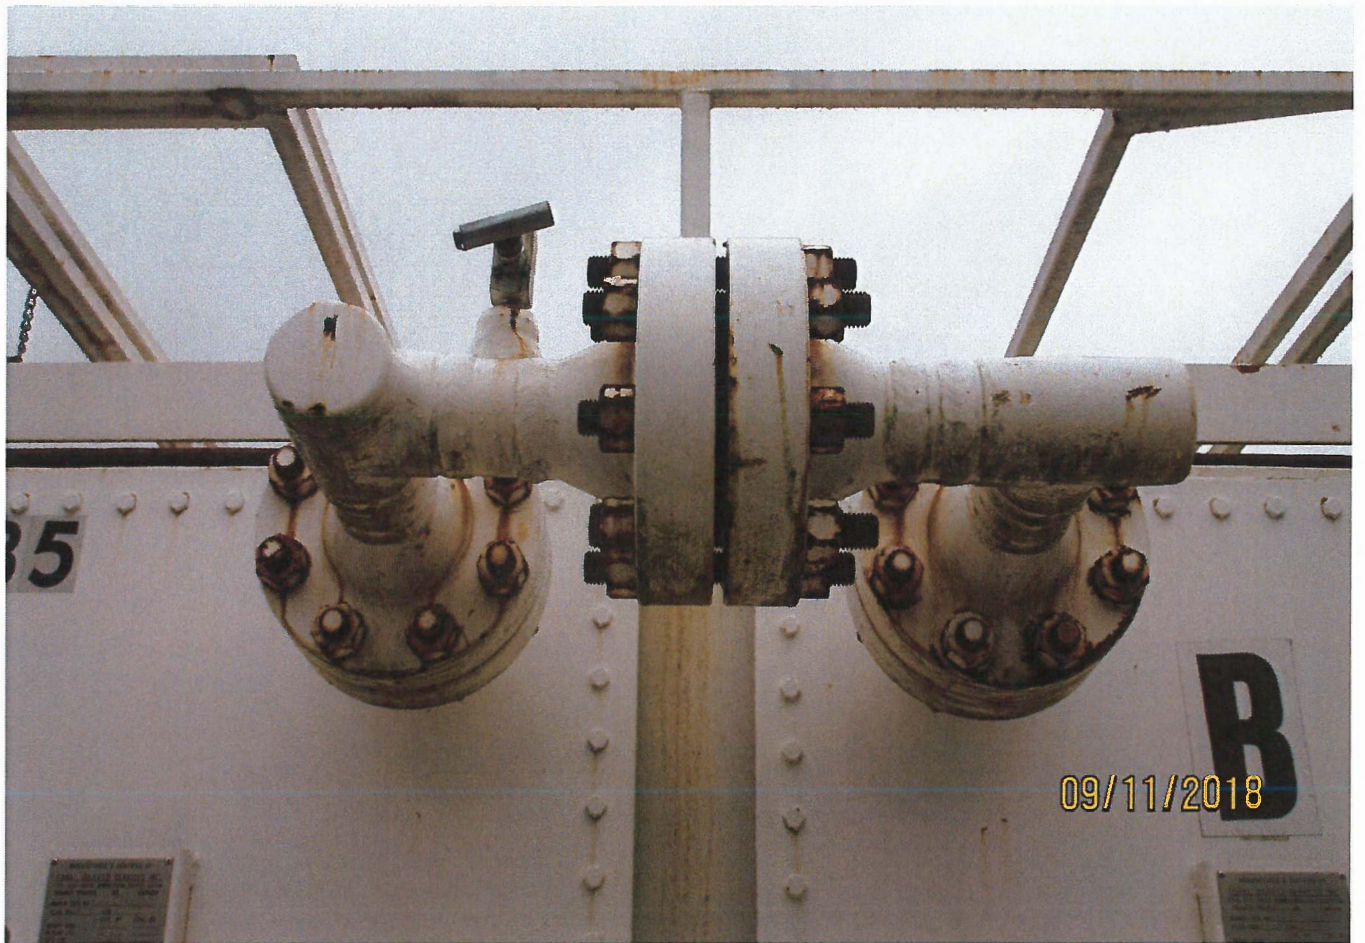
Mechanical Observations:	Comments:
<input type="checkbox"/> Deadleg <input type="checkbox"/> Damaged Flex Hose <input type="checkbox"/> Crack <input type="checkbox"/> Biological Growth <input type="checkbox"/> Threaded Exposed <input type="checkbox"/> Threaded Connections Not Seal Welded <input type="checkbox"/> Expansion Joint Issues <input type="checkbox"/> Low Point Without Drain <input type="checkbox"/> Open Ended <input type="checkbox"/> Vibration (Excessive) <input type="checkbox"/> Weep hole <input type="checkbox"/> Other <input checked="" type="checkbox"/> No Issues	Lower piping and valves are not attached (or on site). Upper pipe between coils only. (See attached photo).
