| <b>Inspection Report for:</b> LH0035-C1 Line Heater | <b>Date Last Inspected:</b> 10/27/2016 |

**FMC Technologies Completion LH0035-C1 (Coil 1)**

# API 510 PRESSURE VESSEL EXTERNAL INSPECTION REPORT

**FMC Technologies Completion LH0035-C2 (Coil 2)**

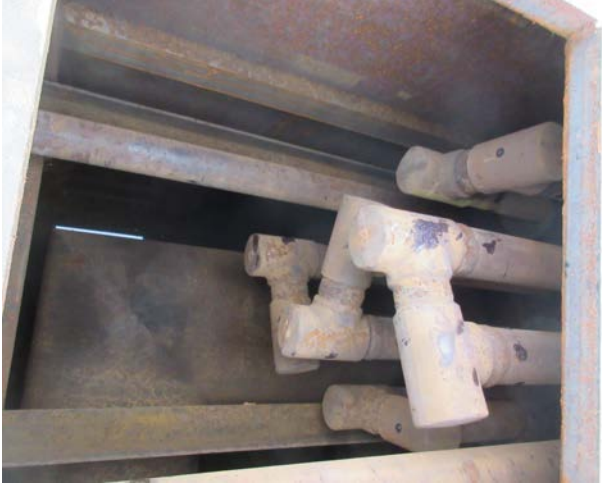
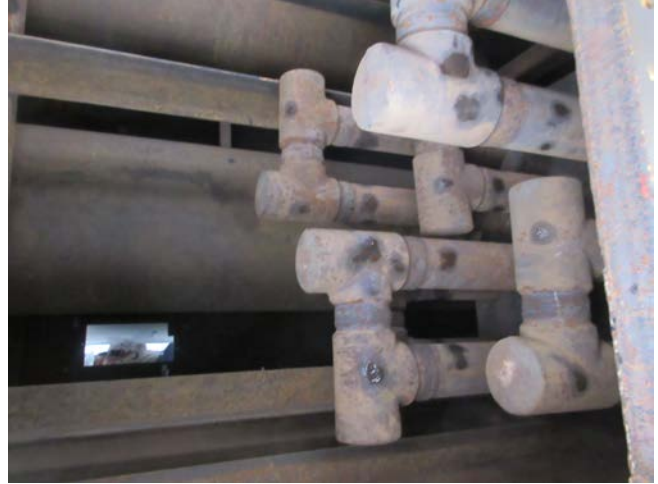
**Condition of Steel Supports, Saddles, and Bolting:** There is light corrosion on the angle iron bottom supports.

**Condition of Nozzles, Flanges, Repads, and Weepholes:** Nozzles and flanges are in good condition. There is a missing elbow on the inlet piping.

**Condition of Paint and/or Insulation:** The paint is in acceptable condition with minor localized chipping and peeling. There is light surface corrosion on the coils.

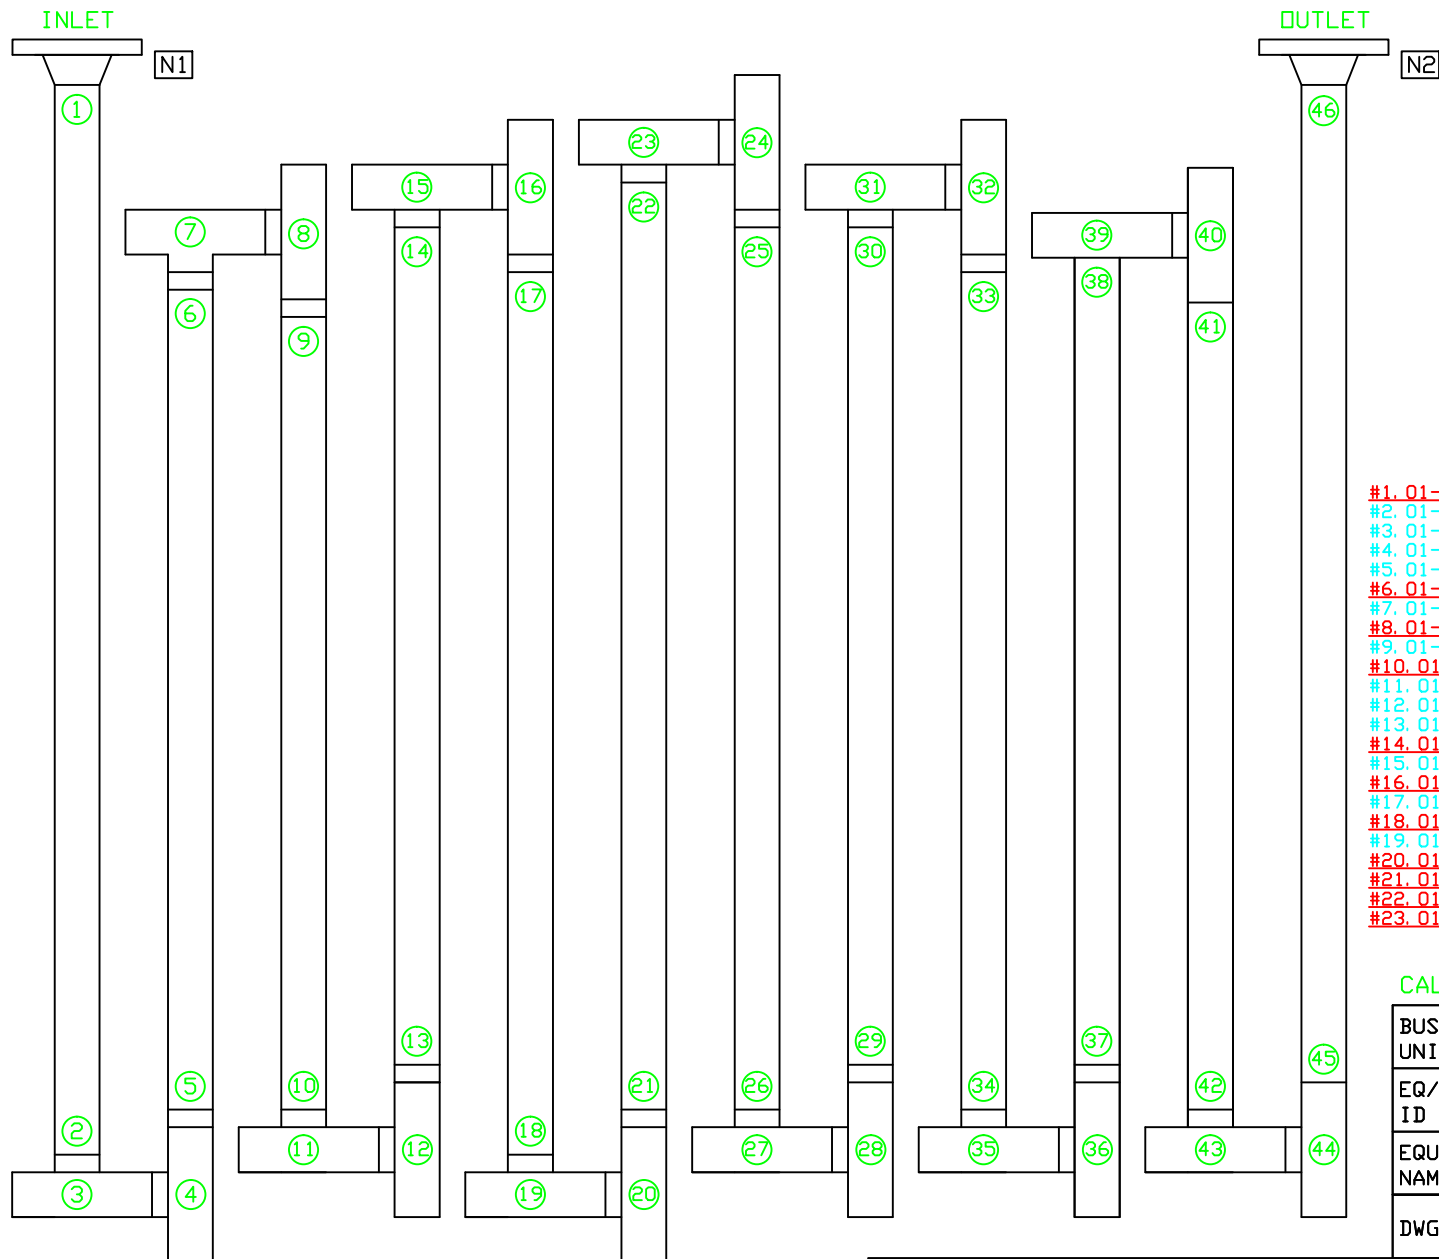
DESC: COIL 1 ON LINE HEATER  
DWG#: LH0035-C1-1.01-46.01

#1.01- STR-B 0.984 TC #24.01- END 1.246 TC  
#2.01- STR-T 0.995 TC #25.01- STR-B 1.006 TC  
#3.01- END 1.290 DC #26.01- STR-T 0.976 TC  
#4.01- END 1.283 TC #27.01- END 1.243 TC

#5.01- STR-L 1.029 TC #28.01- END 1.206 TC  
#6.01- STR-T 0.968 TC #29.01- STR-R 0.987 TC  
#7.01- END 1.286 TC #30.01- STR-L 1.006 TC  
#8.01- END 1.259 TC #31.01- END 1.292 TC

#9.01- STR-R 1.003 TC #32.01- END 1.252 TC  
#10.01- STR-R 0.956 TC #33.01- STR-L 1.004 TC  
#11.01- END 1.318 TC #34.01- STR-L 0.967 TC  
#12.01- END 1.310 TC #35.01- END 1.272 DC

#13.01- STR-R 0.996 TC #36.01- END 1.287 TC  
#14.01- STR-B 1.001 TC #37.01- STR-T 0.967 TC  
#15.01- END 1.298 TC #38.01- STR-T 0.956 TC  
#16.01- END 1.223 TC #39.01- END 1.227 TC

#17.01- STR-T 0.986 TC #40.01- END 1.267 DC  
#18.01- STR-L 0.982 TC #41.01- STR-T 1.010 TC  
#19.01- END 1.292 TC #42.01- STR-R 0.968 TC  
#20.01- END 1.253 TC #43.01- END 1.258 TC

#21.01- STR-L 0.984 TC #44.01- END 1.267 TC  
#22.01- STR-T 0.976 TC #45.01- STR-B 0.980 TC  
#23.01- END 1.243 TC #46.01- STR-B 0.982 TC

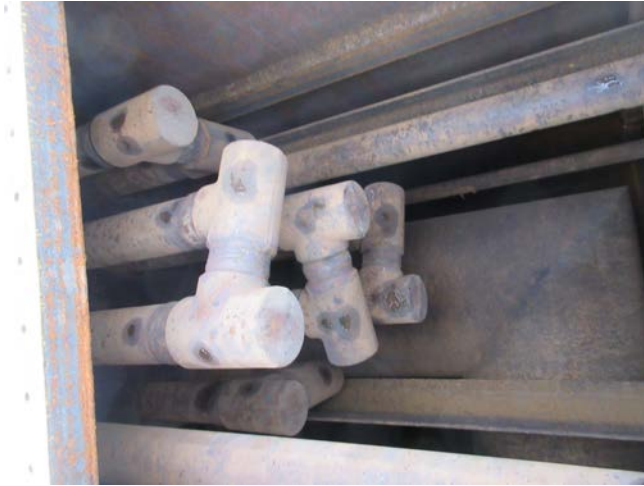
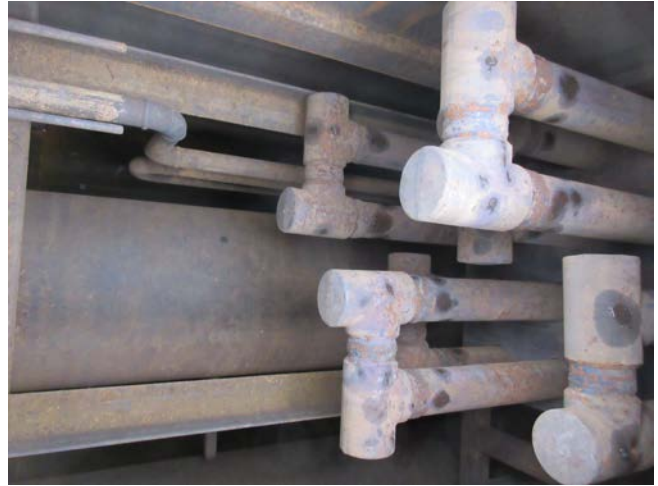
**Condition of Steel Supports, Saddles, and Bolting:** There is light corrosion on the angle iron bottom supports.

**Condition of Nozzles, Flanges, Repads, and Weepholes:** Nozzles and flanges are in good condition. There is a missing elbow on the inlet piping.

**Condition of Paint and/or Insulation:** The paint is in acceptable condition with minor localized chipping and peeling. There is light surface corrosion on the coils.

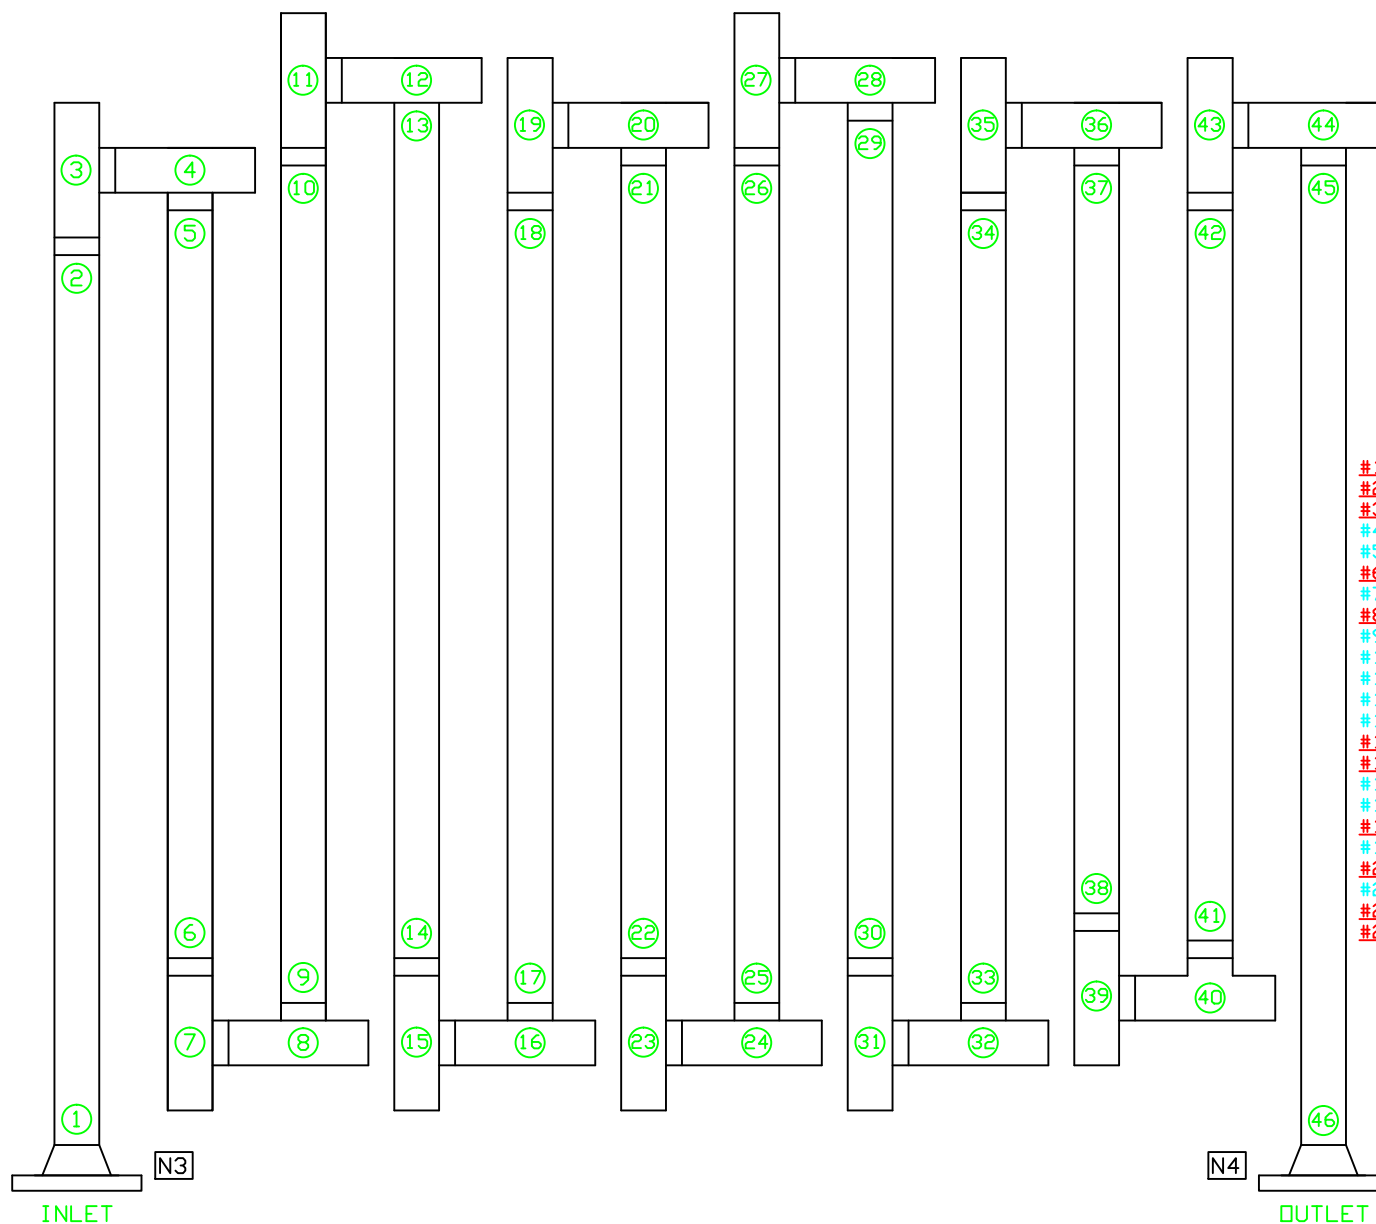
#1.01- STR-L 0.972 TC  
#2.01- STR-T 0.930 TC  
#3.01- END 1.269 TC  
#4.01- END 1.299 TC  
#5.01- STR-T 0.983 TC  
#6.01- STR-R 0.942 TC  
#7.01- END 1.267 TC

#8.01- END 1.231 TC  
#9.01- STR-R 1.009 TC  
#10.01- STR-R 0.993 TC  
#11.01- END 1.296 TC  
#12.01- END 1.307 TC  
#13.01- STR-B 1.008 TC  
#14.01- STR-R 0.946 TC

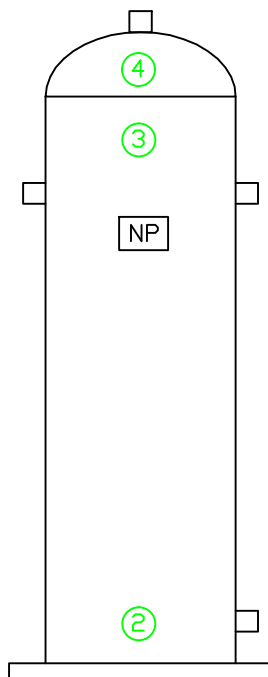
- ```
#2. 01- BTM SHELL-F 0. 340 TC
#2. 02- BTM SHELL-L 0. 338 TC
#2. 03- BTM SHELL-BK 0. 327 TC
#2. 04- BTM SHELL-R 0. 324 TC
#3. 01- TOP SHELL-F 0. 336 TC
#3. 02- TOP SHELL-L 0. 339 TC
#3. 03- TOP SHELL-BK 0. 328 TC
#3. 04- TOP SHELL-R 0. 324 TC
#4. 01- TOP HEAD-F 0. 279 TC
#4. 02- TOP HEAD-L 0. 274 TC
#4. 03- TOP HEAD-BK 0. 276 TC
#4. 04- TOP HEAD-R 0. 272 TC
```
