ULTRASONIC INSPECTION REPORT

DATE:	26-Sep-2016	REPORT #:	UT-CO26SEPT2016A
CLIENT:	TOURMALINE OIL CORP.	AVALANCHE JOB #:	16-105
LOCATION:	05-14-082-08W6M MULLIGAN BATTERY	PROJECT:	N/A
ITEMS EXAMINED:	SEPARATOR A0642464 4-8 O'CLOCK POSITION.		
PROCEDURE:	UT-01	CLIENT PO # / JOB #:	N/A
ACCEPTANCE CRITERIA	ASME VIII	SPECIFICATION:	AS PER CLIENT SPEC.

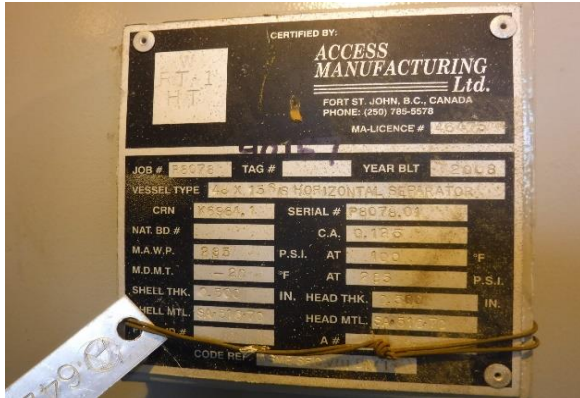
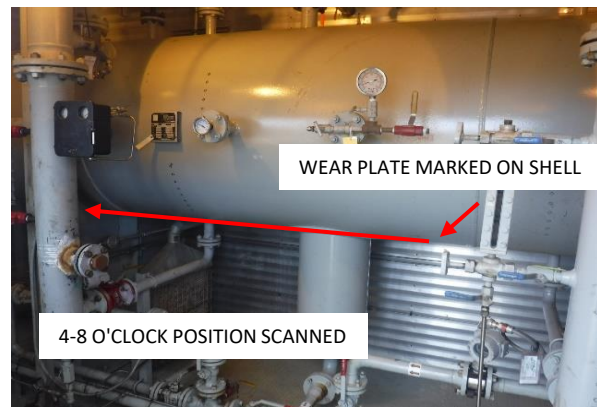
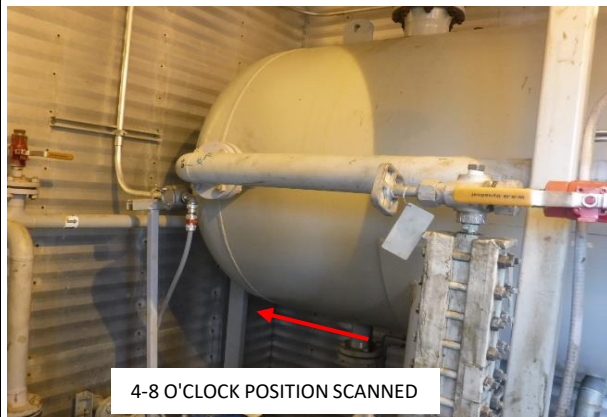
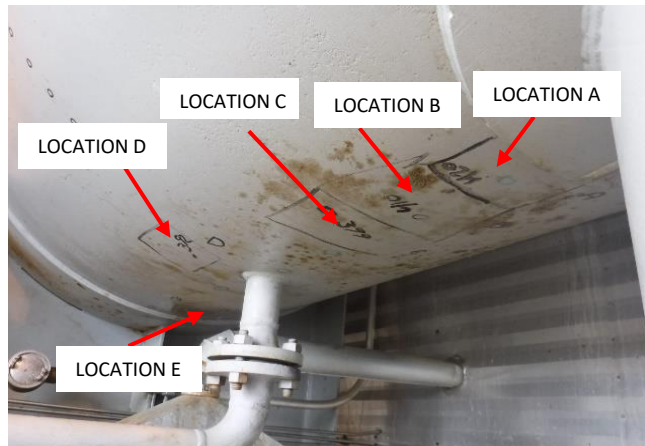
LOCATION A LOW	0.422"	BOOT HEAD SOUTHWEST SIDE	0.301"
LOCATION B LOW	0.410"	BOOT HEAD EAST SIDE	0.307"
LOCATION C LOW	0.399"		
LOCATION D LOW	0.392"		
LOCATION E LOW	0.415"

CORROSION NOTED THROUGHOUT THE 5-7 O'CLOCK POSITION. DEPTHS RANGING FROM 0.020" - 0.108" NOTED. CORROSION NOTED ON BOOT HEAD. LOWS OF 0.080" AND MORE BELOW NOMINAL WHERE MARKED OUT ON VESSEL AND RECORDED, AS PER TOURMALINE INSPECTOR KEVIN GAWLEY.

3 month interval for the UT grid on the bottom of the separator shell. JW Dec 13, 2016

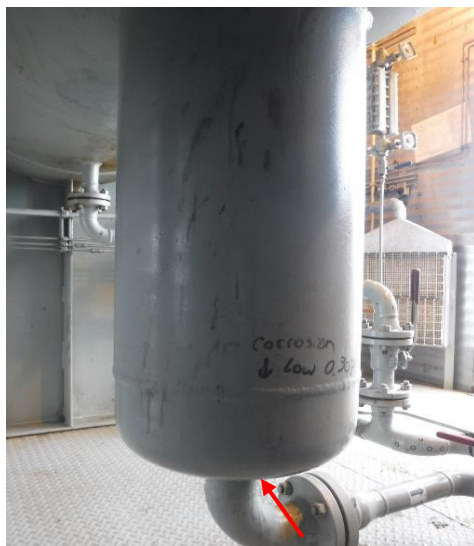
CORROSION ON EAST SIDE BOOT HEAD.

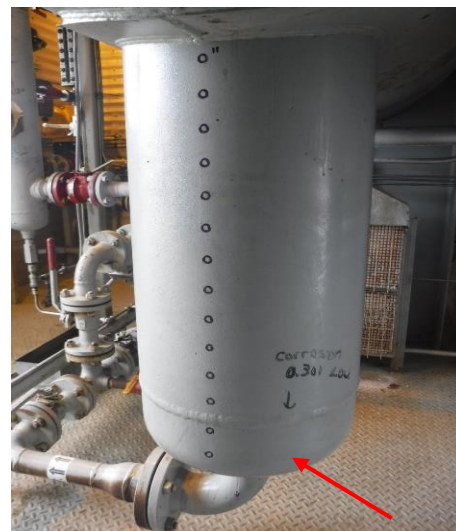
CORROSION ON SOUTHWEST BOOT HEAD
