STATIC E	QUIPMEN	IT INSPEC	TION REPO	ORT - Exhibit	# 300a	
COMPANY: 1	Tourmaline				E-TEGRIT	Y JOB #:	
	gan / Earring nlet Separator	_Facility: <u>5</u>	-14	Lsd	05-14-082-08V	/6M Skid:	Inlet building 2
VESSEL DATA							
Equip#:		Serial #:	P8078.0	1 ABSA#:	0642464	CRN #:	K6964.1
	ss Manufacturino	Code/Div.:	8 div 1	Para:		Code Stamp:	
Yr. Built: 2008		Size:			Actual Est	Insulated:	No
Service: Sour		PWHT:	HT	R.T.:	1	Repairs:	No
Nominal Thickr	ness & Material	_					
Top Head:).5" Ma	terial: SA 5	16-70 c	.A. 0.125"		Reasons:	
Bottom Head:					_		
Shell:).5"	SA 5	16-70	0.125"	_	Status: 🗸	IN SERVICE
Shell:					_		OUT OF SERVICE
Tube:	_		_		_	Manway	S
_	_		_		_	Reason for I	
						✓ PLANNED	- IN SERVICE
Operating Pres: 7	70 psi	C	perating Tem	_{p:} 20 f	_	PROBLEM	INVESTIGATION
MAWP Shell: 2	285 ✓	Psi kPa	Temp:	100	F C	PROCESS	CHANGE
MAWP Tube:		Psi kPa	Temp:		F C	COMMISS	SIONING
Comments:							
PSV INFORMA	TION

EXTERNAL VISUAL INSPECTION

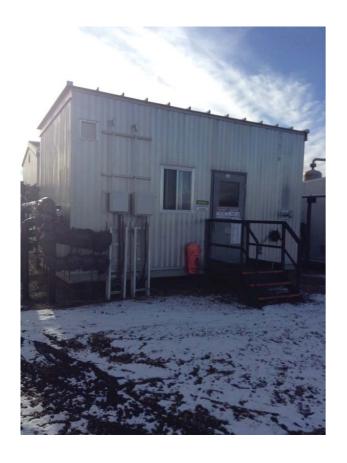
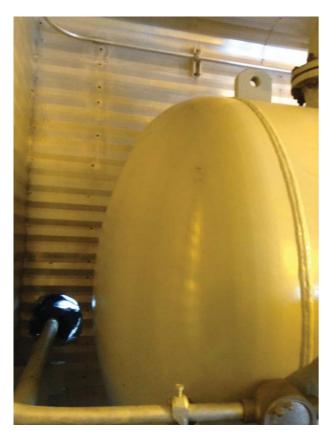
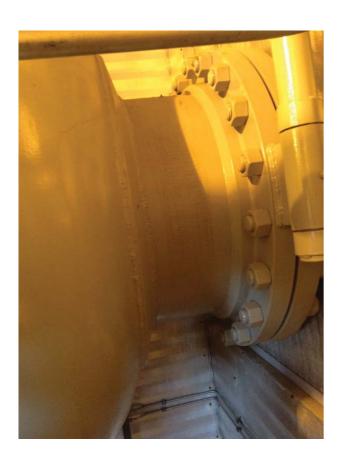
PICTURES:

OBSERVATIONS:				
✓ Vessel is in Good Condition				
 ✓ API 510 External Inspection confirmed the equipment is fit for continued servic NOT FIT FOR SERVICE, DETAILS BELOW 				
Vessel is in good condition Vessel was stamped by ABSA earlier this year. Inspection comments:				
Service PSV. No other concerns noted.				
Inspection interval Grade 1 set at 3 years JA 02/04/2016				
RECOMMENDATIONS:				
Service PSV
