Ref. No: GRASS-001

Re: July 2025 – Internal Visual Inspections  
Pre-Purchase Inspections – Flare Knockouts

- A481746 – Flare Knockout – Vessel
- SN 003387 – Flare Knockout – Double Wall Tank

# Pressure Equipment Integrity Management System Internal Inspection Form – Unfired Separators

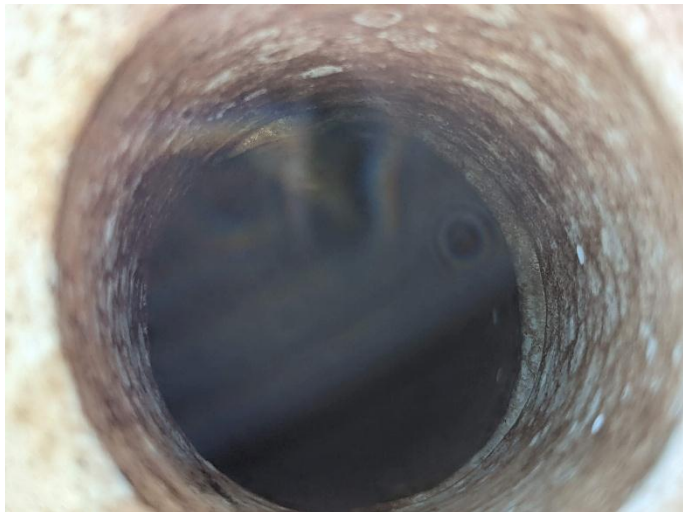
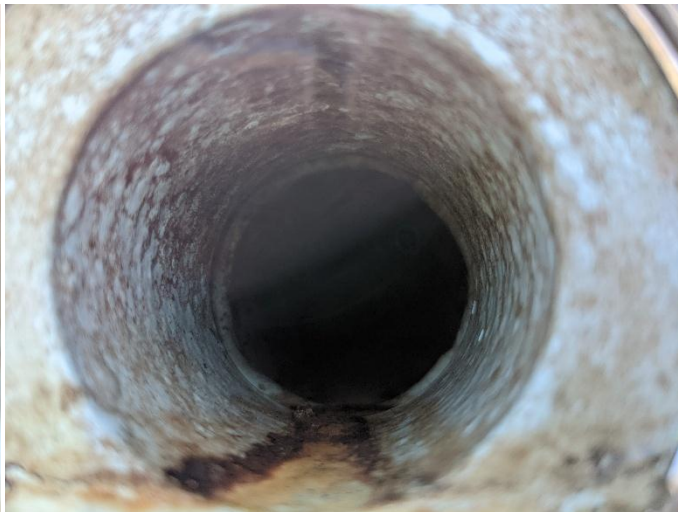
Signs of internal corrosion? ☒ Yes ☐ No General surface corrosion was identified on the exposed substrate of the inlet/outlet nozzles.

Figures 4 and 5 – 1.5" Nozzle Overviews from the Vessel Exterior  
Note: Left photo is of the left nozzle, right photo is of the right nozzle

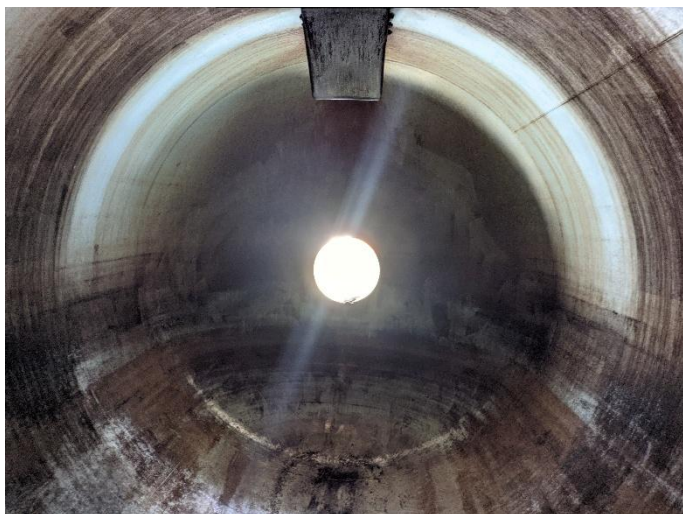
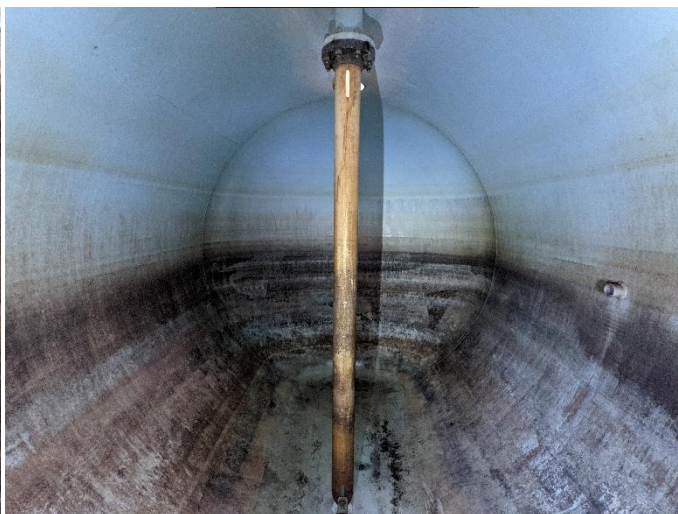
Figures 6 and 7 – Internal Overviews

Overall condition of coating: The coating was in good condition overall. Staining was present throughout the vessel from prior service conditions.

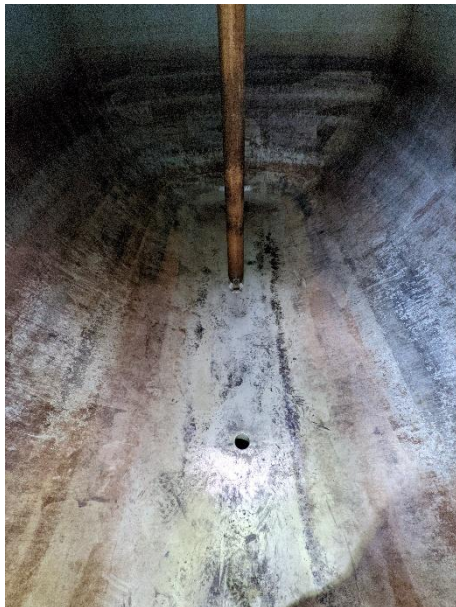
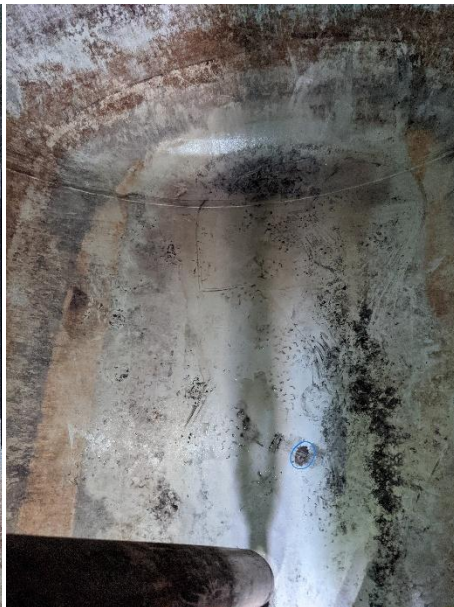
Condition of Shell and Heads (metal substrate at holidays): The shell and heads were in good condition. The metal substrate was found to be in good condition overall. General surface corrosion was present. No pitting or corrosion of concern was identified.

Figures 8 and 9 (Left and Center) – Bottom Shell Overviews  
Figure 10 (Right) – Drain Nozzle Overview

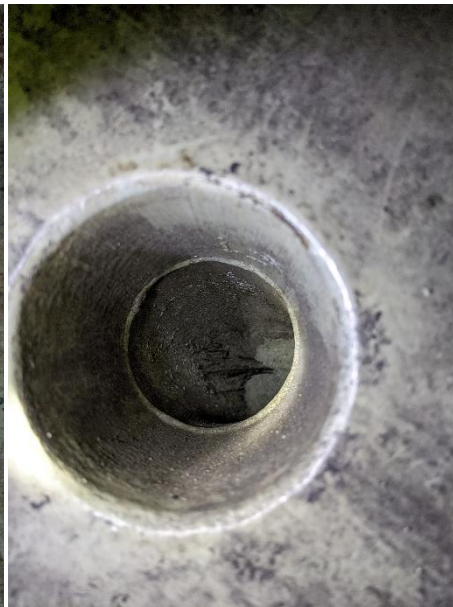
The drain line piping was visually accessible. The piping was uncoated; however, the drain nozzle was coated. General surface corrosion was present on the drain piping, no pitting was identified however inspection access was limited.

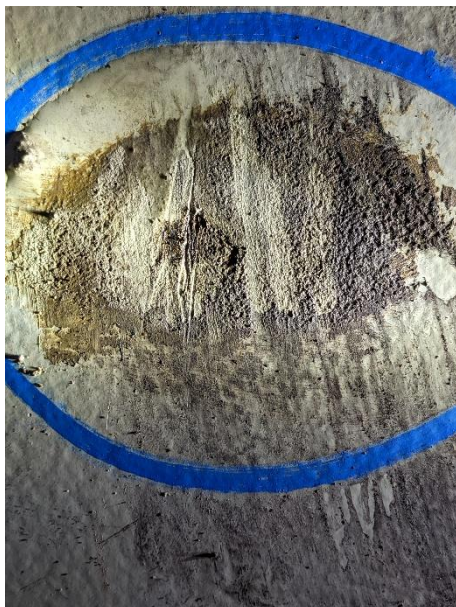
- Multiple holidays identified on the manway neck. Likely caused by cleaning and/or entry into the vessel.
- One coating holiday was identified on the bottom shell of the vessel. A historic coating patch was covering this holiday and was disbonded.
- Multiple coating holidays noted on the inlet nozzle flange face
- Minor coating holidays noted on the outlet nozzle flange face

Figure 11 (Left) – Holiday on Bottom Shell  
Figures 12 and 13 (Center and Right) – Holidays on Manway Neck

If the vessel is purchased it is recommended to proceed with coating repairs (Calroc offered to complete the coating repairs). QC for any coating repairs

should be obtained with the purchase of this vessel.

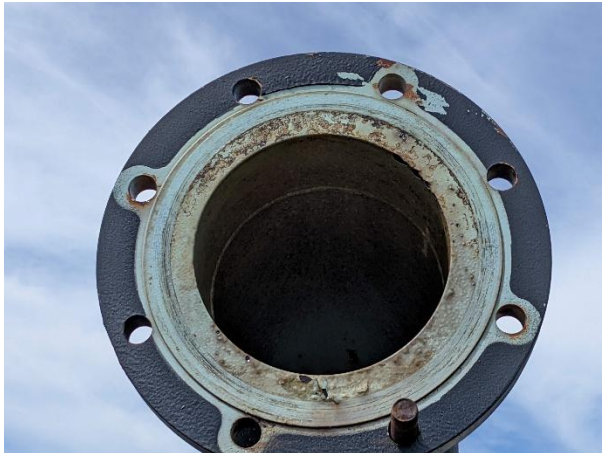
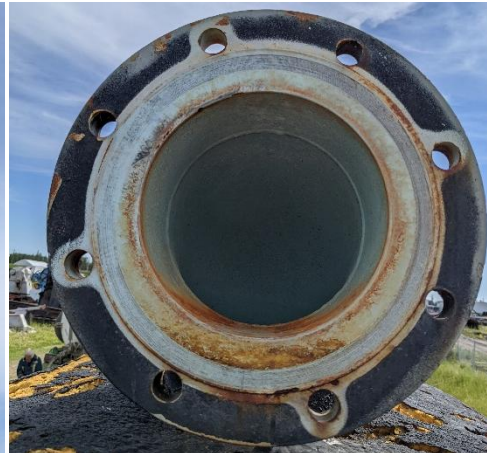
Condition of nozzle openings: Access to the inlet/outlet nozzles was restricted due to the height of the vessels. Inspection was performed from a ladder approximately 6' away via camera. There did not appear to be any significant corrosion to the metal substrate on these nozzles, there appeared to be general surface corrosion present.

Figure 14 (Left) – Inlet Nozzle Overview  
Figure 15 (Right) - Outlet Nozzle Overview

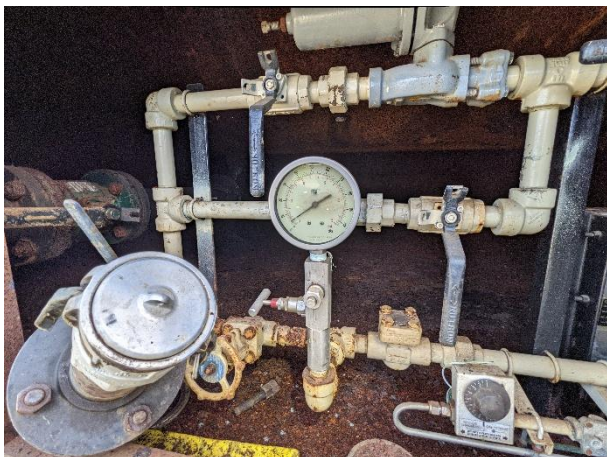
Internal piping: Vertical float piping. Found to be in good condition. General staining present on the coating.

Figure 16 (Left) – Bottom Shell and Piping Overview  
Figure 17 (Right) – Drain Line Overview, from Vessel Exterior

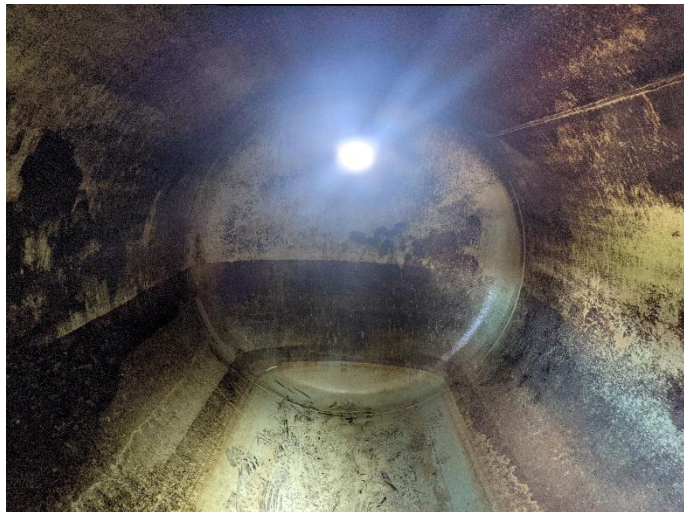
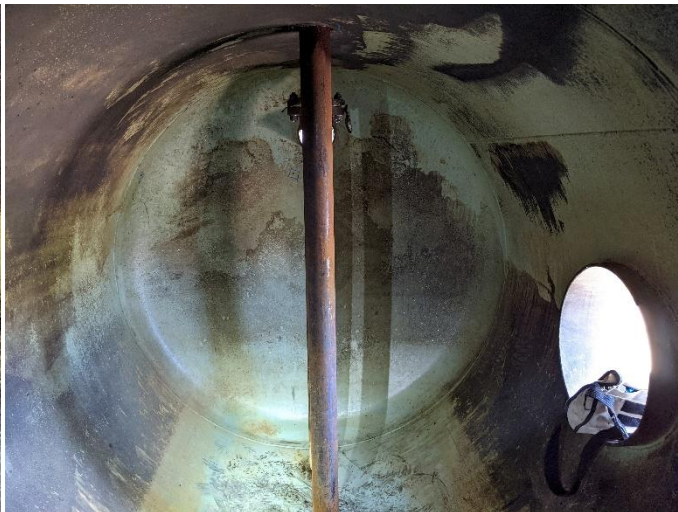
Figures 3 and 4 – Internal Overviews

Overall condition of coating: The coating was in good condition overall. A historic patch on the top shell was identified, it was tightly adhered.

The coating was stained throughout the tank from prior service conditions.

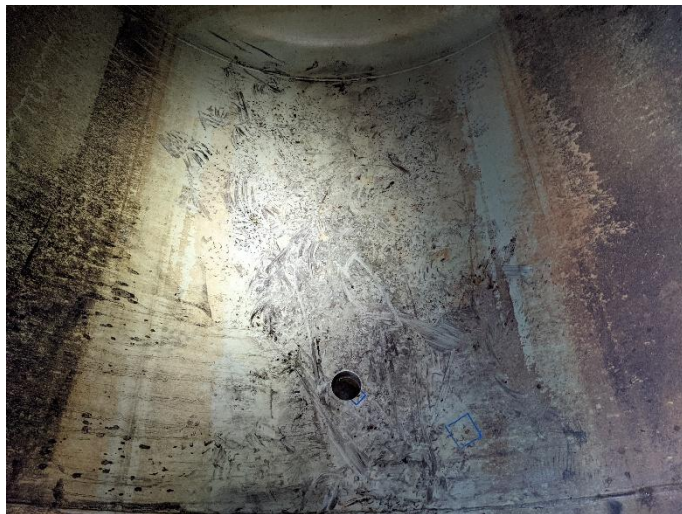
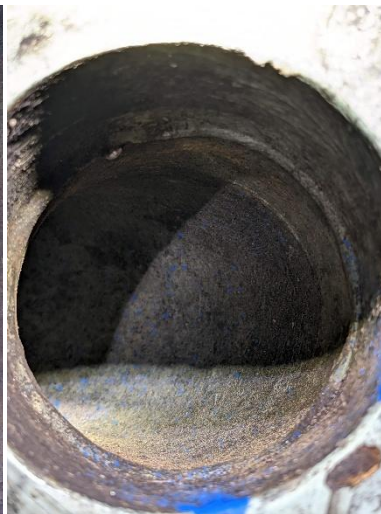
Figure 5 (Left) – Bottom Shell Overview  
Figure 6 (Right) – Drain Nozzle Overview

Condition of Shell and Heads (metal substrate at holidays): The metal substrate of the shell and heads was found to be in good condition.

General surface corrosion was identified on all exposed substrate; however, no pitting or corrosion of concern was identified.

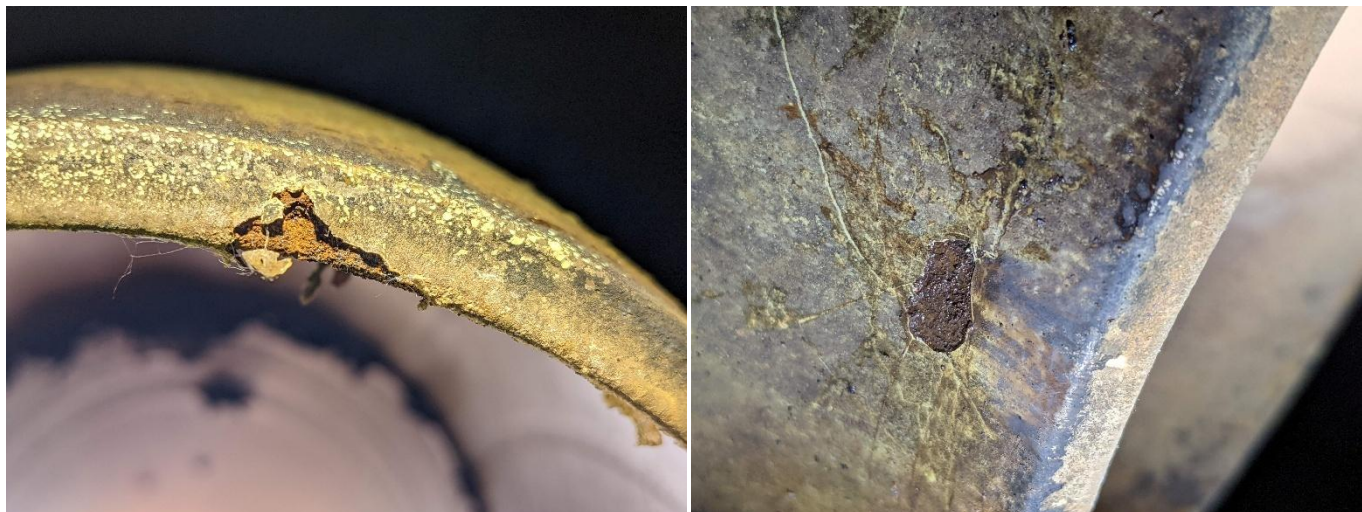
- 2x on the inlet nozzle (one on the lip, one on the outer surface)
- 4x on the shell/head (two on the bottom shell near the drain nozzle, two on the outlet head)
- Multiple holidays noted around the lip of the top shell nozzle for the level column
- Multiple holidays throughout the outlet nozzle from the internal surface to the flange face
- Multiple holidays on the manway neck, likely from cleaning and/or entry to the tank

Figures 7 and 8 – Coating Holidays on Inlet Nozzle

If this tank is purchased it is recommended to proceed with coating repairs (Calroc offered to complete the coating repairs). QC for any coating repairs should

be obtained with the purchase of this tank.

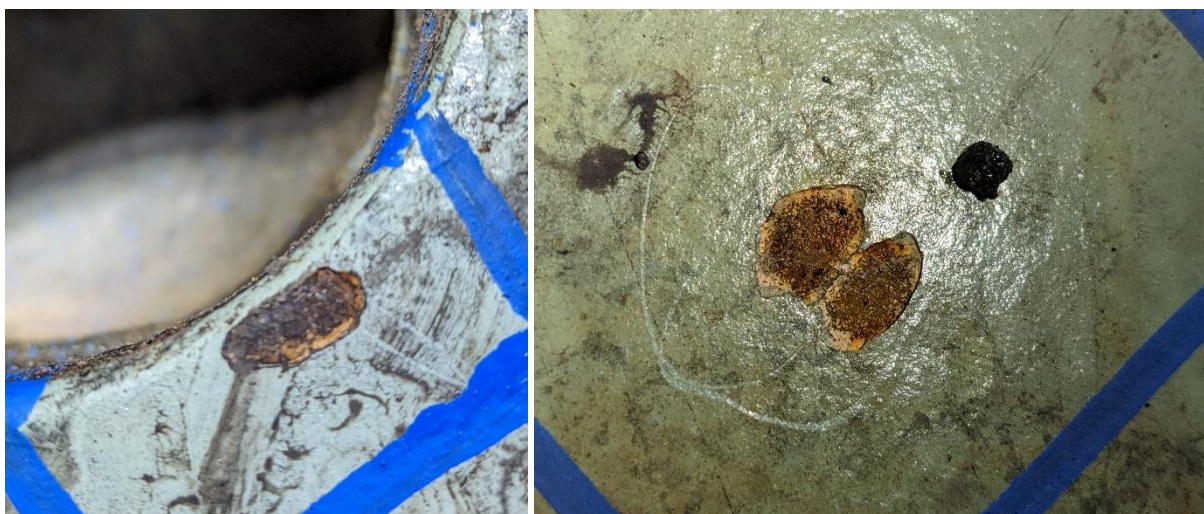
Figures 9 and 10 – Coating Holidays on the Bottom Shell, Near Drain Nozzle

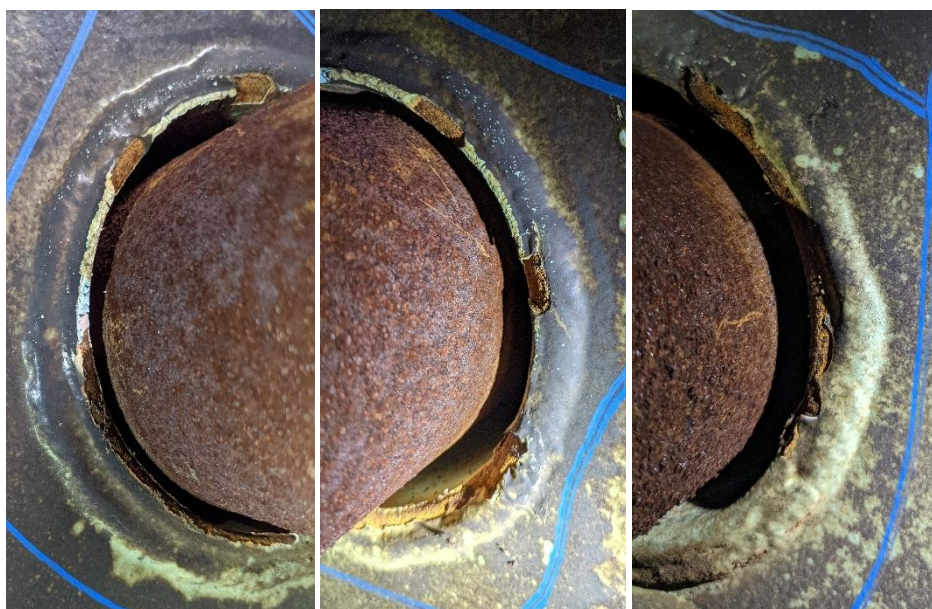
Figures 11 to 13 – Coating Holidays on the Level Column Nozzle

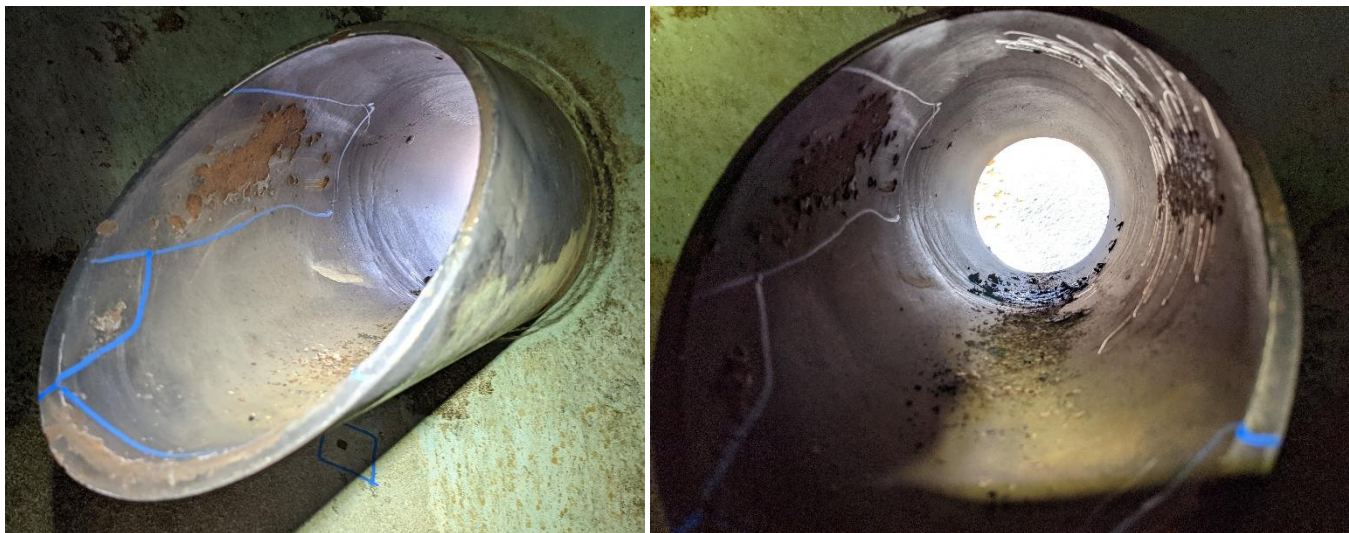
Signs of internal corrosion? ☒ Yes ☐ No The outlet nozzle had disbonded coating. General surface corrosion was present on the substrate.

Figures 14 and 15 – Outlet Nozzle Internal Overviews

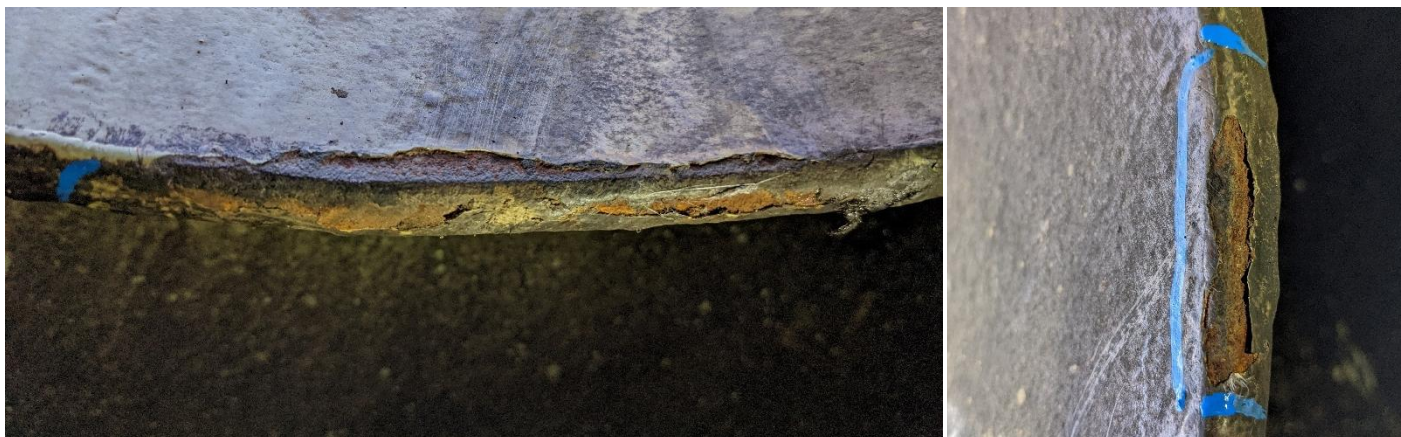
Figures 16 and 17 – Manway Lip Coating Holidays

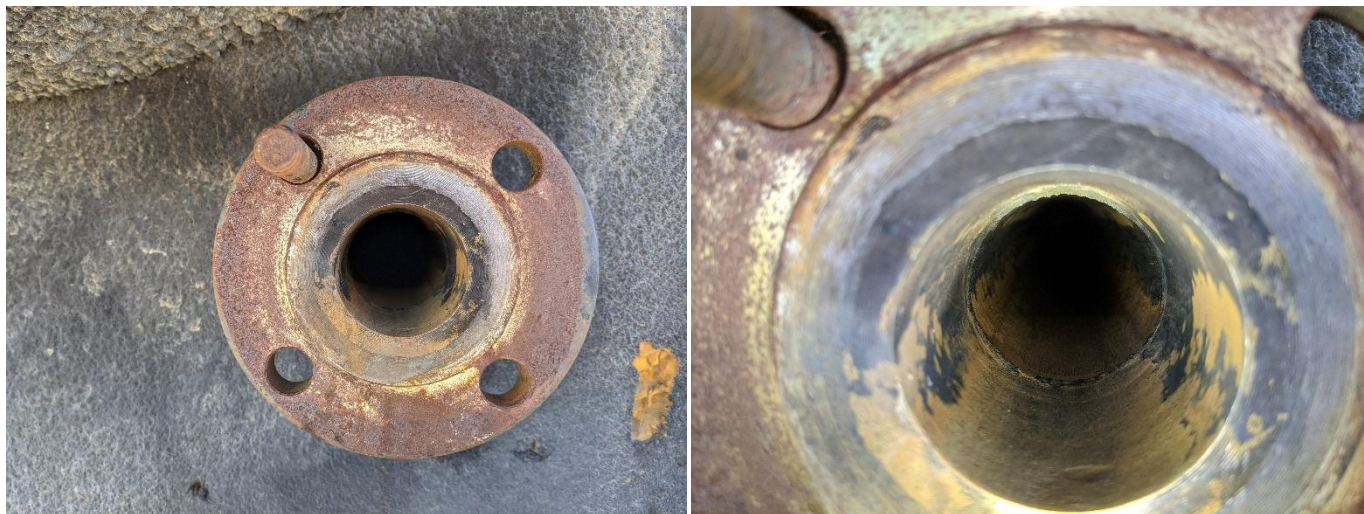
Condition of nozzle openings: General surface corrosion was identified on the substrate of all nozzles that had coating holidays. No pitting or corrosion of concern was identified on any of the exposed substrate. One small pit was identified in the small diameter nozzle at six o'clock. The pit was estimated to be 0.010" in depth and is not of concern.

Figures 18 and 19 – Nozzle External Overview

Note: Small pit at six o'clock estimated to be 0.010" in depth based on feel

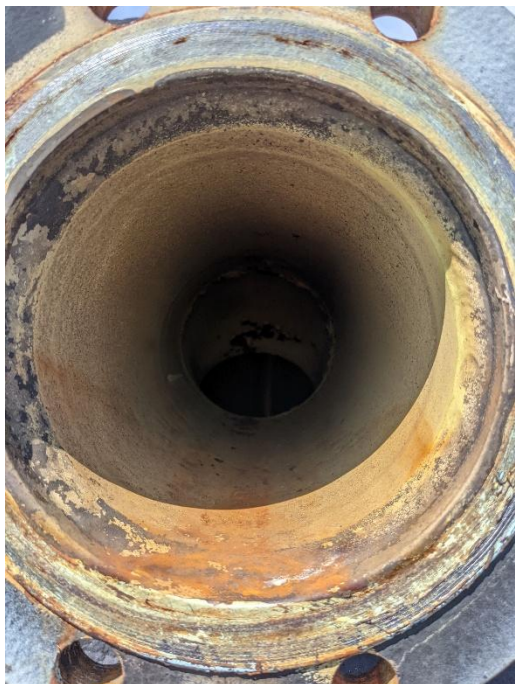
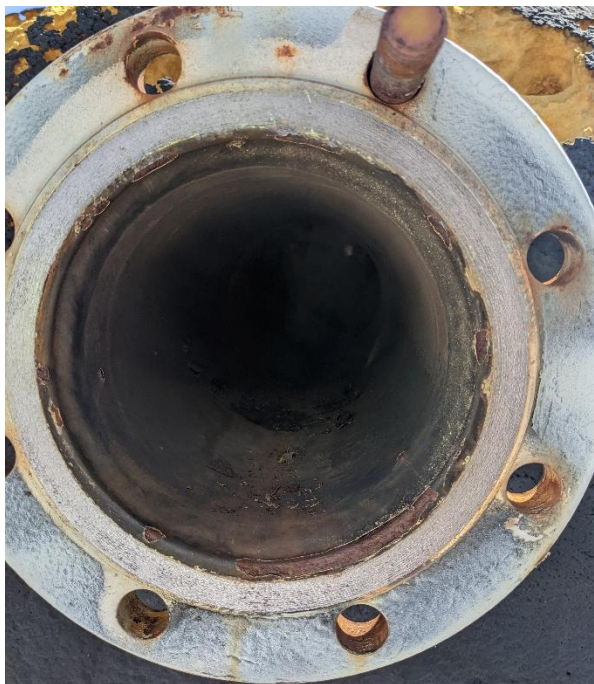
Figure 20 (Left) – Inlet Nozzle External Overview  
Figure 21 (Right) – Outlet Nozzle External Overview
