| Item(s) Inspected: Horizontal Separator | Surf. Prep: None | WO #: N/A |

**Job Scope:** To perform a limited external visual inspection on the described vessel.

### Horizontal Separator A# 0444877

VT\_0444877\_sep2019

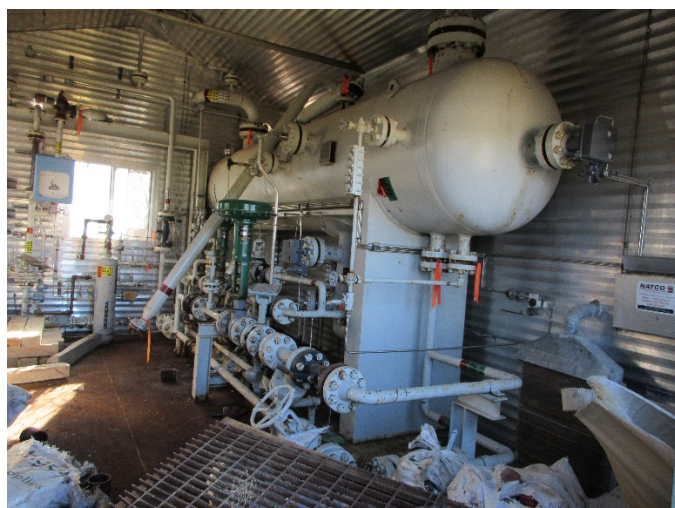
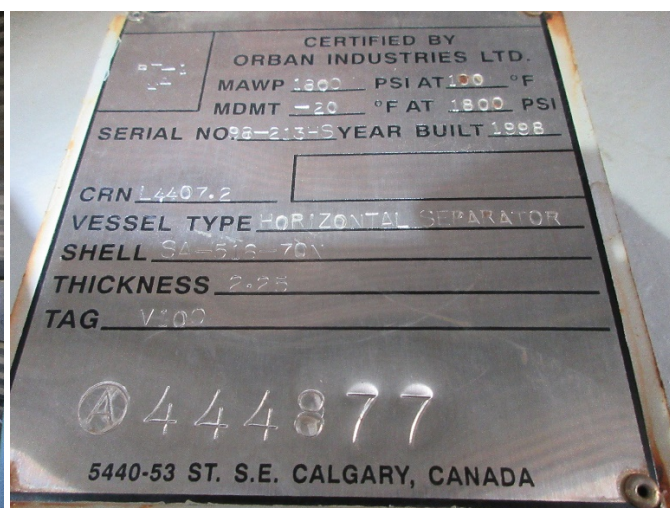
Inspector's Notes: This vessel has been out of service for several years, therefore a fitness for service level could not be determined without extensive re-furbishing and an Internal Visual Inspection.

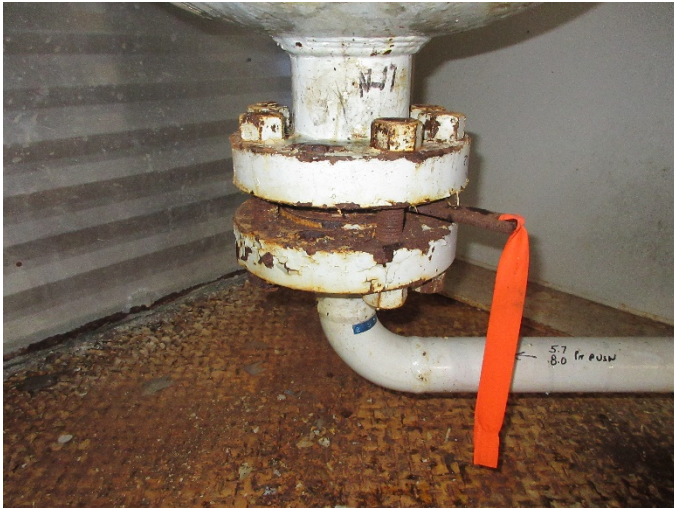
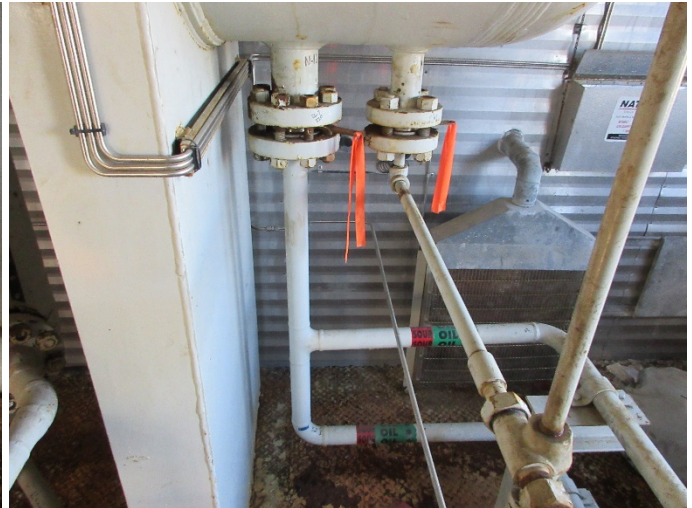
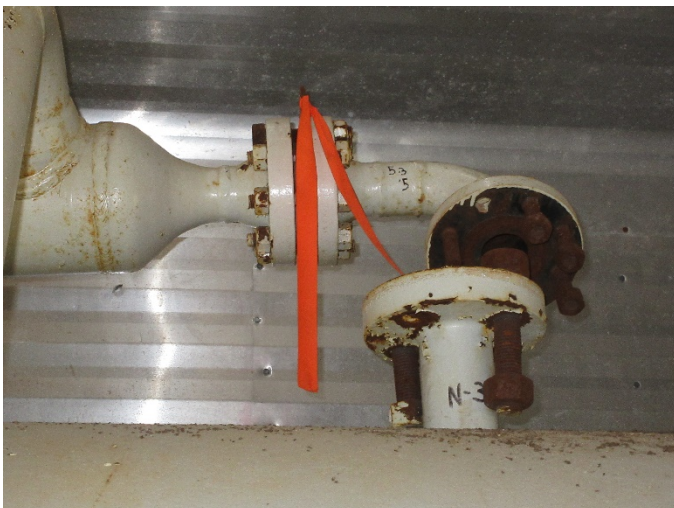
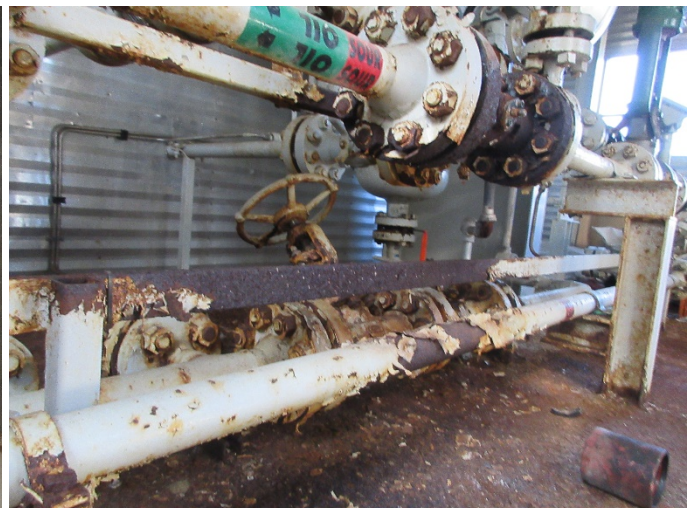
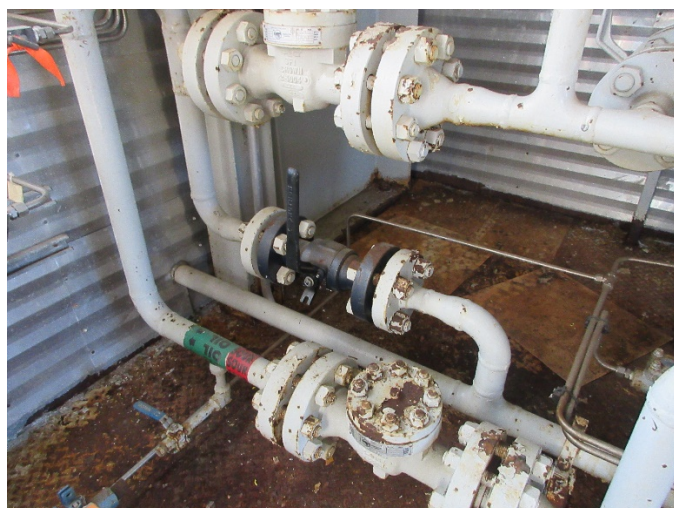
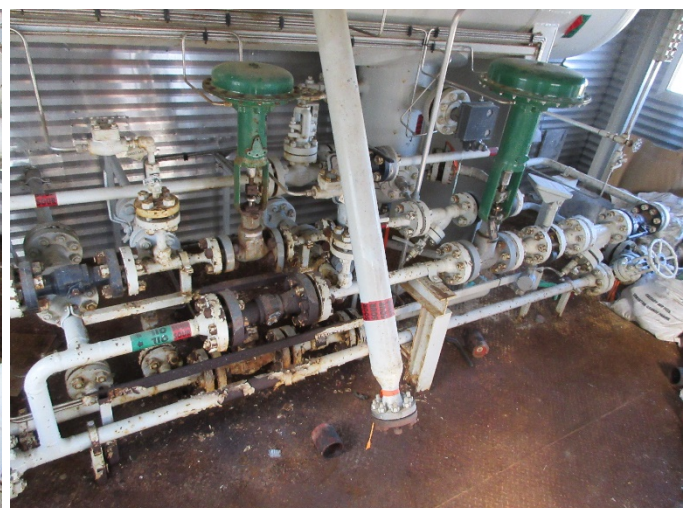
### Piping & Connections

- All piping spool and nozzle connections require disconnecting, cleaning, inspection, and new gaskets.
- Many studs and nuts are missing or loose throughout the skid package.

- Some nozzles are open and not blinded, allowing the weather and elements to enter the vessel.
- The piping and floor plates on this skid have very little well-bonded paint, therefore the floor and piping have begun to corrode. The floor and piping would all require sandblasting and repainting.

- Some 2" 90° elbows on the drain piping were found to have internal corrosion and pitting with wall loss up to 55%.
- See UTS Report # **UTS\_A0444877\_sep2019** for all thickness measurements and locations.

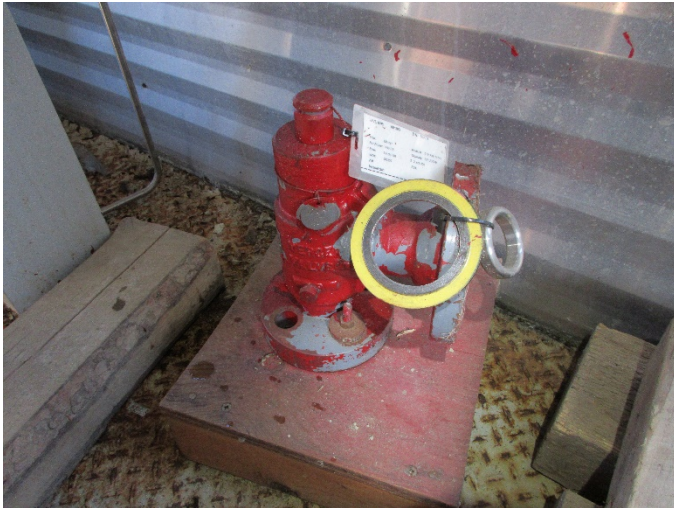
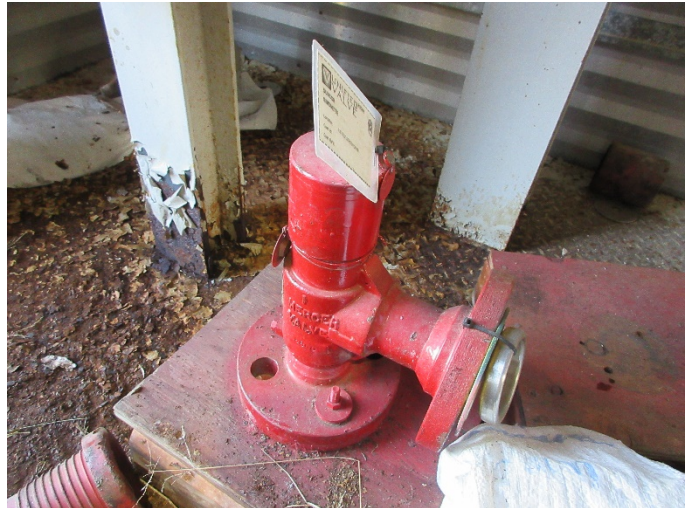
**PSV's**

- The PSV's for this vessel are sitting on the floor of the skid and have service tags from 2005 on them, they require full inspection and testing to see if they are still serviceable.

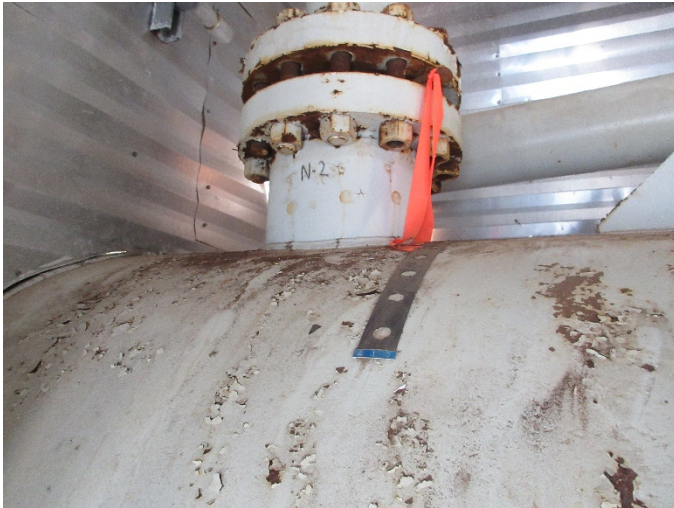
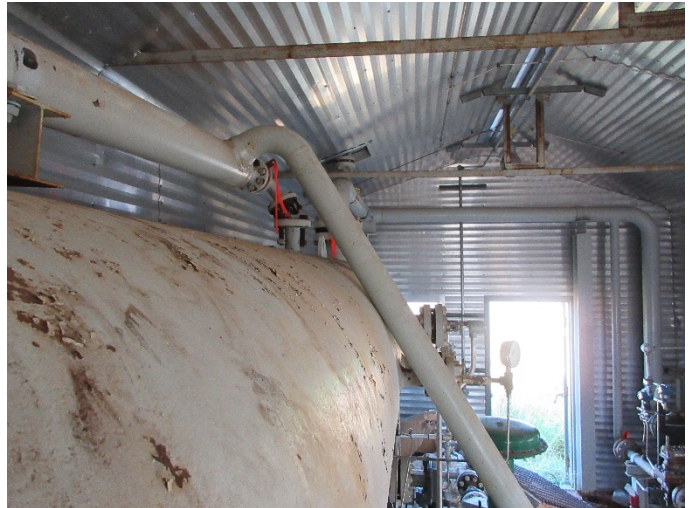
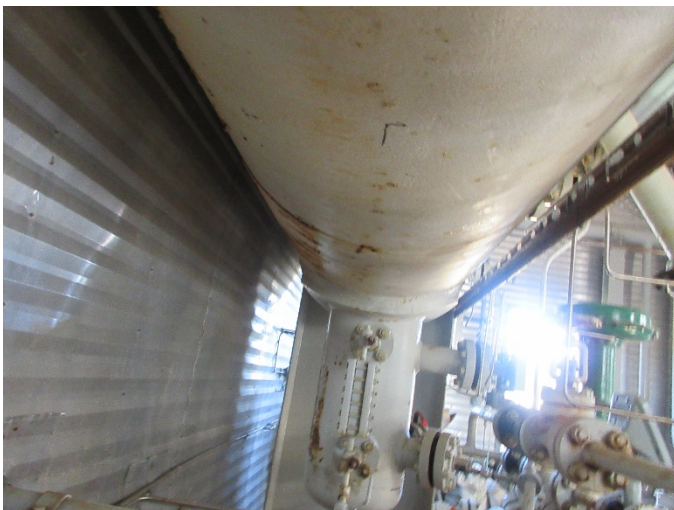
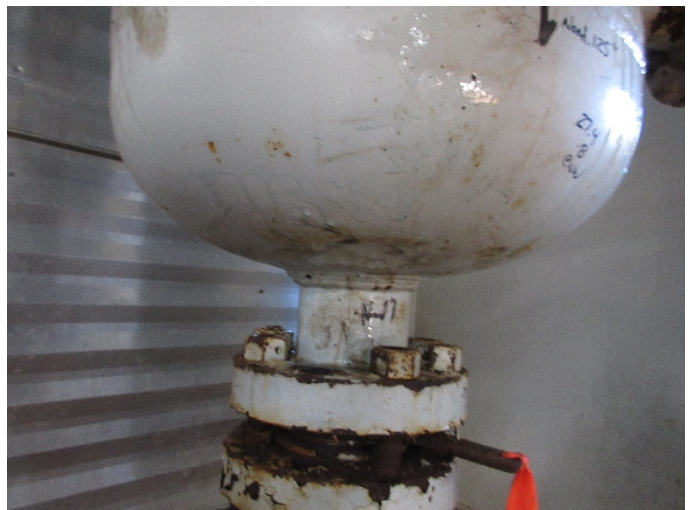
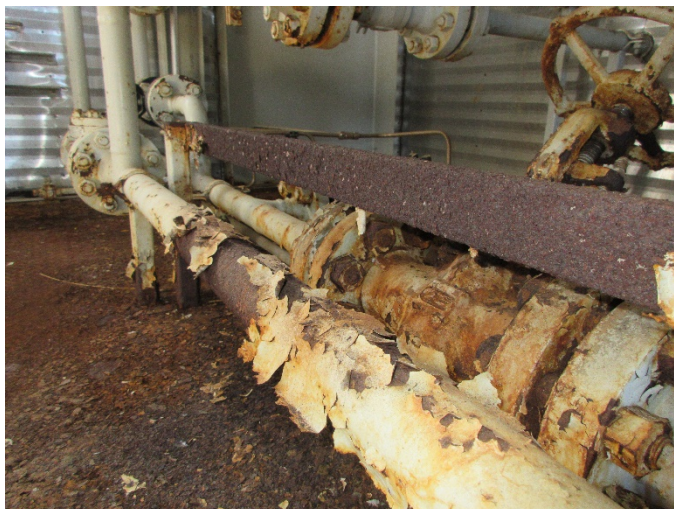
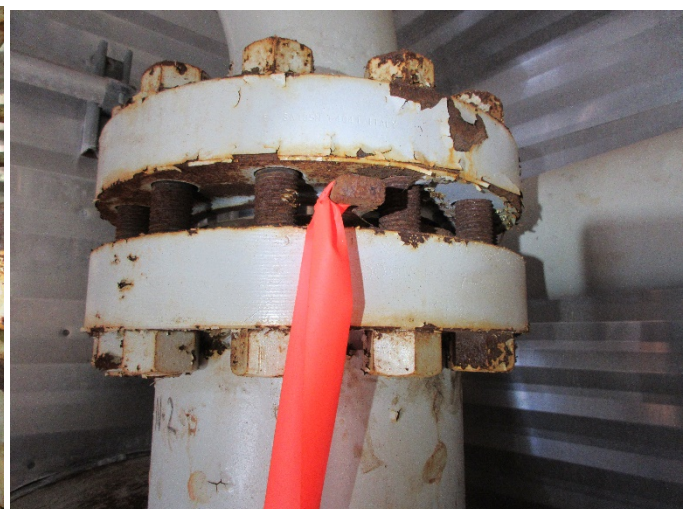
### Paint Condition

- The paint on the shell of the vessel is also in poor condition with many areas flaking and chipping and starting to corrode, re-painting this vessel is recommended.

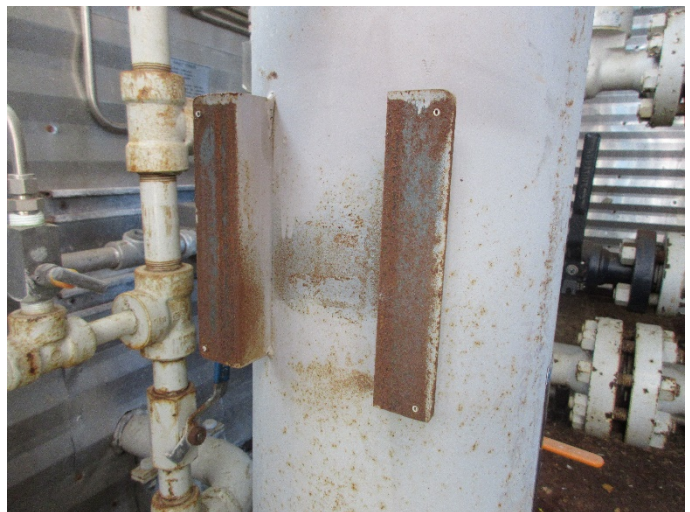
Missing Data Plate

- The Fuel Gas Scrubber in this Skid has no Data Plate / Name Plate, it appears to have been removed, a UT survey was completed on it as well, see the above-mentioned report.
