Field Inspection Report – Rare Oilfield Services

ST82253_10/06/2021_VLT_Internal

Vessel Number	ST82253	Vessel Name	AST - PRODUCTION TANK	Province	Alberta
District	INVENTORY	LSD	00-00-000-00W0	Location	INVENTORY
Method	VLT	Access	Internal	Cleaning	Good
Inspection Date (mm/dd/yyyy)	10/06/2021	Inspection Interval (months)	60	Next Inspection (mm/dd/yyyy)	10/06/2026
CRN	N/A	Skid Number	N/A	Service	SOUR
Internal Access	Entry	Internal Coating	Yes	Status	Spare
MAWP (PSI)		MAWP (kPa)		Outstanding NCRs	0
MAWT (°C)		MAWT (°F)

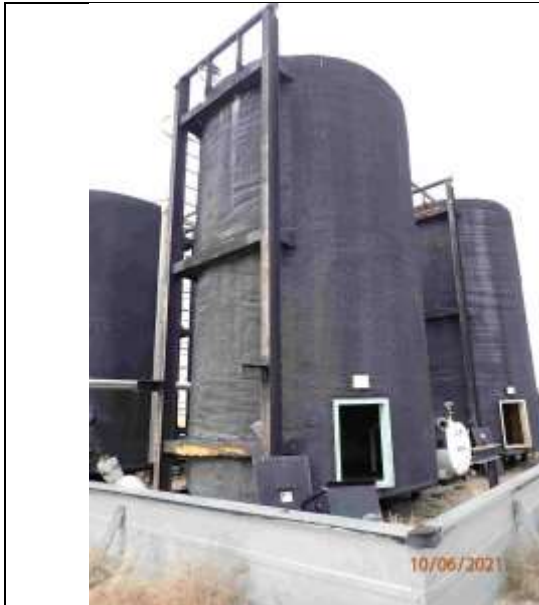
RARE-ST82253-AST-PrePurchase-Ext-Shell1-10-06-2021.JPG

- Tank external surfaces were insulated with spray urethane and sealed.
- Insulation was in good condition. Insulation was well bonded to tank external surfaces, no evidence of disbondment noted. Very little / minor bird damage noted to external surfaces.
- No evidence of distortion or mechanical damage noted to external surfaces.
- No evidence of salt staining or leaks noted on lower shell surfaces.
- Tank floor was in good condition. No issues noted.

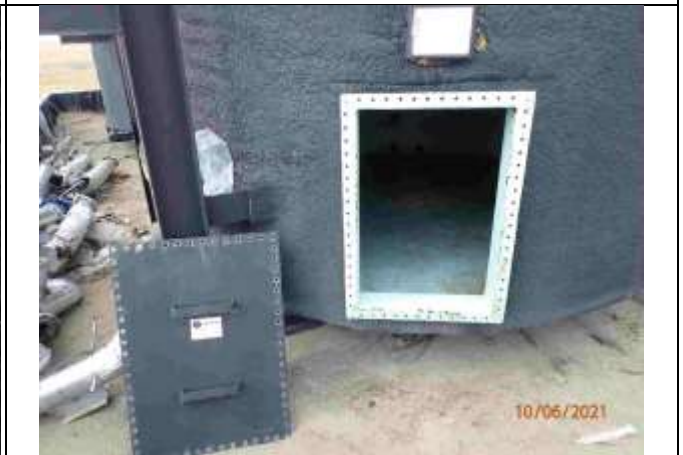
RARE-ST82253-AST-PrePurchase-Ext-Manway-10-06-2021.JPG

- manway throat and bolting flange were in good condition.
- flange seal face was flat and true. Coating on seal face was in good condition. No corrosion issues noted to face.
- No evidence of leaks noted around manway seal.

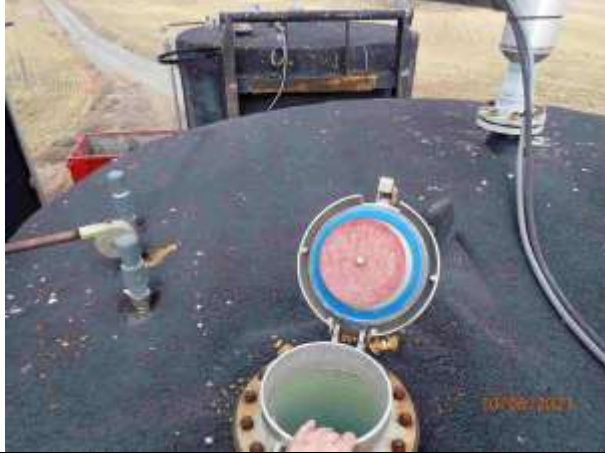
RARE-ST82253-AST-PrePurchase-Ext-Roof-10-06-2021.JPG

- Inspection performed from attached ladder for safety reasons and to prevent damage to roof insulation.
- Tank roof external surface was insulated with spray urethane and sealed.
- Insulation was well bonded to tank surface, no evidence of disbondment noted. Minor bird damage noted to external surface.

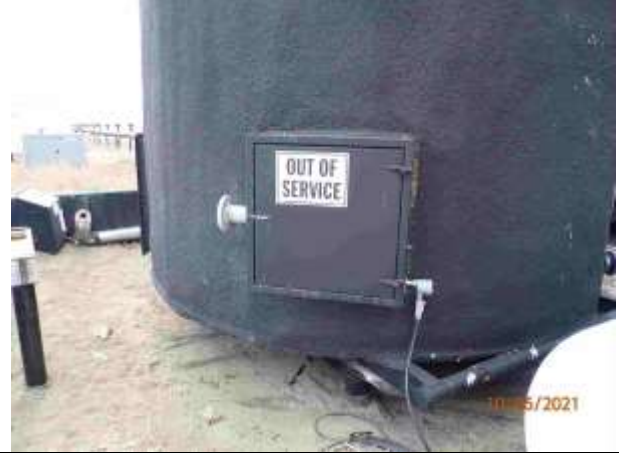
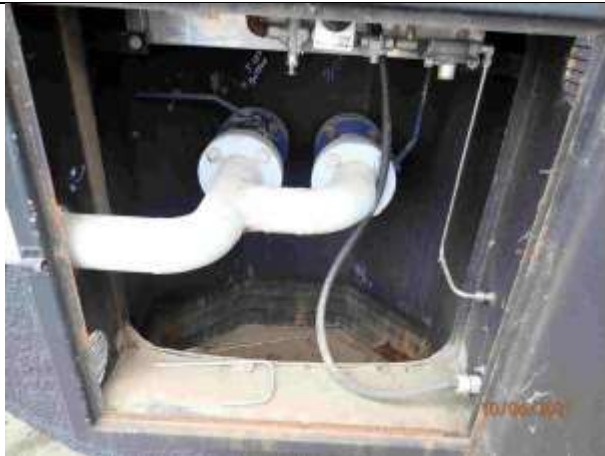
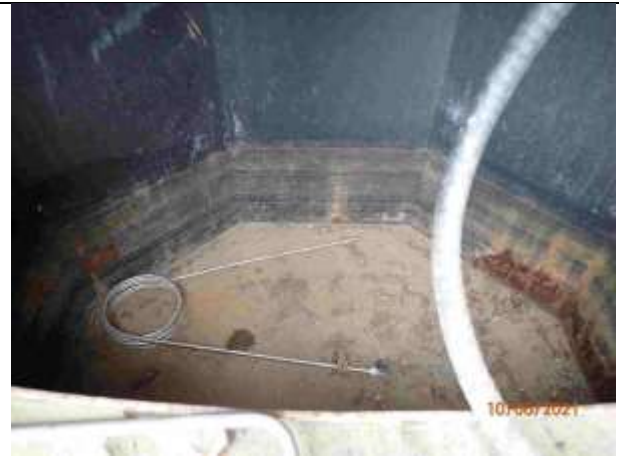
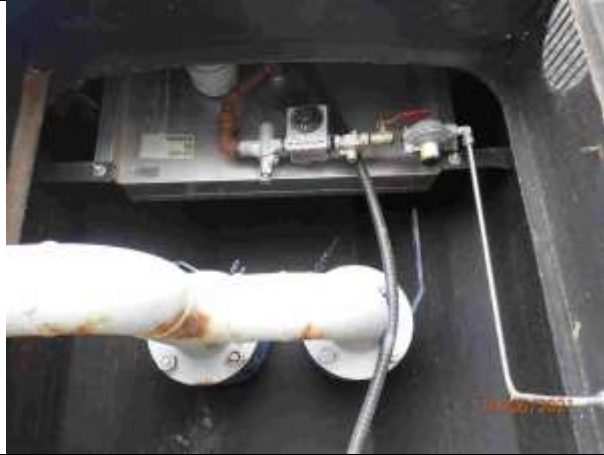
- heater box assembly was in good condition. Door was in good condition and free to move.
- catadyne heater was well supported and appeared to be in good condition.
- no evidence of any leaks inside the envirovault as viewed from the outdoors.

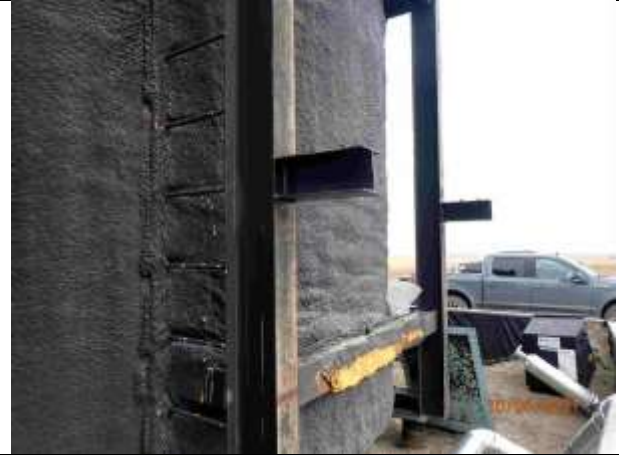
RARE-ST82253-AST-PrePurchase-Ext-Piping Supports on Transportation Skid-10-06-2021.JPG

- Welded steel skid under tank floor was in good condition. No issues noted.
- Welded steel transportation skid, up side of tank, was in good condition. No issues noted.
- Integral ladder to roof was in good condition.
- Transportation skid has welded I-beam piping supports that would need to be removed prior to loading and moving of tank.

Tank was in good condition, and needed only minor repairs.
 -removal of external piping supports welded to transportation skid
 -spot coating repairs on identified areas.

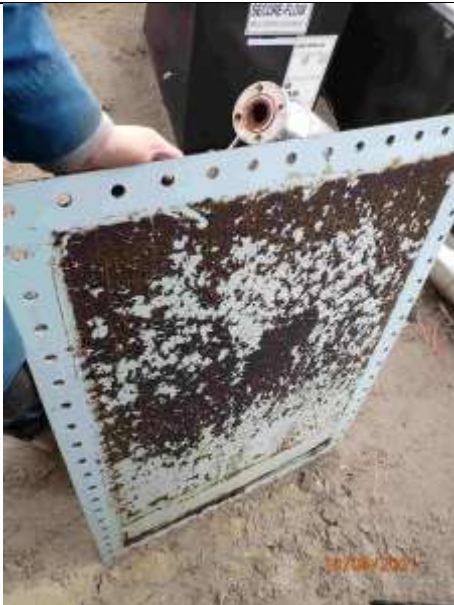
RARE-ST82253-AST-PrePurchase-Int-Manway-10-06-2021.JPG

- manway throat and internal surfaces were coated and in good condition.
- welds were in good condition, as viewed through coating.

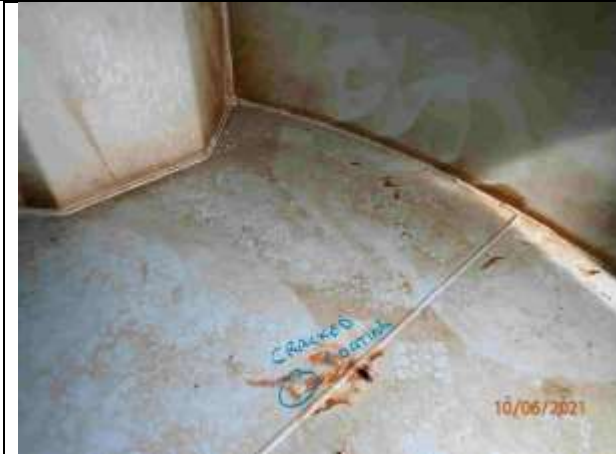
RARE-ST82253-AST-PrePurchase-Int-Overview1a-Coating Crack Overview-10-06-2021.JPG

- Tank floor was internally coated.
- Coating was in good condition. There were two areas of coating defects found.
- One was a crack in the coating, which was located between the manway envirovault and manway, along the floor plate weld, 24" from shell. No blistering associated with coating crack. Unable to catch edge on crack and pull on coating. Don't suspect any corrosion issues underneath coating in affected area.
- The other defect was a coating chip located 30" of shell, along floor weld, in close proximity to float floor connections. No wall loss noted in exposed area.
- minor coating repairs completed in the past. Repairs in good condition and well bonded. No issues noted.
- welds were in good condition, as viewed through coating

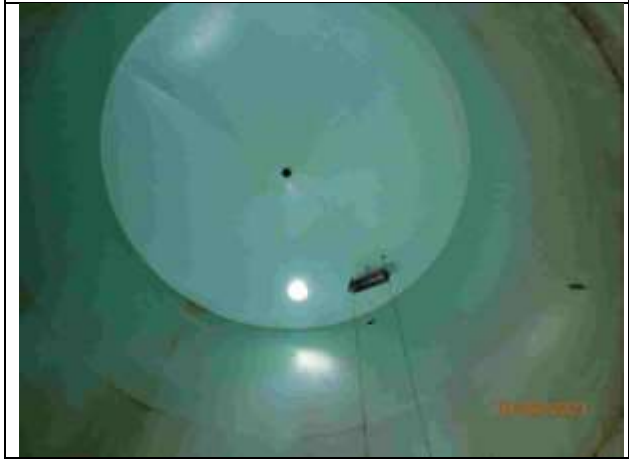
- Tank roof was self-supporting with no internal trusses or supports.
- Roof was internally coated. Coating appeared in good condition. No large open areas of coating damage noted.
- No visible holes through roof.
- No unusual staining noted on surface.
- No coating repairs noted on roof surface.
