## Field Inspection Report – Rare Oilfield Services

### ST82252\_10/06/2021\_VLT\_Internal

Rare Oilfield has requested a third party pre-purchase inspection to be performed on a used tank located outside of High River. Tank was being brokered by Rare Oilfield Services. Tank was located on a site that was being abandoned and reclaimed. Equipment has been out of service for approximately 10 years as per Brokerage Company.

Tank was a 400 barrel capacity, skid mounted, insulated and heated type. Equipment has welded steel transportation skid attached. Tank was insulated with spray urethane and sealed. Fluids heated by catadyne heater installed inside envirovault.

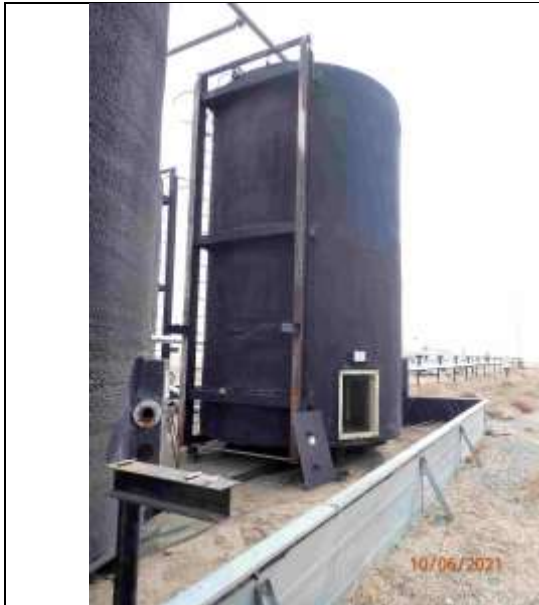
Rare-ST82252-AST-PrePurchase-Ext-Shell1-10-06-2021.JPG

- Tank external surfaces were insulated with spray urethane and sealed.
- Insulation was in good condition. Insulation was well bonded to tank external surfaces, no evidence of disbondment noted. Very little / minor bird damage noted to external surfaces.
- No evidence of distortion or mechanical damage noted to external surfaces.
- No evidence of salt staining or leaks noted on lower shell surfaces.
- Tank floor was in good condition. No issues noted.

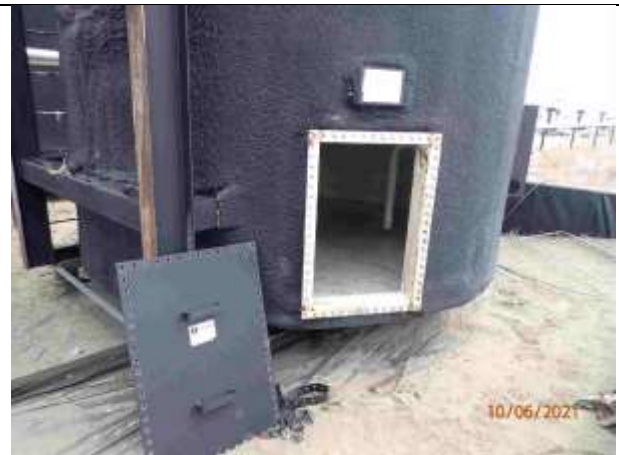
Rare-ST82252-AST-PrePurchase-Ext-Manway-10-06-2021.JPG

- manway throat and bolting flange were in good condition.
- flange seal face was flat and true. Coating on seal face was in good condition. No corrosion issues noted to face.
- No evidence of leaks noted around manway seal.

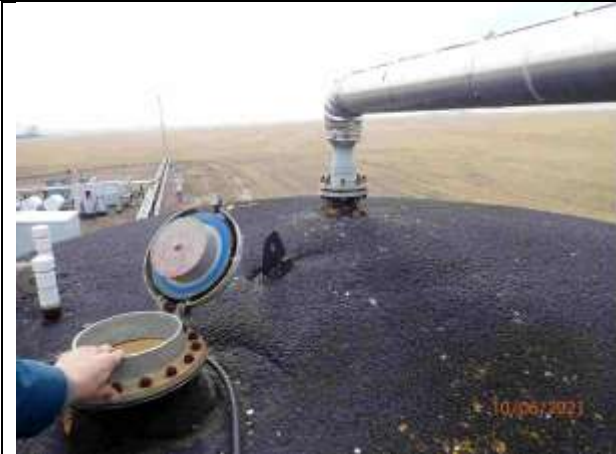
Rare-ST82252-AST-PrePurchase-Ext-Roof-10-06-2021.JPG

- Inspection performed from attached ladder for safety reasons and to prevent damage to roof insulation.
- Tank roof external surface was insulated with spray urethane and sealed.
- Insulation was well bonded to tank surface, no evidence of disbondment noted. Minor bird damage noted to external surface.

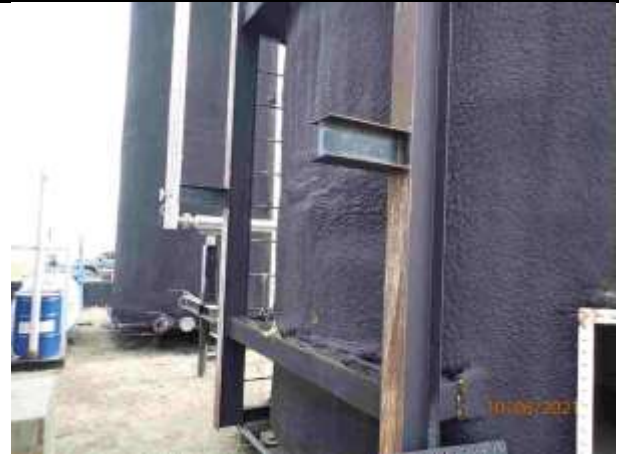
Rare-ST82252-AST-PrePurchase-Ext-Piping Supports on Transportation Skid-10-06-2021.JPG

- Welded steel skid under tank floor was in good condition. No issues noted.
- Welded steel transportation skid, up side of tank, was in good condition. No issues noted.
- Integral ladder to roof was in good condition.
- Transportation skid has welded I-beam piping supports that would need to be removed prior to loading and moving of tank.

Tank was in good condition, and needed only minor repairs.  
 -removal of external piping supports welded to transportation skid  
 -spot coating repairs on identified areas.

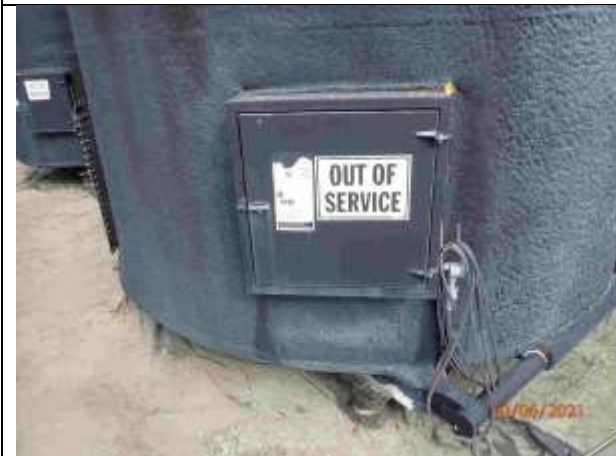
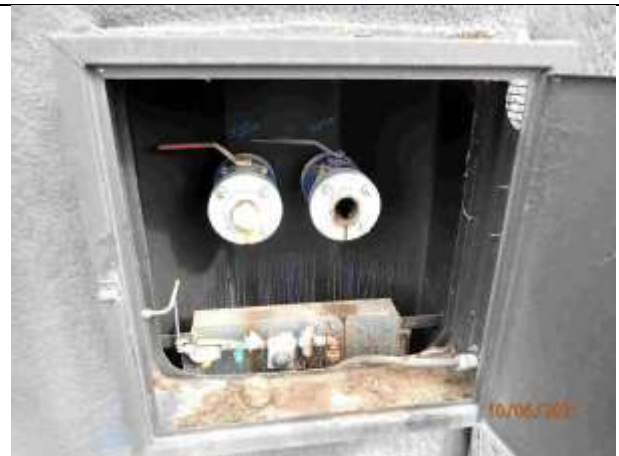
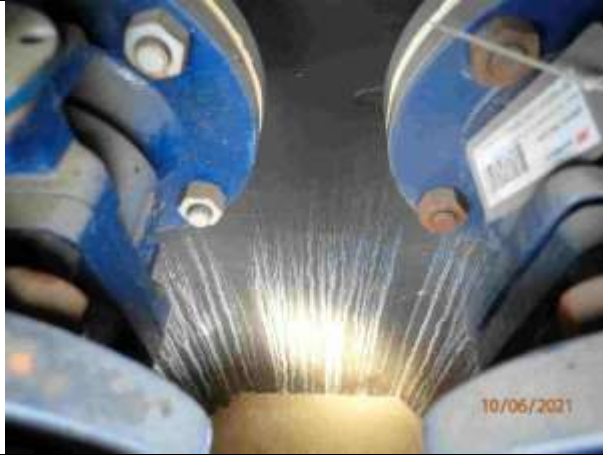
- heater box assembly was in good condition. Door was in good condition and free to move.
- catadyne heater was well supported and appeared to be in good condition.
- no evidence of any leaks inside the envirovault as viewed from the outdoors.

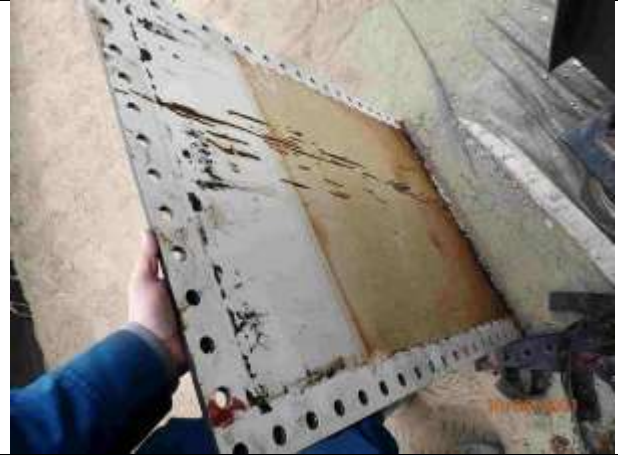
Rare-ST82252-AST-PrePurchase-Int-Manway-10-06-2021.JPG

- manway throat and internal surfaces were coated and in good condition.
- welds were in good condition, as viewed through coating.

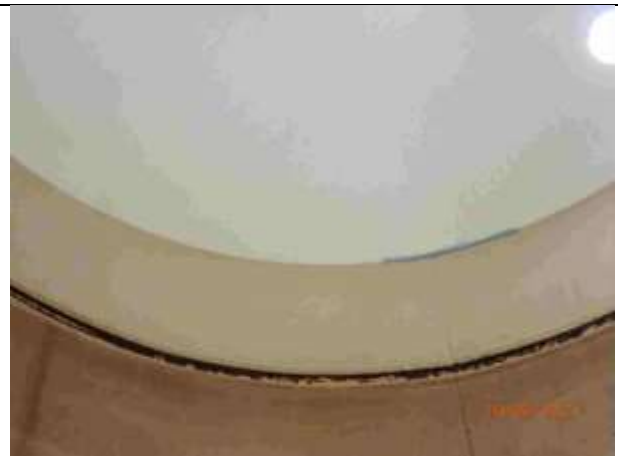
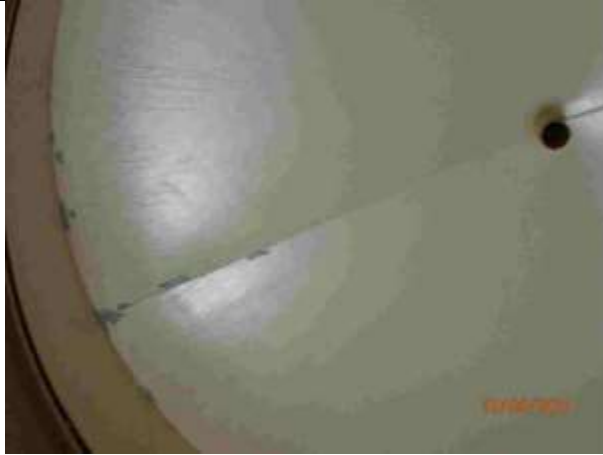
- Tank roof was self-supporting with no internal trusses or supports.
- Roof was internally coated. Coating appeared in good condition. No large open areas of coating damage noted.
- No visible holes through roof.
- No unusual staining noted on surface.
- past coating repairs completed on roof surfaces; unable to assess condition.

- Shell was washed from floor level and up 10 feet. Upper liquid level approximately 4 feet from tank roof. Oily type product staining noted on unwashed surfaces.
- Shell was internally coated, full height of tank.
- Coating was in good general condition. No chips, cracks, or peeling noted.
- welds were in good condition, as viewed through coating
- past coating repairs were tightly bonded and in good condition; lower repairs examined only.

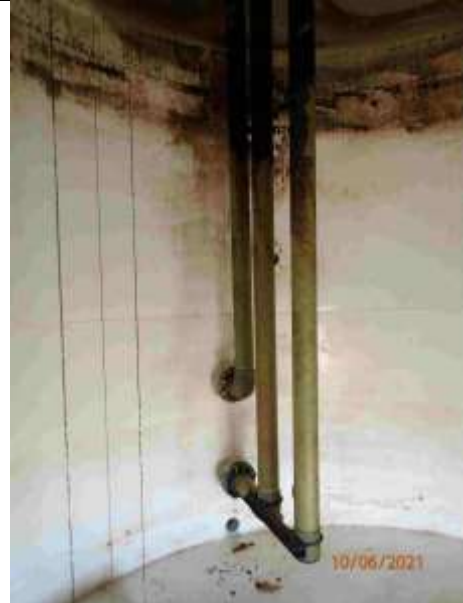
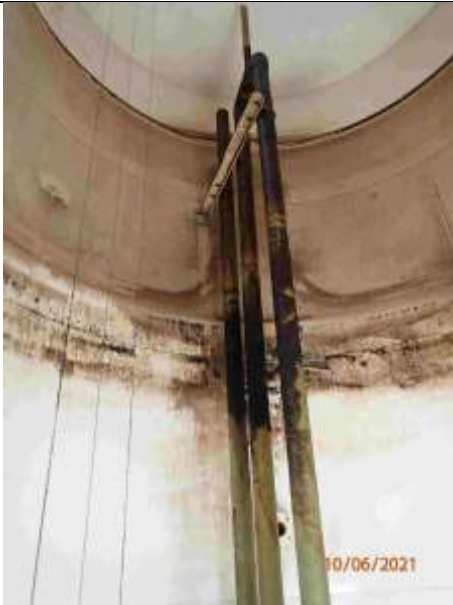
- limited amount of internal piping found in tank.
- fiberglass piping found connected to 4" and 6" flange connections on back wall. Unsure of process associated with piping. Fiberglass piping was adequately supported. Associated U-bolts were tight and secure. Associated flange bolts were stainless steel and were tight and secure.
- No issues noted with internal piping coating or with nozzle internal coating.
