**Informational Visual Inspection
Report**
**Informational Visual
Inspection_A0496015 FKOD_aug2025**

Client: Fuelled	Facility: CNRL Wapiti Field	Date: August 11, 2025
LSD: 10-07-68-09W6M (CNRL)	Equipment Inspected: A0496015 Flare Knockout Drum	LII Job #: 13720

Job Scope: To perform external and internal informational visual inspections on a horizontal Flare Knockout Drum, A#0496015. This FKOD is out of service and currently located at the CNRL 10-07-068-09W6M Wapiti location.

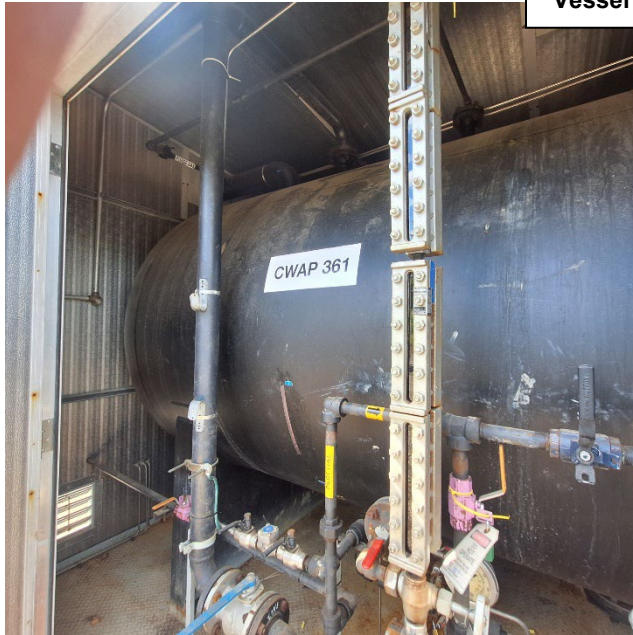
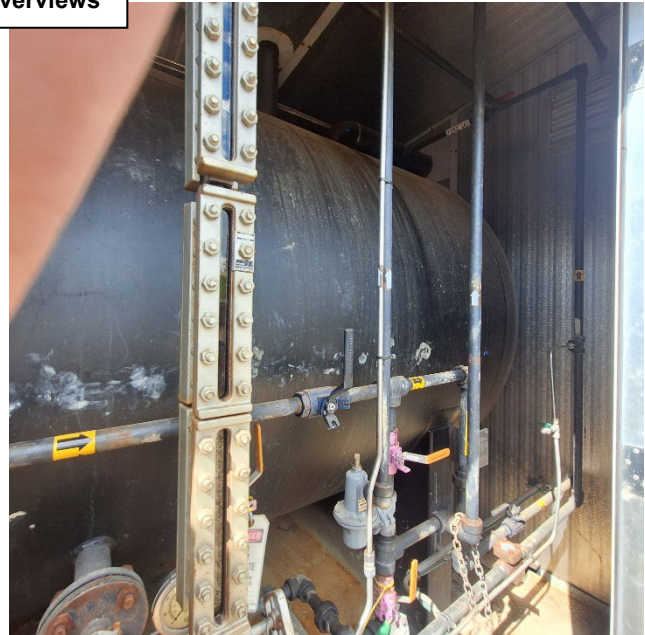
Vessel Overviews

- **External Surface:** This vessel is carbon steel, painted, and uninsulated. No visible signs of damage.
- **Insulation:** This vessel is uninsulated and inside of a utilidor building. The building appears well sealed with no visible signs of damage.

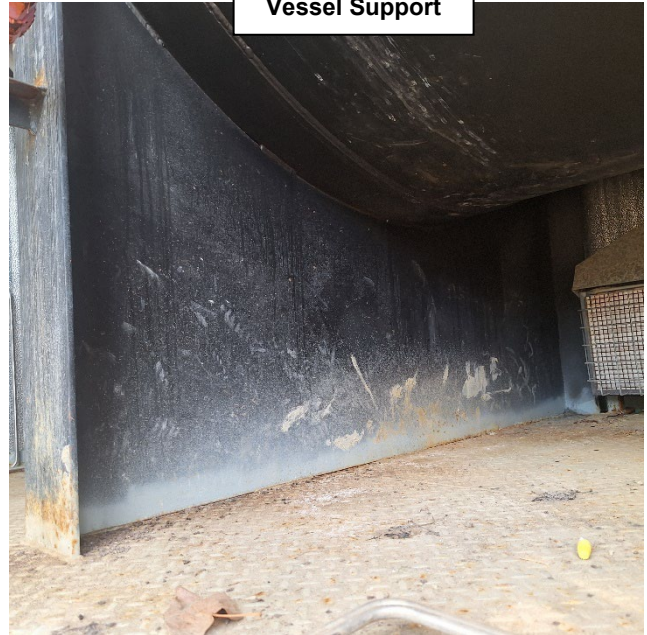
Vessel Support

- **Nameplate:** Firmly fastened and legible.
- **Foundation/Support:** This vessel is supported by two saddle supports welded to the skid floor. No visible signs of damage.

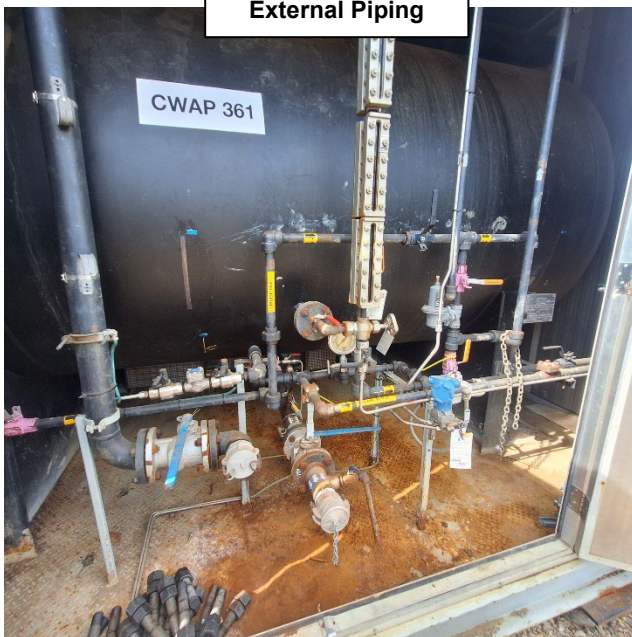
External Piping

- **External Piping:** All visible external piping is uninsulated and painted. All piping appears to be properly supported with no visible signs of damage.

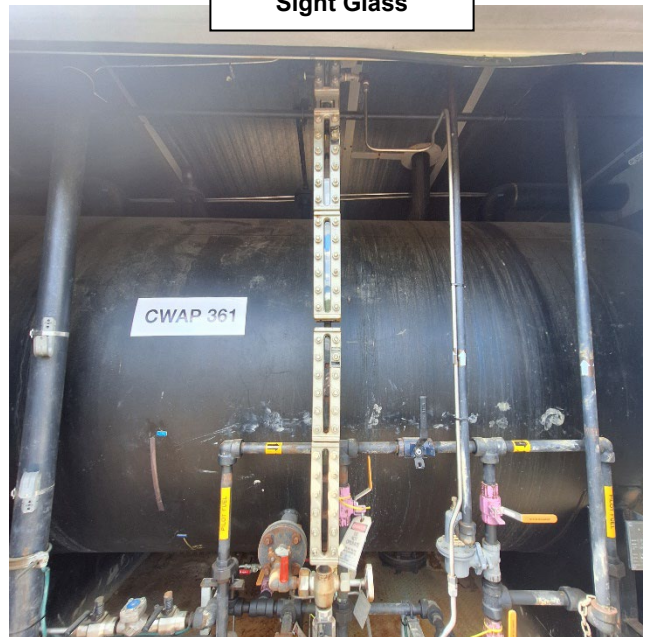
Sight Glass

- **External Components:** This FKOD has two Catadyne heaters, one sight glass and one air quality monitoring system installed. Neither were functioning at the time of inspection but appear to be intact.

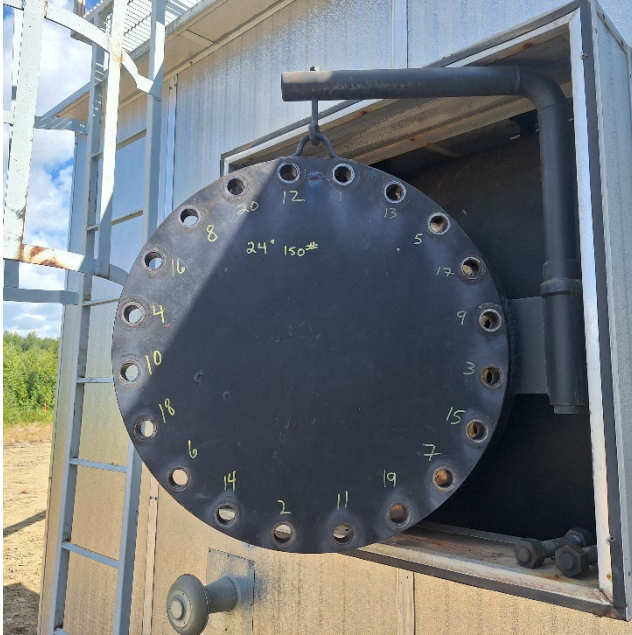
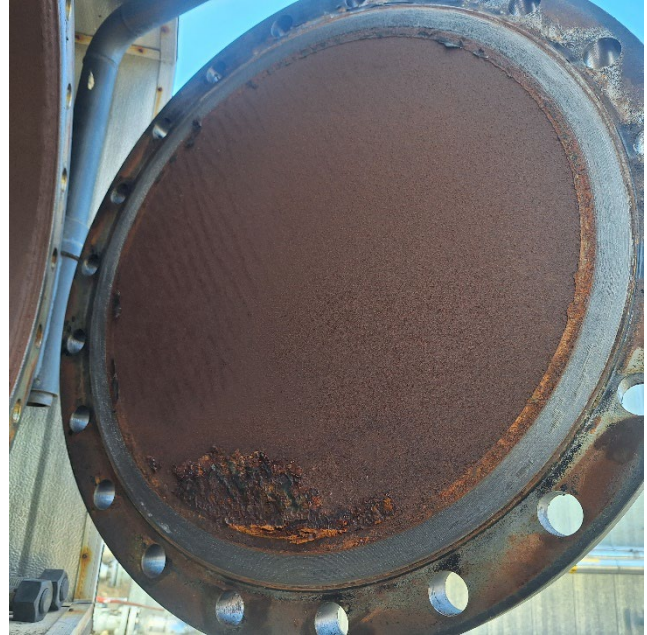
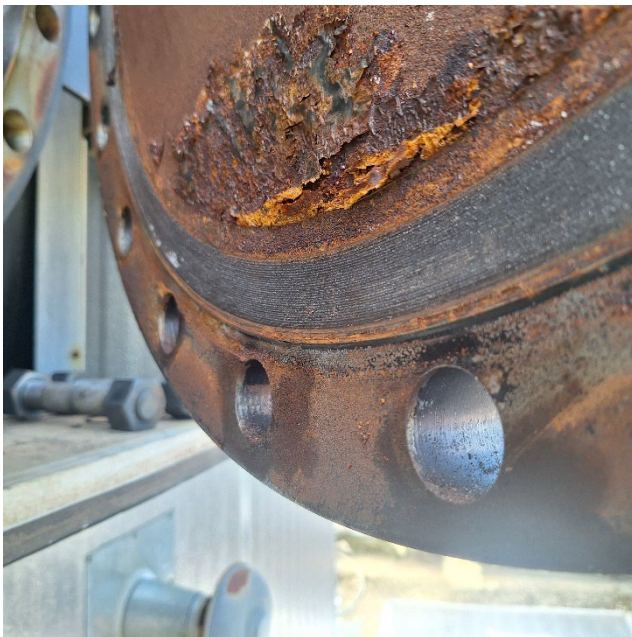
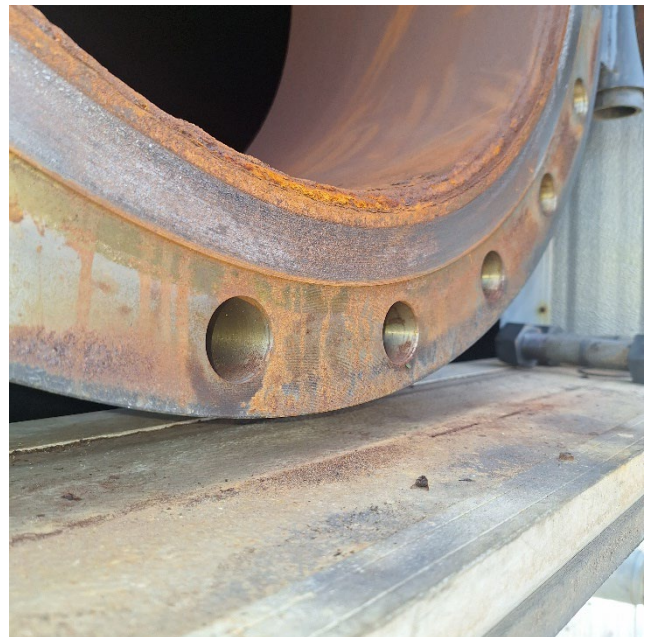
Visual Inspection Photos (Manway) – Flare Knockout Drum (A0496015)

- **Nozzles:** No visible signs of damage or deflection.
- **Manway:** This vessel has a 24" manway with no notable external deficiencies.
- **Overpressure Protection:** There was on attached PSV associated with this vessel. The set pressure is at or below the vessel MAWP of 50 PSI. The last known service date is August 11, 2009, by Ideal Precision Valve Ltd.

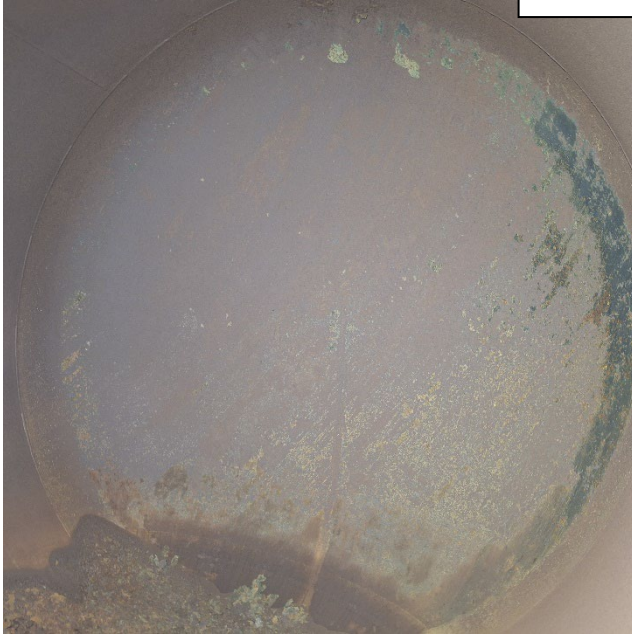
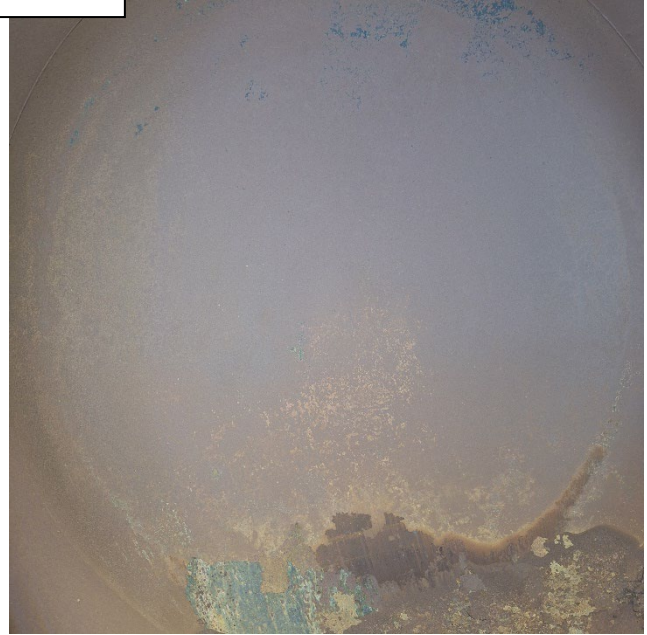
Vessel Heads

- **Internal Components:** This vessel is not internally coated. Surface corrosion and scale buildup noted in the bottom portion of the vessel. No visible signs of damage to the internal surfaces of the shell and heads.
