Report No: BM1000115

Client	Midstream Equipment	Inspection Date	Jan 26, 2022		
Prov. Reg. #	AB 0511499	Inspection Type	VE / UT / PSV		
Equipment Type	Liquid Blowcase	LSD	AB		
Tag/Equip.		Location	Midstream Yard		
Status	In Service	Area			
Manufacturer	UNIVERSAL COMPRESSION CANADA, LIMITED PARTNERSHIP	Year Built	2004		
Serial Number	047063-2	Service	Sweet		
CRN #	P3896.213	Manway	None		
Comp/Unit Id	1022	Coating	Paint		
Nat.Board #		Owned By	Midstream Equipment		
Interim Insp'n		Interim Insp Type			
Next Inspection	2026	Next Insp Type	VE / UT / PSV		
Length		Height			
Volume	8.29 ft³	RT	2	HT	
Job No.	PR0000150	Client Reference			
Foreman	Jay Formenti	DownholdLSD			
ABSA	Plant: H Vessel: P Process: G	Special: A	ASME	Sec. VIII div. 1	
History Log	U1A - entered March 7, 2012 Vessel relocated as per ESR - previously at Rocky View - 11-08-059-12W5 - entered March 2, 2017. Certificate of Inspection - entered March 22, 2017. AB-10 - In Relocated. Internal entry August 22, 2018 E-mail - Units Removed from Service - 2019-02-23 AB-10 - Not in Service. Internal entry 2019-05-10 AB-10 - Not in Service - internal entry January 2021 AB-10 - in service - internal entry 13-May-2022

Field Inspecti

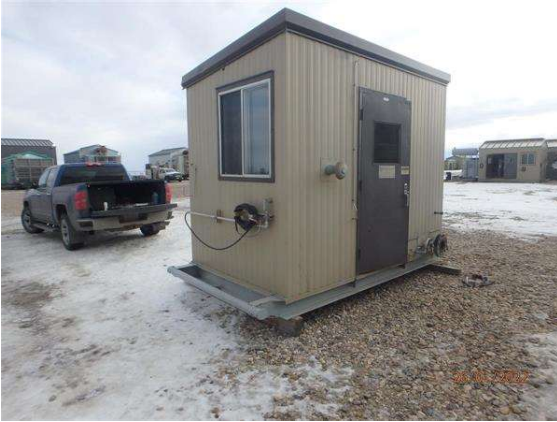
Figure: 1

The building was generally in good condition and well supported.

It was noted that there was no ground wire attached to the building structure. The building structure shall be grounded prior to start-up.

Building Overview

1. The vessel is fit for service.
2. The building should be grounded before start-up, as there was no grounding wire attached to the building structure.
3. The PSV Service Reports shall be provided to RAE Engineering for review by the Chief Inspector and data entry.

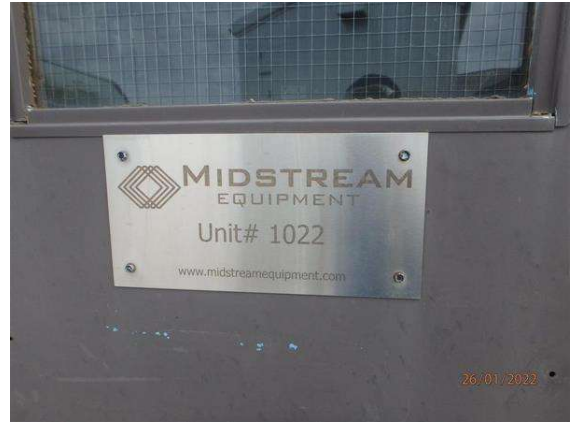
Figure: 2

Door Placard

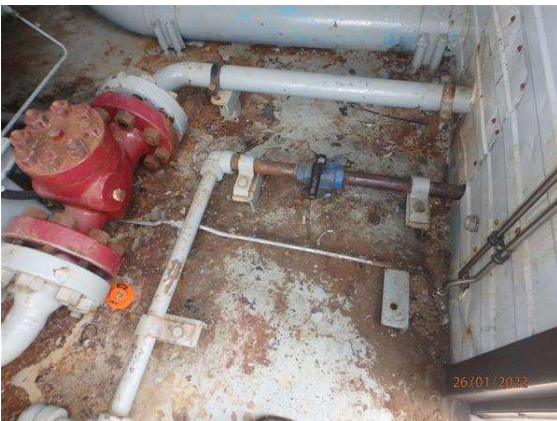
Figure: 3

The attached piping was sufficiently support and was in good condition.

It was noted that one spool of piping was missing support clamps.

The piping was painted and there was no damage, distortion or stress evident on the piping.

The piping had welded joints and flanged connections that showed no signs of leakage. The flanged connections were fully bolted and appeared to be in good condition.

Piping Overview

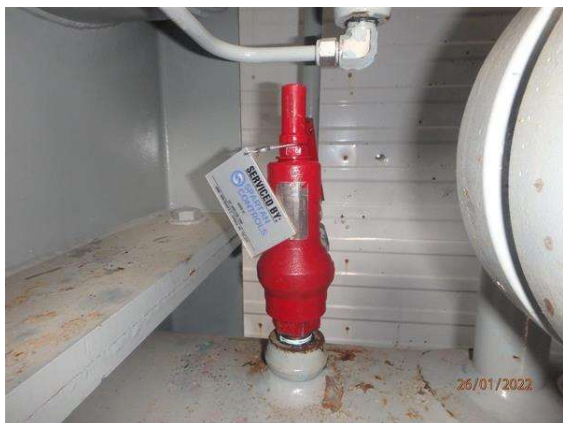
Figure: 4

The relief valve was installed on top of the vessel and the valve relieves outside the building.
The relief valve had all the required seals and they were intact.
There was a service tag attached to the relief valve and a metal service company identification tag.
The relief valve was installed in a vertical position with the discharge line grading away from the valve complying with regulatory standards.
There were no valves on the PSV piping.

PSV Overview

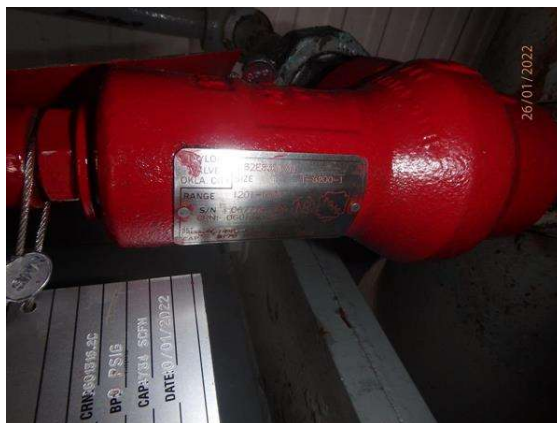
Figure: 5

PSV Nameplate

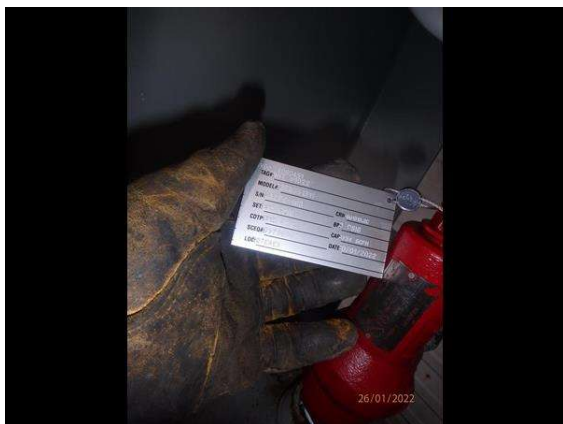
Figure: 6

PSV Service tag

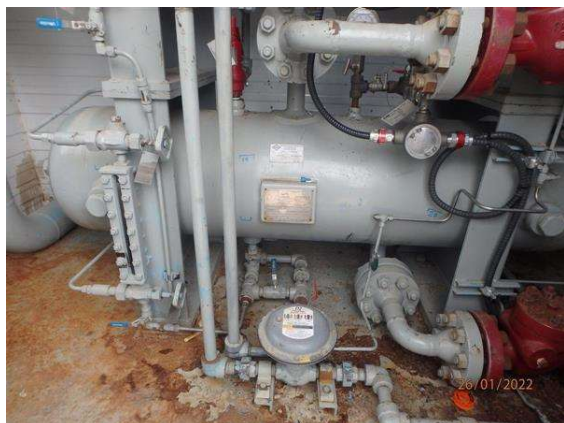
Figure: 7

The vessel was supported on channel supports and was anchored and welded to the skid floor. The vessel was adequately supported.

The heads, shell, nozzles and bolting appeared to be in good condition.

There was no stress evident on piping or nozzle connections and there was no damage or distortion evident on the vessel surface.

The vessel was painted grey and is in acceptable condition.

Vessel Overview

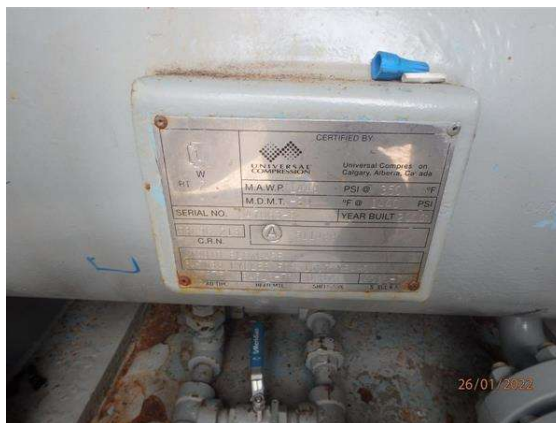
Figure: 8

The vessel was identified by the Alberta Registration Number stamped on the nameplate. The nameplate was legible and securely mounted to the vessel.

Vessel Nameplate
