Client: Fuelled	Facility: CNRL Bilbo Field	Date: Sept. 8, 2025
LSD: 07-19-65-07W6M (CNRL)	Equipment Inspected: Flare Knockout Drum SN-K637	LII Job #: 14130

Job Scope: To perform external and internal informational visual inspections with Ultrasonic Testing (UT) on a horizontal Flare Knockout Drum, SN-K637. This FKOD is out of service and currently located at the CNRL 07-19-065-07W6M Bilbo location.

Visual Inspection Information – Flare Knockout Drum (SN-K637)

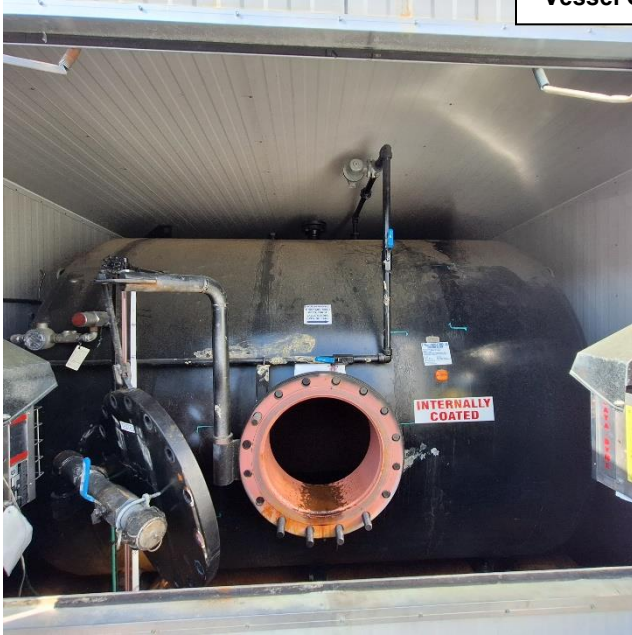
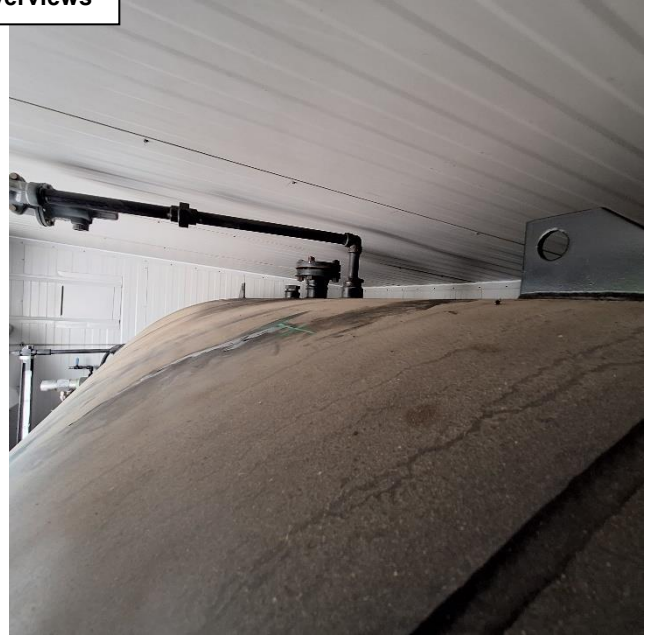
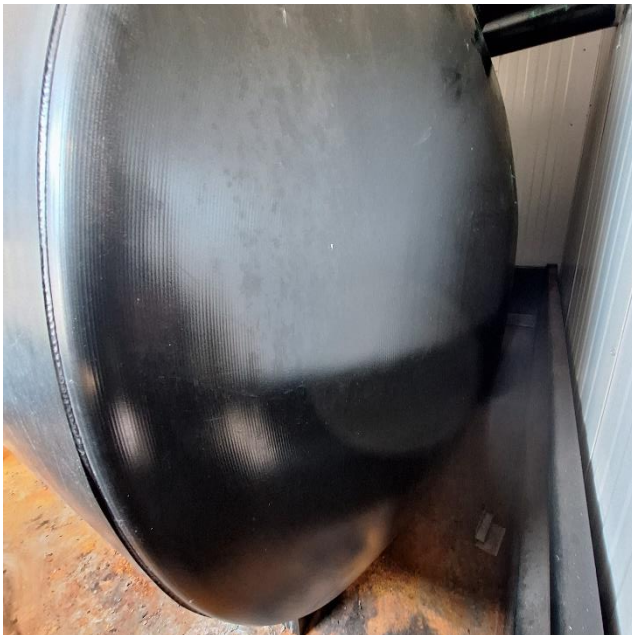
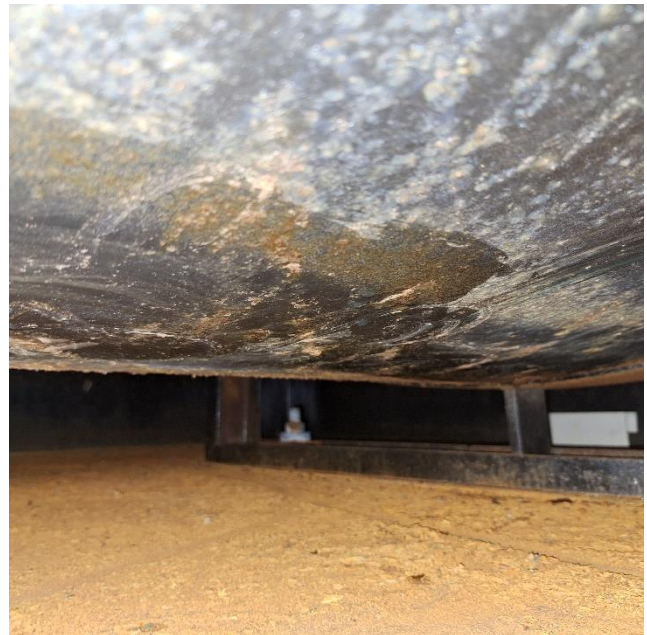
Vessel Overviews

- **External Surface:** This vessel is carbon steel, painted, and uninsulated. Some paint deterioration with minor surface corrosion was noted on the bottom of the vessel.

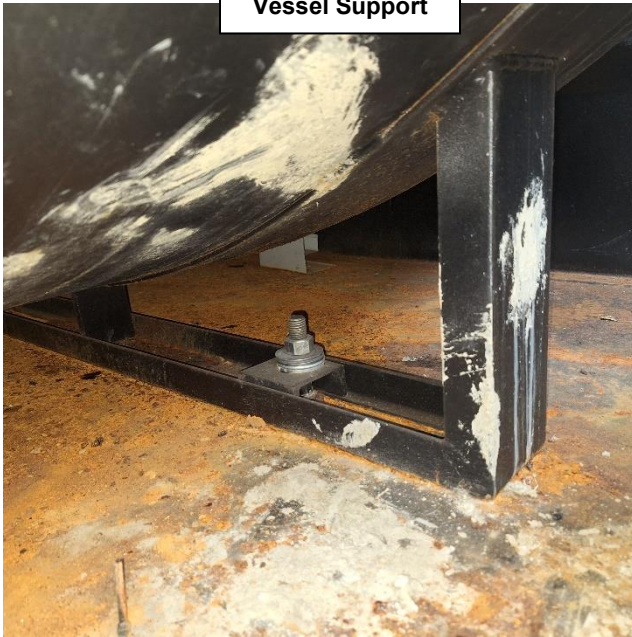
Vessel Support

- **Nameplate:** Firmly fastened and legible. Vessel serial number is welded into the manway cover.
- **Foundation/Support:** This vessel is supported by three bottom saddle supports anchor bolted to the skid floor. No visible signs of damage.

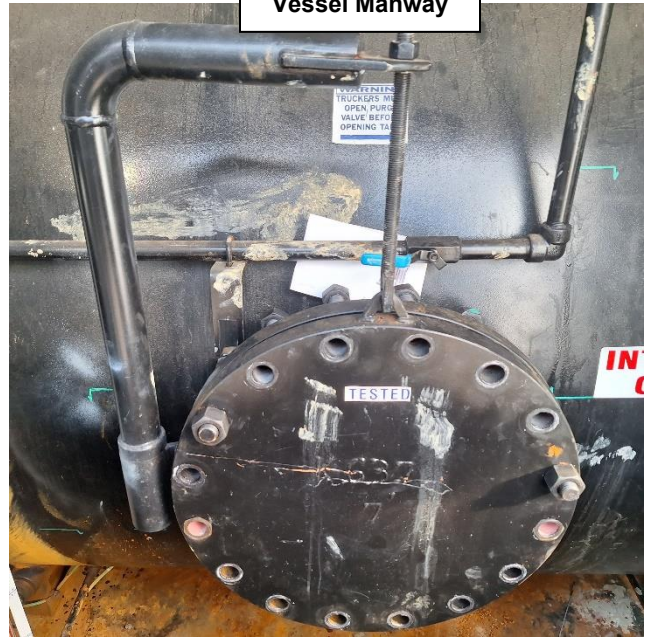
Vessel Manway

- **Nozzles:** All nozzles have a flange rating of 150#. No visible signs of damage or deflection.
- **Manway:** This vessel has an 18" manway with no notable external deficiencies.

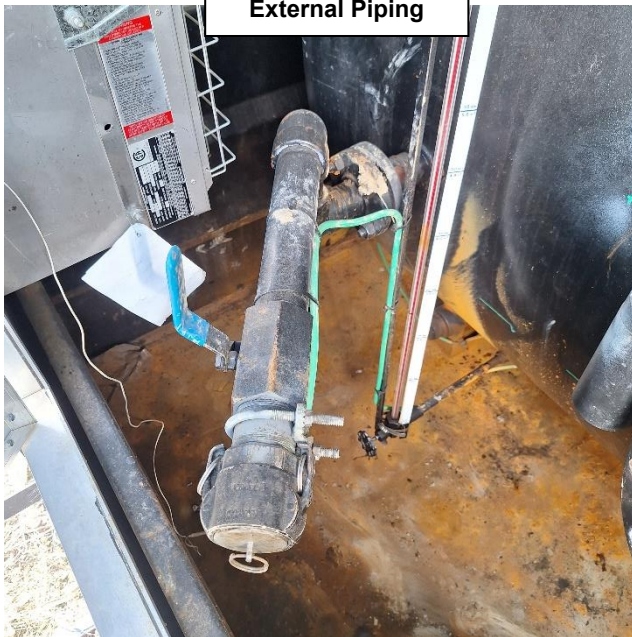
External Piping

- **External Piping:** All visible external piping is uninsulated and painted. All piping appears to be properly supported with no visible signs of damage.

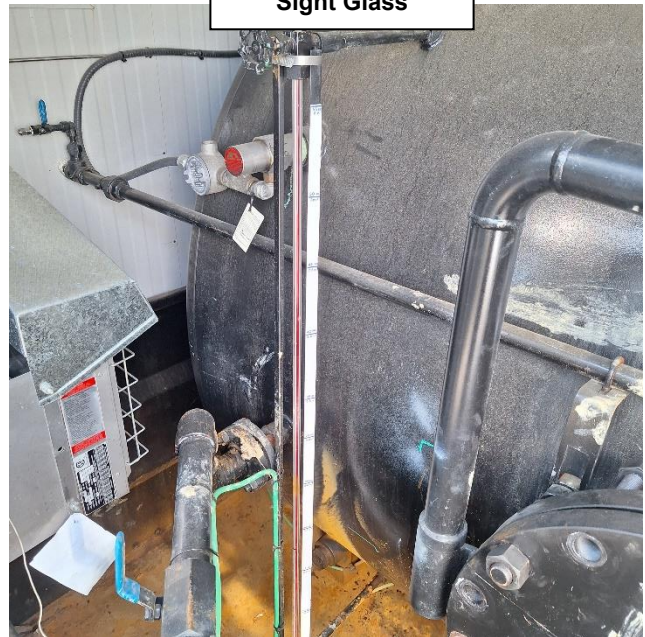
Sight Glass

- **Overpressure Protection:** This FKOD has no attached PSV. The 4" and 6" outlets are vented to atmosphere.
- **External Components:** This FKOD has two Catadyne heaters and one sight glass installed. All visible external components appear to be in good condition. This FKOD has a steel dike for secondary containment with no deficiencies observed.

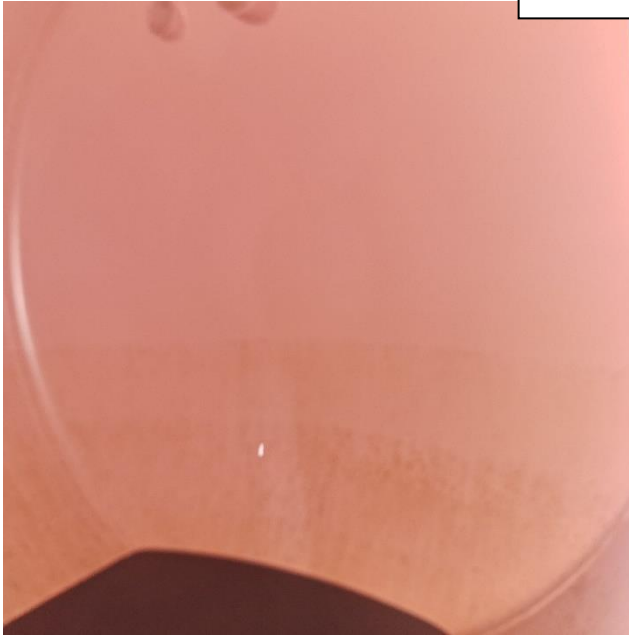
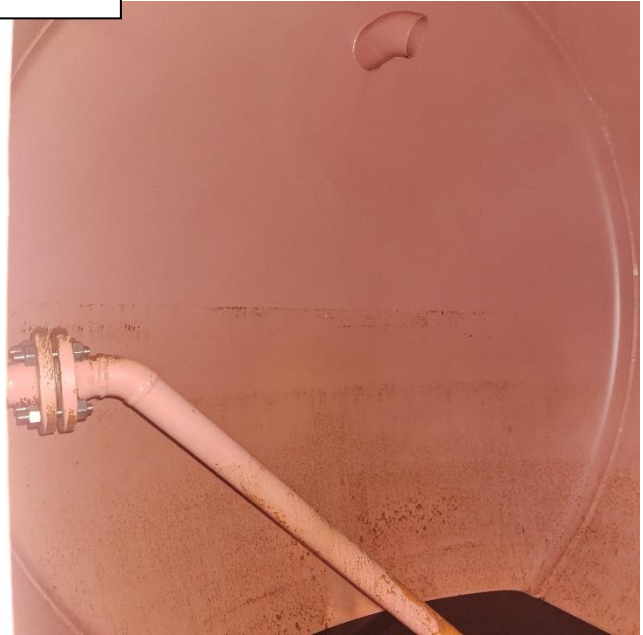
Vessel Heads

- **UT:** A UT baseline survey was conducted on the vessel shell, heads, and nozzles. Thinning in the knuckles of both heads was noted. Likely from the manufacturing process of the heads as there was no damage detected with UT. See Lance Inspections UTS report (**UT_SN-K637_sep2025**) for CML locations and thickness results.

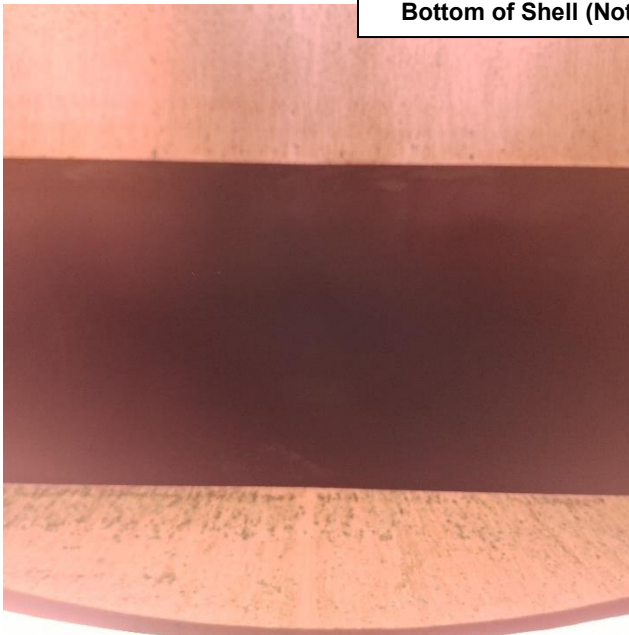
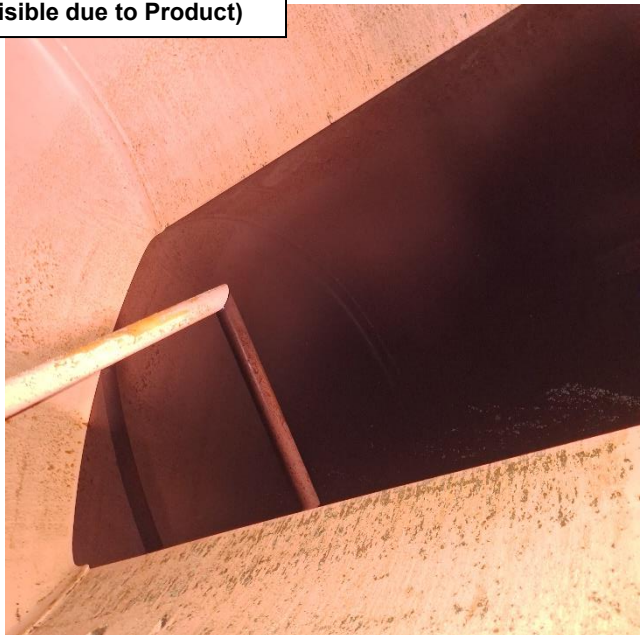
Bottom of Shell (Not Visible due to Product)

- **Internal Components:** Visually inspected from the manway. This FKOD is internally coated with residual product in the bottom of the vessel. No visual access to the 4 to 7 o'clock position of the vessel internals. No concerns observed in the visible internals of this FKOD.
