Report No: IG001263

Client	Midstream Equipment	Inspection Date	Jun 6, 2025		
Prov. Reg. #	AB RAE49501	Inspection Type	VE / UT / PSV		
Equipment Type	Fuel Gas Scrubber	Location	27 DURUM DRIVE, AB (MIDSTREAM YARD)		
Tag/Equip.		LSD			
Status	Not in Service	Downhole LSD			
Manufacturer	Industrial Fabrication Corporation	Area			
Serial Number	17013-01	Year Built	2005		
CRN #	P2308.231	Service	Sweet		
Comp/Unit Id	UNIT 1029	Manway	None		
Nat.Board #		Coating	Painted		
Interim Insp'n		Interim Type			
Next Thorough Insp	2030	Next Insp Type	VE / UT / PSV		
Length		Height			
Volume	Capacity	Client Reference			
Owner	Midstream Equipment	RT	2	HT	NO
Foreman		RAE Job No.	PR0004444		
ABSA	Plant: R Vessel: Y Process: G Special: Z		ASME	Sec. VIII div. 1	
History Log	Inspection Report Complete - Inspection Date: 2025-June-06 Inspection Type: VE/UT/PSV

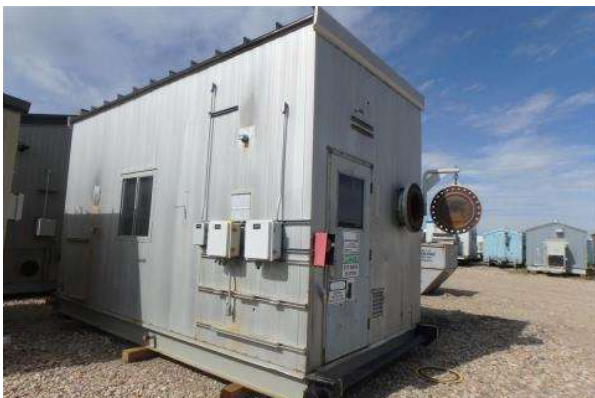
Figure: 1

The building was generally in good condition and well supported.

Overall, the building was in acceptable condition.

BUILDING

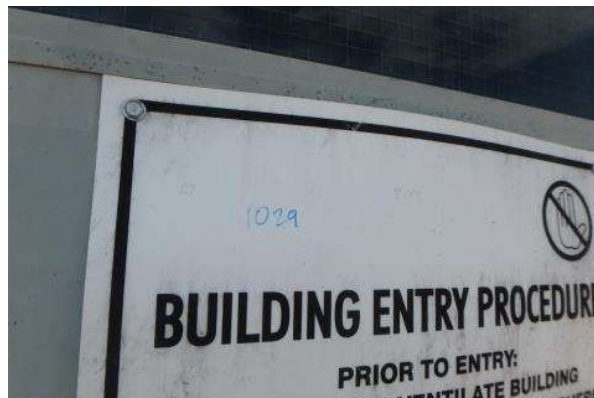
Figure: 2

Midstream unit number was written on the building door.

UNIT NUMBER

1. The vessel is fit-for-service.
2. A permanent Midstream unit label should be affixed to the building door.
3. There should be an installation inspection of the unit after being installed on site to ensure no damage occurred during shipping and to verify proper installation.

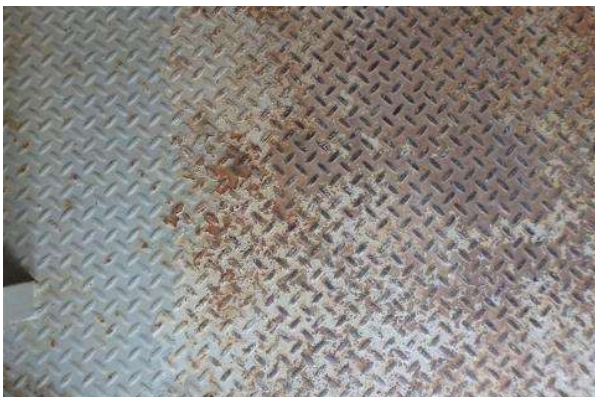
Figure: 3

The building floor was a checkered steel plate that had paint damage and corrosion and was in overall good condition.

FLOOR

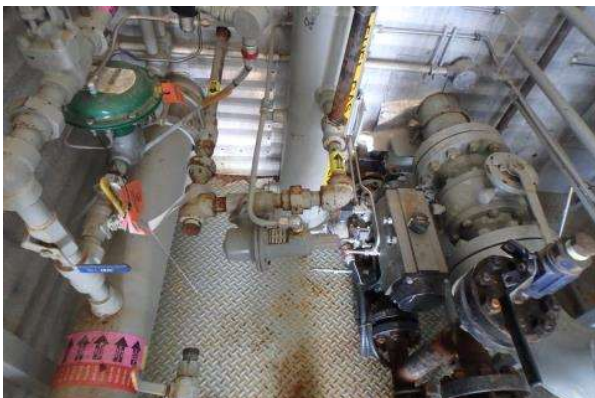
Figure: 4

Overall the piping appeared to be in good condition.

INLET PIPING

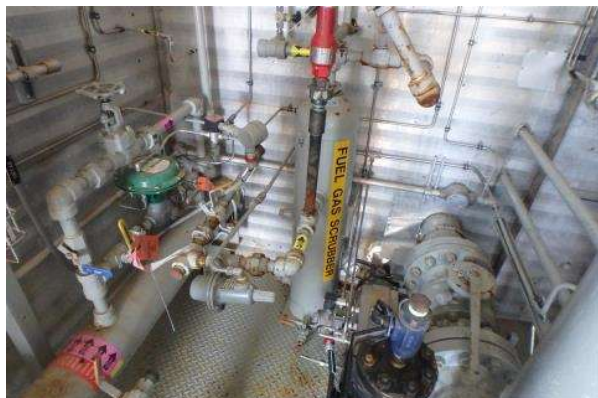
Figure: 6

The PSV had all the required seals and they were intact.

The was installed in a vertical position with the discharge line grading away from the valve complying with regulatory standards.

PSV was serviced in 2022.

PSV

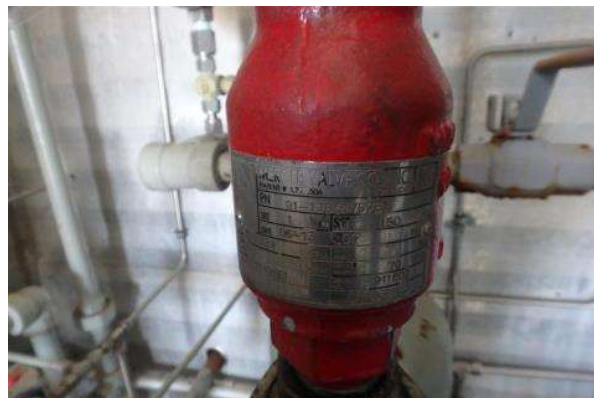
Figure: 7

The nameplate was securely attached and legible.

NAMEPLATE

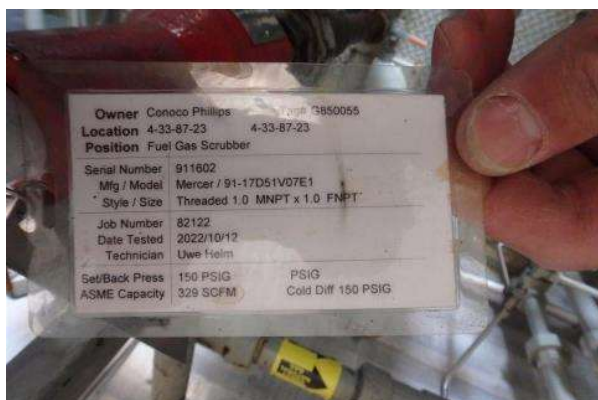
Figure: 8

There was a service tag attached to the PSV and a metal service company identification tag.

SERVICE TAG

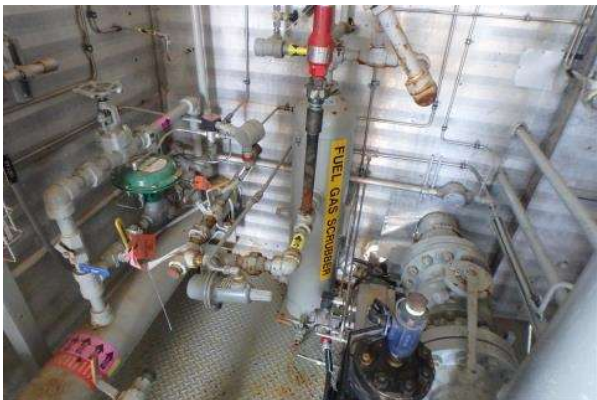
Figure: 9

There was minor paint chips and minor external corrosion noted on the vessel surfaces.

VESSEL

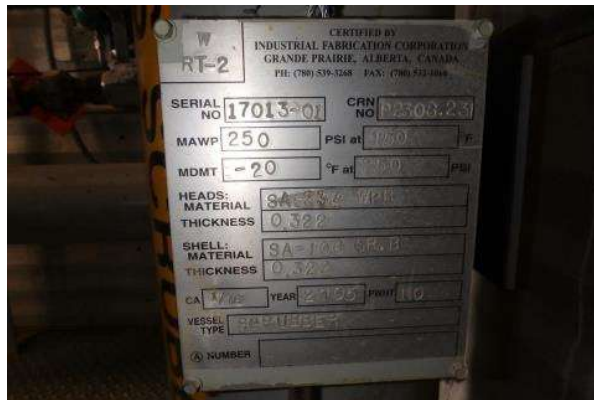
Figure: 10

NAMEPLATE

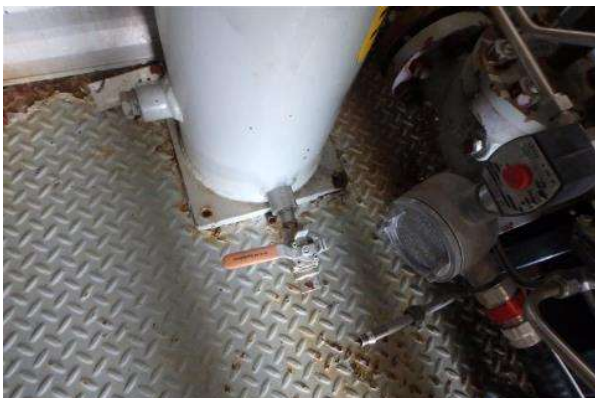
Figure: 11

SUPPORT
