Client	Midstream Equipment	Inspection Date	Jun 6, 2025		
Prov. Reg. #	AB 0514156	Inspection Type	VE / UT / PSV		
Equipment Type	Separator	Location	27 DURUM DRIVE, AB (MIDSTREAM YARD)		
Tag/Equip.		LSD	AB		
Status	Not in Service	Downhole LSD			
Manufacturer	Ifc Industrial Fabrication Corporation	Area			
Serial Number	16091-01	Year Built	2005		
CRN #	T3942.231	Service	Sour		
Comp/Unit Id	UNIT 1029	Manway	Yes		
Nat.Board #		Coating	Painted		
Interim Insp'n		Interim Type			
Next Thorough Insp	2030	Next Insp Type	VI / VE / UT / PSV		
Length		Height			
Volume	205 ft³	Client Reference			
Owner	Midstream Equipment	RT	1	HT	YES
Foreman		RAE Job No.	PR0004444		
ABSA	Plant: R Vessel: P Process: W Special: Z		ASME	Sec. VIII div. 1	
History Log	Vessel relocated as per ESR - previously at Enerflex Yard - entered March 2, 2017. Certificate of Inspection - entered March 22, 2017. AB-25 - entered March 24, 2017. AB-10 - Unit 1029 - Midstream Ownership - 2017-02-13 AB-10 - Unit 1029 Operated in BC - 2018-08-21 Inspection Report Complete - Inspection Date: 2025-June-06 Inspection Type: VE/UT/PSV

Comments

RAE Engineering and Inspection Ltd. www.raeengineering.ca Phone: (780) 469-2401 Fax: (780)-469-2

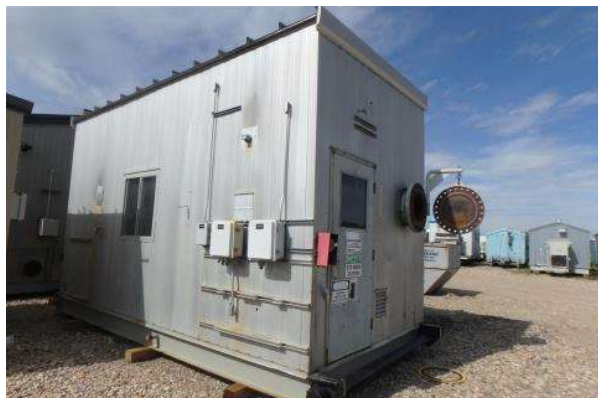
Figure: 1

The building was generally in good condition and well supported.

Overall, the building was in acceptable condition.

BUILDING

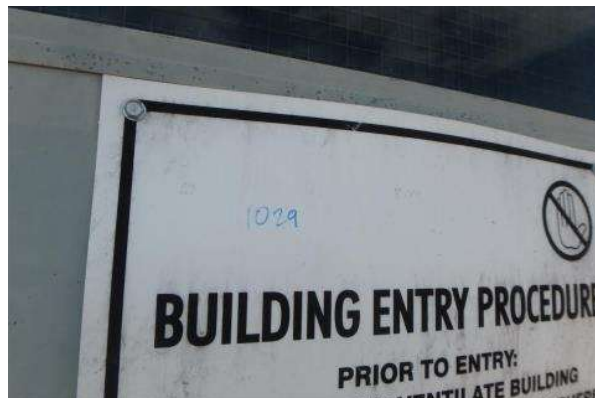
Figure: 2

Midstream unit number was written on the building door.

UNIT NUMBER

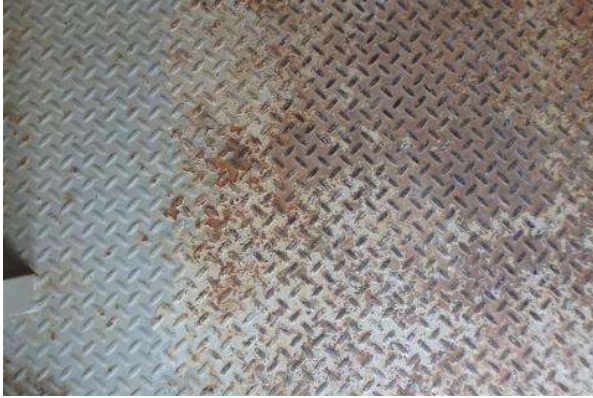
Figure: 3

The building floor was a checkered steel plate that had paint damage and corrosion and was in overall good condition.

FLOOR

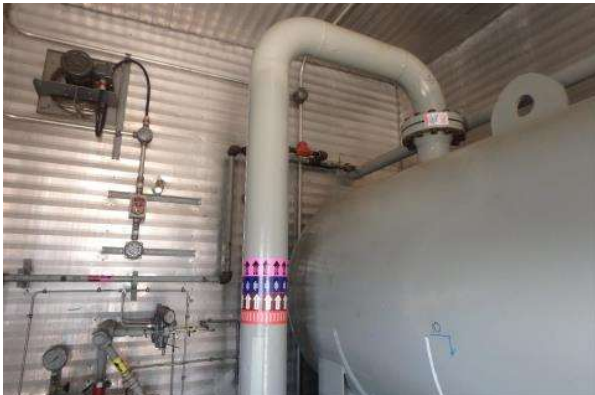
Figure: 4

There was minor paint chips and minor external corrosion noted on the piping surfaces.

INLET PIPING

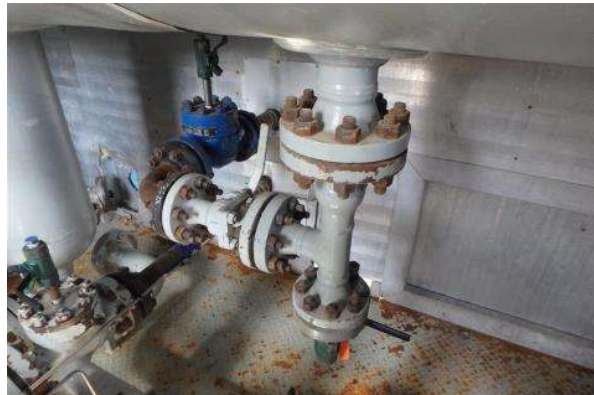
Figure: 5

WATER OUTLET PIPING

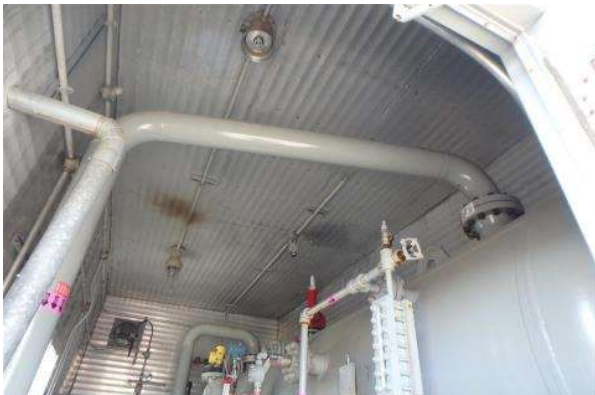
Figure: 6

GAS OUTLET PIPING

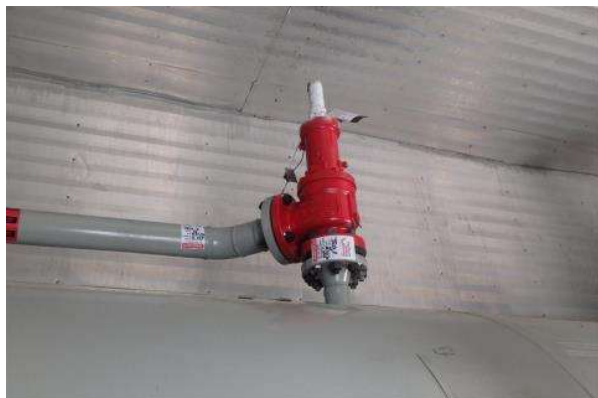
Figure: 7

The PSV was installed on the vessel and relieves outside the building.

The relief piping should have a the means to prevent insects, water or debris from entering the piping.

PSV was serviced in 2022.

PSV

The relief piping should have a means to prevent insects, water or debris from entering the piping. Recommend that a 90 elbow and pipe should be added to the existing relief piping.

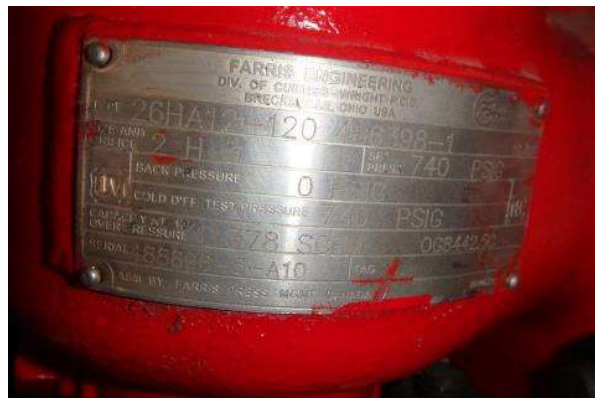
Figure: 8

The nameplate was securely attached and legible.

NAMEPLATE

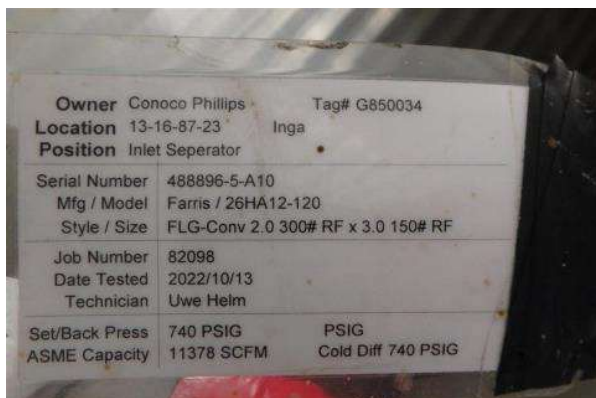
Figure: 9

There was a service tag attached to the PSV and a metal service company identification tag.

SERVICE TAG

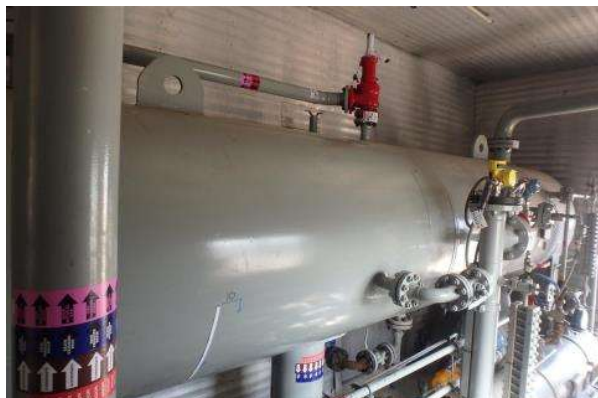
Figure: 10

The vessel was identified by the Alberta Registration Number stamped on the nameplate.
The nameplate was legible and securely mounted to the vessel.
The vessel was located inside the building was ergonomically placed.
The manway was located outside the building.
The vessel was adequately supported on saddle supports and was welded to the skid floor.
The heads, shell, nozzles and bolting appeared to be in good condition.
There was no stress evident on piping or nozzle connections and there was no damage or distortion evident on the vessel surface.
The vessel was painted grey and is in acceptable condition.
The gauges were in good condition.
PSV was serviced in 2022.

VESSEL

1. The vessel is fit-for-service provided an internal inspection is completed prior to placing the unit back into service
2. The relief piping should have a means to prevent insects, water or debris from entering the piping. Recommend that a 90 elbow and pipe should be added to the existing relief piping.
3. A permanent Midstream unit label should be affixed to the building door.
4. There should be an installation inspection of the unit after being installed on site to ensure no damage occurred during shipping and to verify proper installation.

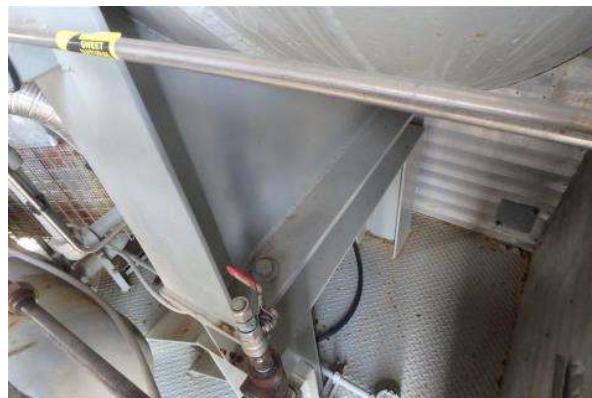
Figure: 11

SUPPORT

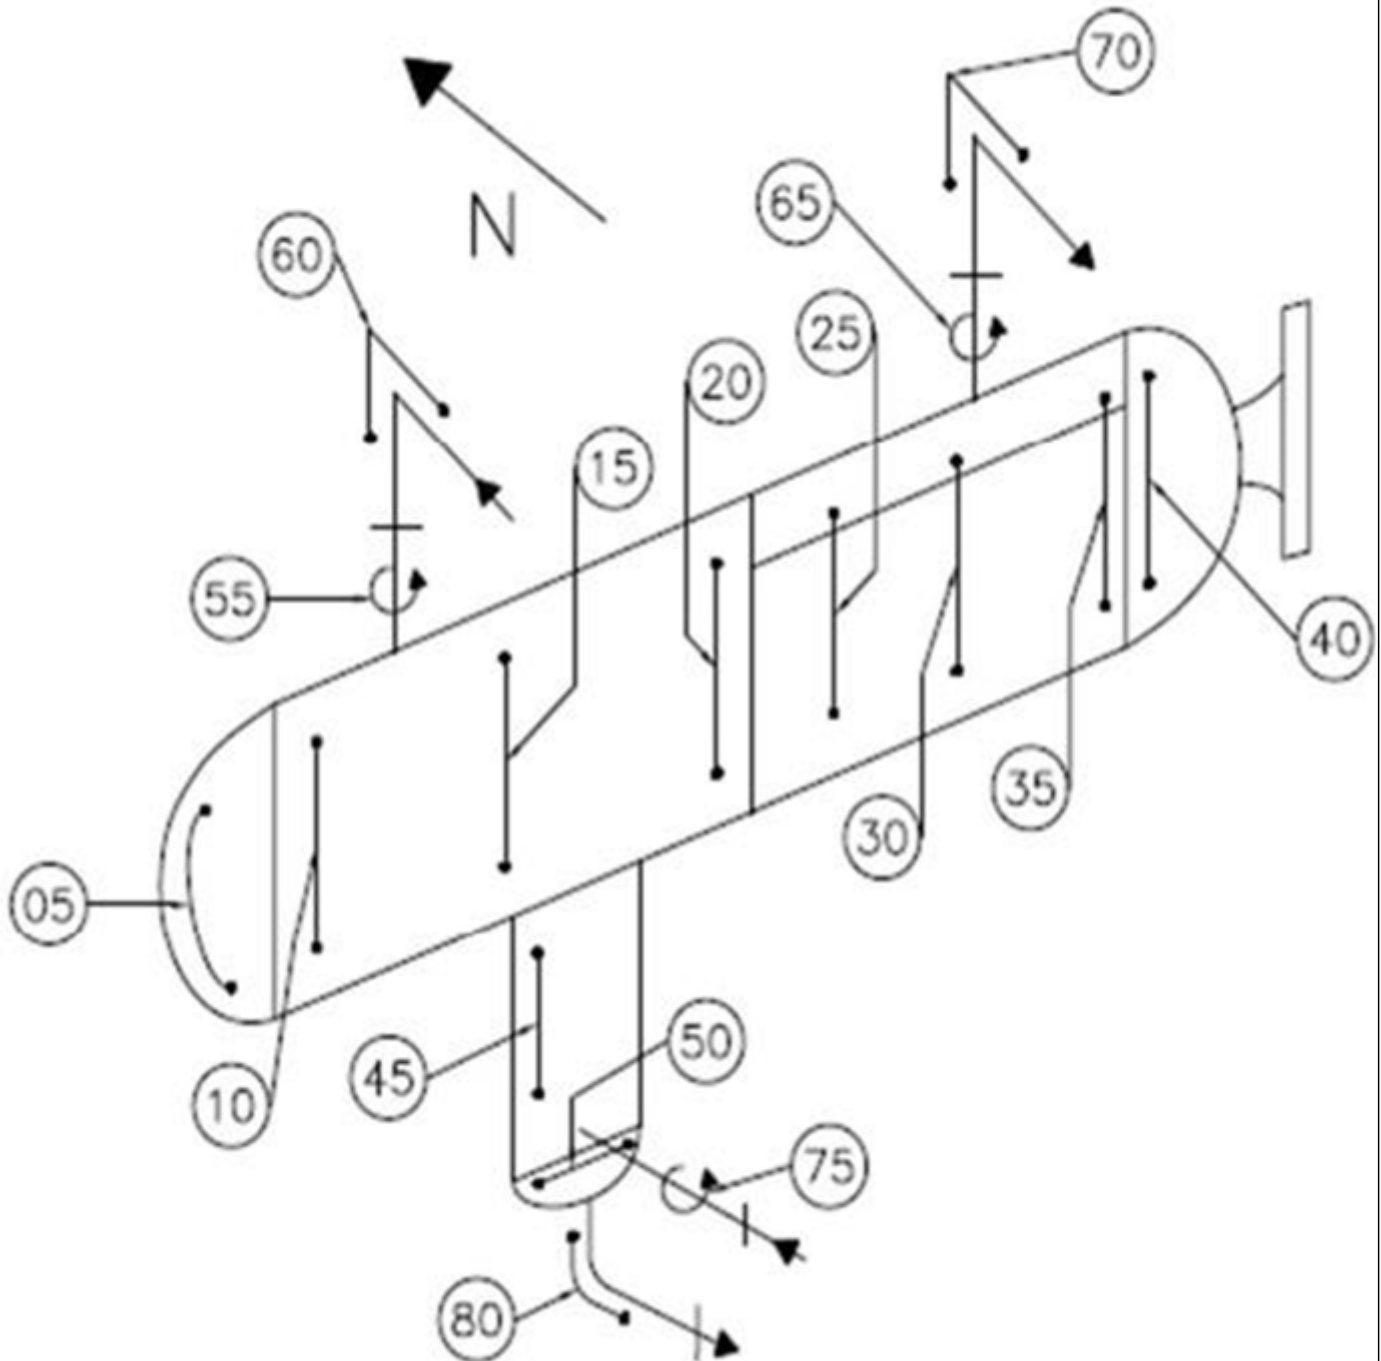
ISO

The measurements obtained from the inspection locations showed the thicknesses of all the components inspected to be at or around nominal. There were no signs of wall thinning, internal corrosion, erosion, laminations or inclusions at the time of inspection. All piping measurements were within the 12.5% mill tolerance, as per ASTM specifications.
