Client	Midstream Equipment	Inspection Date	Jun 6, 2025		
Prov. Reg. #	AB RAE46443	Inspection Type	VE / UT / PSV		
Equipment Type	Fuel Gas Scrubber	Location			
Tag/Equip.		LSD	AB		
Status	In Service	Downhole LSD			
Manufacturer	Aquila Fabrication & Equipment Ltd.	Area			
Serial Number	S-3120	Year Built	2014		
CRN #	0H5837.231	Service	Sour		
Comp/Unit Id	UNIT 1063	Manway	None		
Nat.Board #		Coating			
Interim Insp'n		Interim Type			
Next Thorough Insp	2030	Next Insp Type	VE / UT / PSV		
Length		Height			
Volume	Capacity	Client Reference			
Owner	Midstream Equipment	RT	2	HT	NO
Foreman		RAE Job No.	PR0004445		
ABSA	Plant: H	Vessel: K	Process: W	Special: R	ASME Sec. VIII div. 1
History Log	Inspection Report Complete - Inspection Date: 2025-June-06 Inspection Type: VE/UT/PSV

RAE Engineering and Inspection Ltd. www.raeengineering.ca Phone: (780) 469-2401 Fax: (780)-469-2401		Inspection Date:		June 06, 2025		<h1 style="text-align: center;">UT Report</h1>								
			Report Number:		IG000069										
			Page:		1 of 4										
Client:		Midstream Equipment		Job Number:		PR0004445									
Facility:		Midstream Yard		Location/LSD:		Midstream Yard									
Equipment Number:		RAE46443		Client R

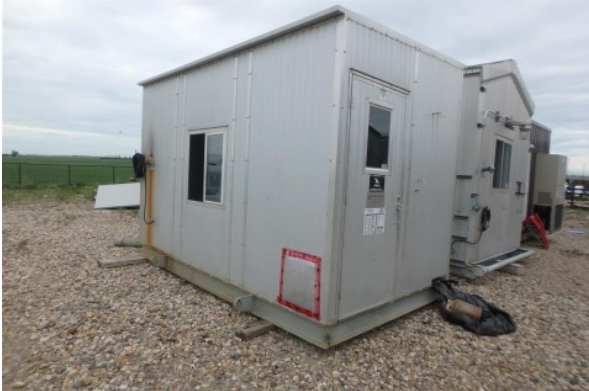
Figure: 1

The building was in good condition and there were no signs of damage.

The building was level and there were no structural concerns.

BUILDING

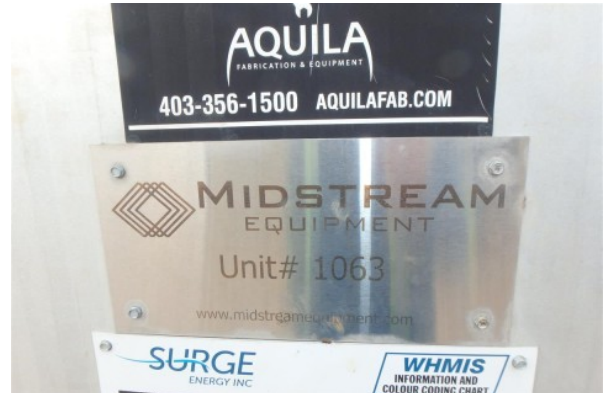
Figure: 2

UNIT NUMBER

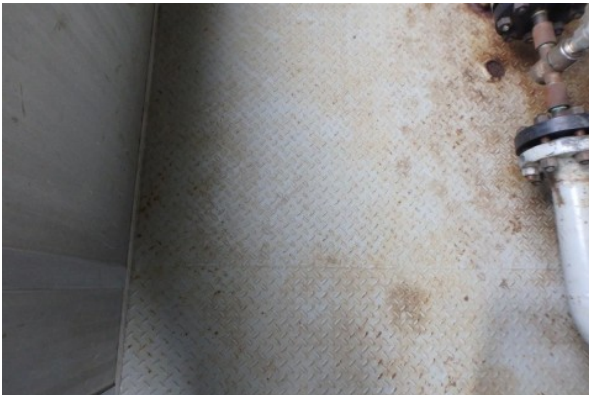
Figure: 3

Lighting: Good Floors : Checker plate steel

FLOOR

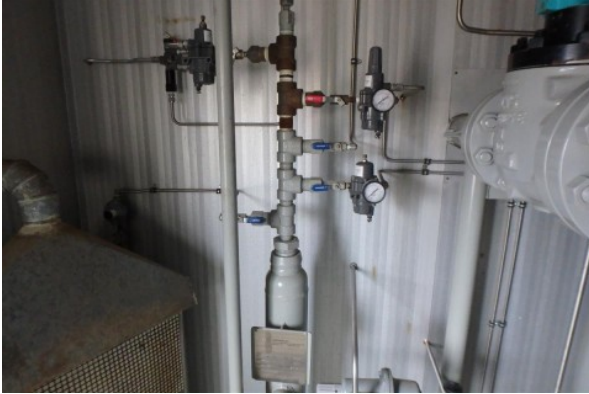
Figure: 4

The inlet and outlet piping as well as the piping associated with the vessel were in place and properly bolted and supported.

The piping was coated and in serviceable condition.

There was no evidence of pipe strain due to poor fit up. There were no concerns with the piping.

PIPING

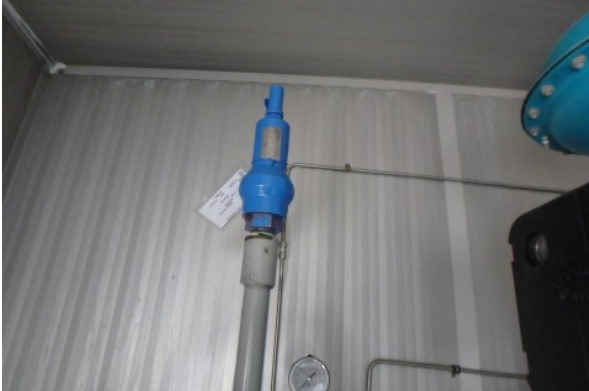
Figure: 5

The PSV was located on the associated piping.
The PSV was in serviceable condition, securely mounted in the vertical position.
The nameplate was securely attached and legible.
The service tag was securely attached and legible.
The set pressure was acceptable for the vessel MAWP.
The seal wire was attached and intact.
There were no reductions in vent line size, or visible restrictions in flow.

The PSV outlet pipe needs a 90 fitting put on the end to keep rain and snow out.

PSV

1. The vessel is fit-for-service.
2. The PSV outlet pipe needs a 90 fitting put on the end to keep rain and snow out.
3. There should be an installation inspection of the unit after being installed on site to ensure no damage occurred during shipping and to verify proper installation.

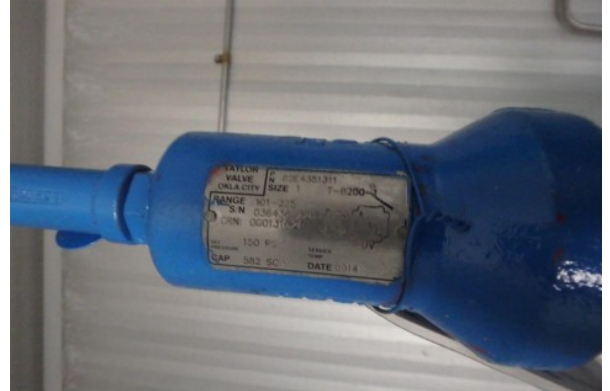
Figure: 6

NAMEPLATE

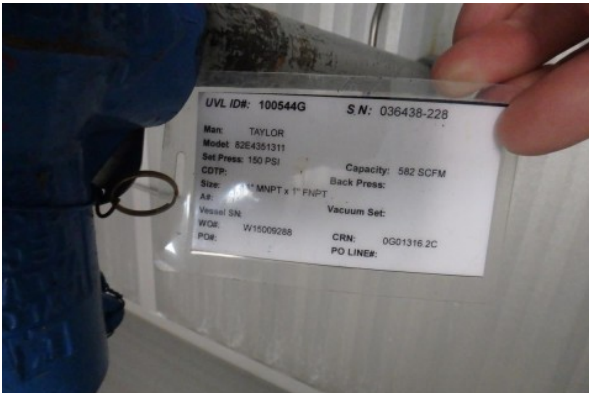
Figure: 7

SERVICE TAG

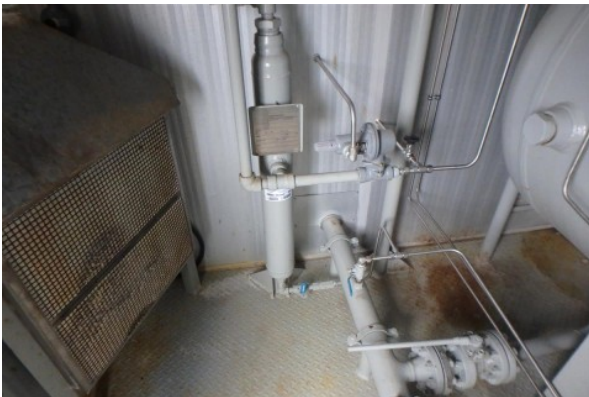
Figure: 8

The vessel was located inside a building.
The nameplate was legible and securely attached.
The exterior was fully painted, and the paint was in serviceable condition.
The heads and shell appeared to be in serviceable condition.
There was no damage, distortion, or stress evident on piping connections.
The vessel was adequately supported, with no makeshift structural attachments on any of the pressure containing components.

VESSEL

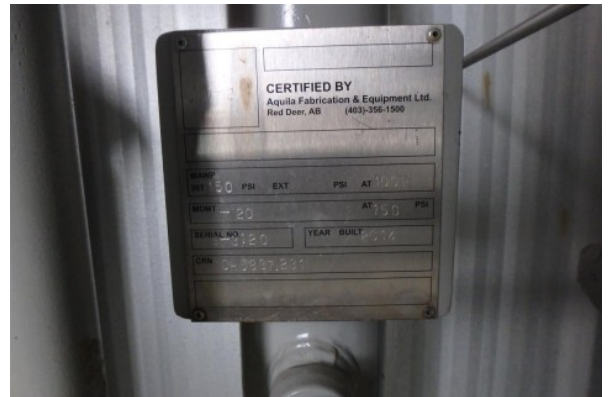
Figure: 9

NAMEPLATE

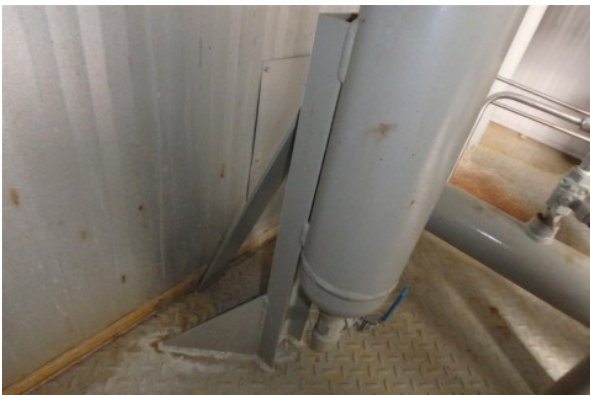
Figure: 10

SUPPORT

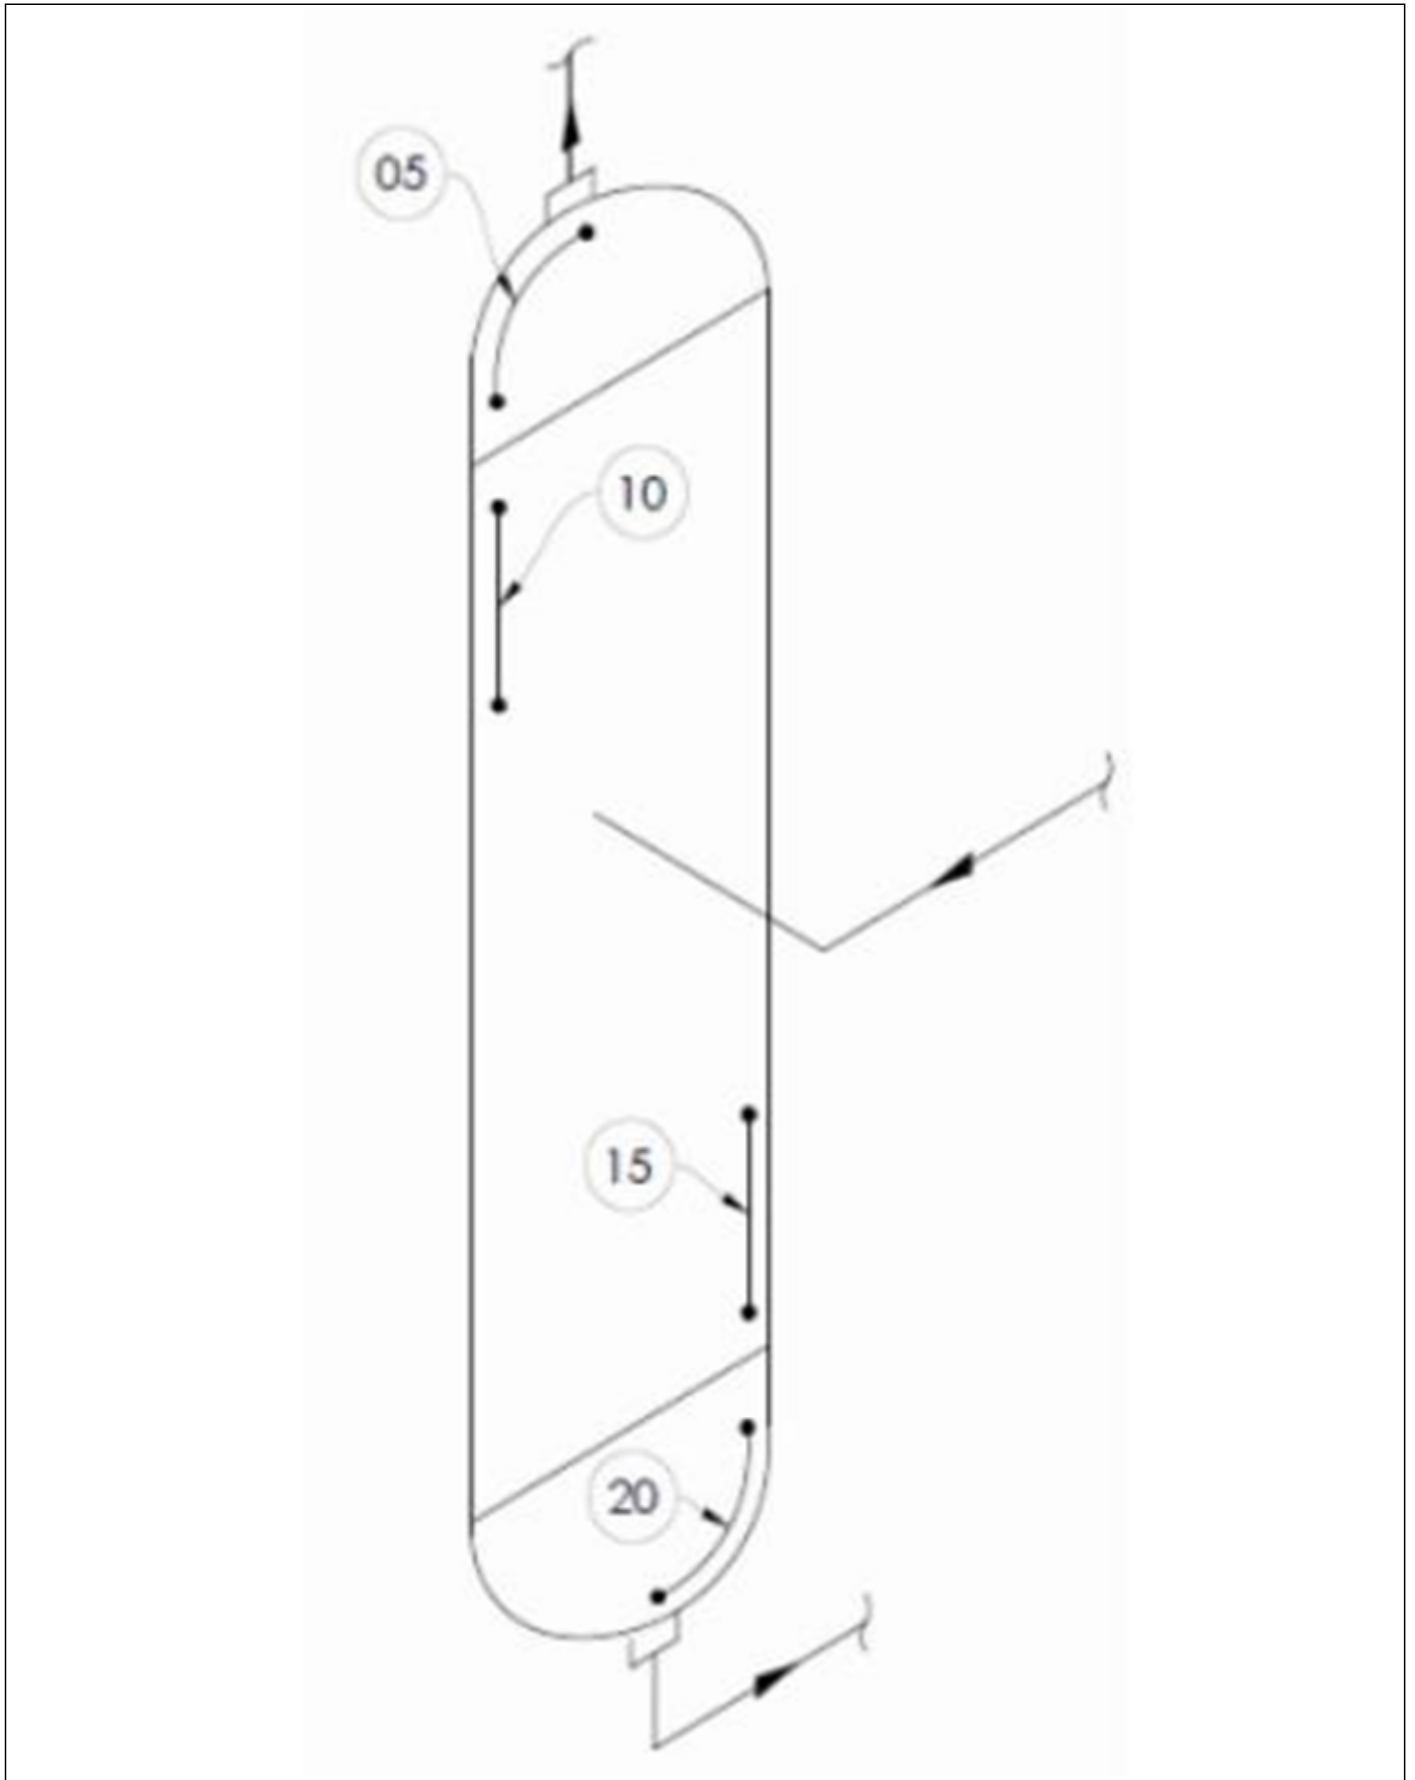
ISO

The measurements obtained from the inspection locations show the thickness of all of the components inspected to be consistent. However, there was no nominal thickness at the time of inspection.

#	01	02	03	04	05	06	07	08	09	10	11	12	Min & Avg	
4							Nom	N/S	Mil	N/S	CA	N/S	Min:	0.238
	0.238	0.245	0.261	0.280									Avg:	0.256
8							Nom	N/S	Mil	N/S	CA	N/S	Min:	0.249

0.249	0.250	0.252	0.249	0.263	0.259	0.260	0.257	0.250	0.249			Avg:	0.254
12							Nom	N/S	Mil	N/S	CA	N/S	Min:	0.235
	0.249	0.247	0.242	0.239	0.238	0.245	0.239	0.235	0.239	0.239			Avg:	0.241
16							Nom	N/S	Mil	N/S	CA	N/S	Min:	0.220

0.295	0.250	0.242	0.221	0.220								Avg:	0.246
5	Top Head						Nom	N/S	Mil	N/S	CA	N/S	Min:	0.238
	0.238	0.245	0.261	0.280									Avg:	0.256
10	Top Shell						Nom	N/S	Mil	N/S	CA	N/S	Min:	0.249

0.249	0.250	0.252	0.249	0.263	0.259	0.260	0.257	0.250	0.249			Avg:	0.254
15	Bottom Shell						Nom	N/S	Mil	N/S	CA	N/S	Min:	0.235
	0.249	0.247	0.242	0.239	0.238	0.245	0.239	0.235	0.239	0.239			Avg:	0.241
20	Bottom Head						Nom	N/S	Mil	N/S	CA	N/S	Min:	0.220

0.295	0.250	0.242	0.221	0.220								Avg:	0.246
