Client	Midstream Equipment	Inspection Date	Jun 6, 2025		
Prov. Reg. #	AB 0640366	Inspection Type	VE / UT / PSV		
Equipment Type	Horizontal Separator	Location	27 DURUM DRIVE, AB MIDSTREAM YARD		
Tag/Equip.		LSD	AB		
Status	Not In Service	Downhole LSD			
Manufacturer	Aquila Fabrication & Equipment Ltd.	Area			
Serial Number	S-3113	Year Built	2014		
CRN #	R9624.213	Service	Sour		
Comp/Unit Id	UNIT 1063	Manway	None		
Nat.Board #		Coating			
Interim Insp'n		Interim Type			
Next Thorough Insp	2030	Next Insp Type	VE / UT / PSV		
Length	120 in	Height			
Volume	70 ft³	Client Reference			
Owner	Midstream Equipment	RT	2	HT	NO
Foreman		RAE Job No.	PR0004445		
ABSA	Plant: R Vessel: P Process: W Special: Z	ASME	Sec. VIII div. 1		
History Log	U1A - entered 2018-01-26 AB-10 - Not in Service - internal entry Mar2025 Inspection Report Complete - Inspection Date: 2025-June-06 Inspection Type: VE/UT/PSV

Component	Shell				
MAWP	720.0 PSI @ 100 °F		MDMT	-20 °F @ 720.0 PSI	
Material	SA-516-70N		Material Thickness	0.875 in	
Diameter	36 in		Length		
Corrosion Allowance	0.125 in

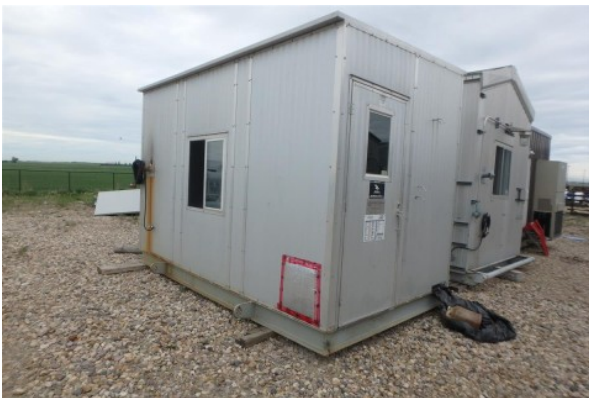
Figure: 1

The building was in good condition and there were no signs of damage.
The building was level and there were no structural concerns.
All points of access were complete with platforms.
The building ground wire was installed as well.
There were no concerns with the building itself.

BUILDING

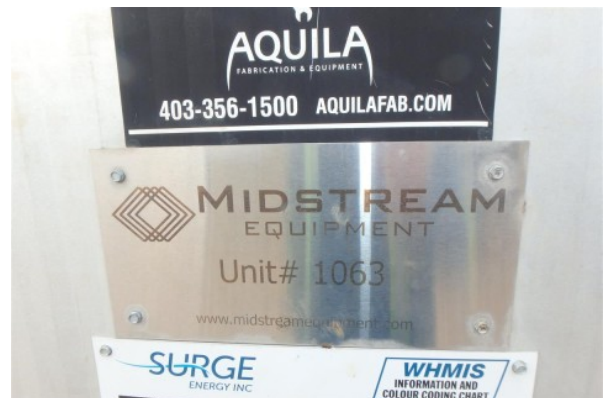
Figure: 2

UNIT NUMBER

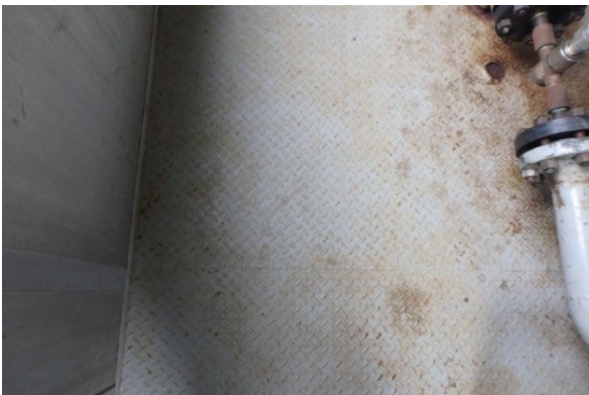
Figure: 3

FLOOR

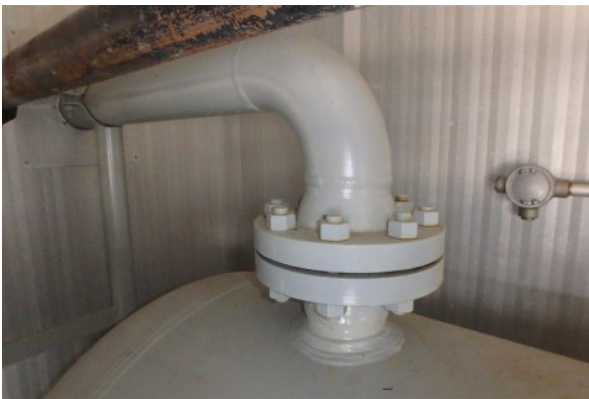
Figure: 4

The inlet and outlet piping as well as the piping associated with the vessel were in place and properly bolted and supported.

INLET PIPING

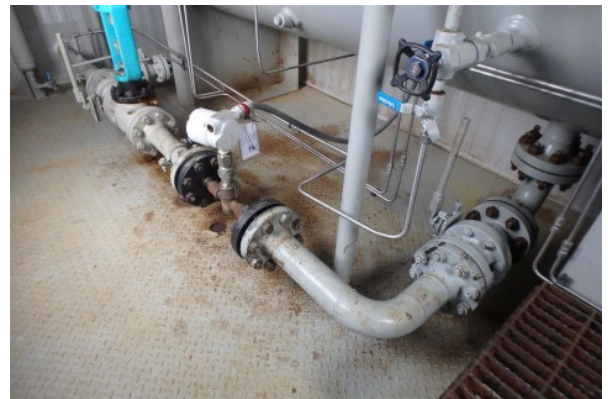
Figure: 5

WATER OUTLET PIPING

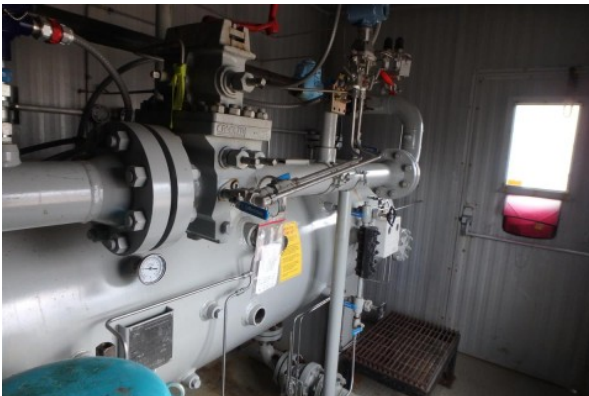
Figure: 6

GAS OUTLET PIPING

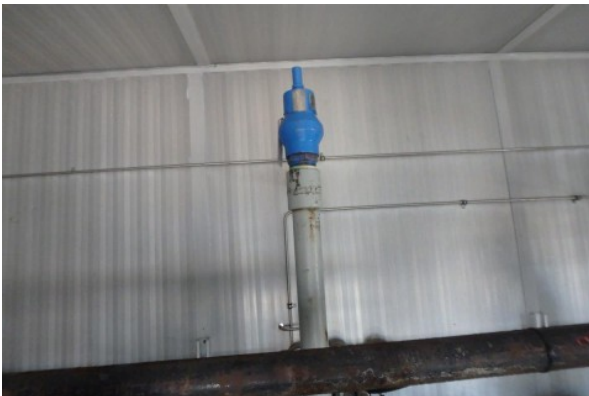
Figure: 7

The PSV was located on the associated piping.
The PSV was in serviceable condition, securely mounted in the vertical position.
The nameplate was securely attached and legible. The service tag was securely attached and legible.
The set pressure was acceptable for the vessel MAWP.
The seal wire was attached and intact.
There were no reductions in vent line size, or visible restrictions in flow.

The PSV outlet pipe needs a 90 fitting put on the end to keep rain and snow out.

PSV

1. The vessel is fit-for-service.
2. The PSV outlet pipe needs a 90 fitting put on the end to keep rain and snow out.
3. There should be an installation inspection of the unit after being installed on site to ensure no damage occurred during shipping and to verify proper installation.

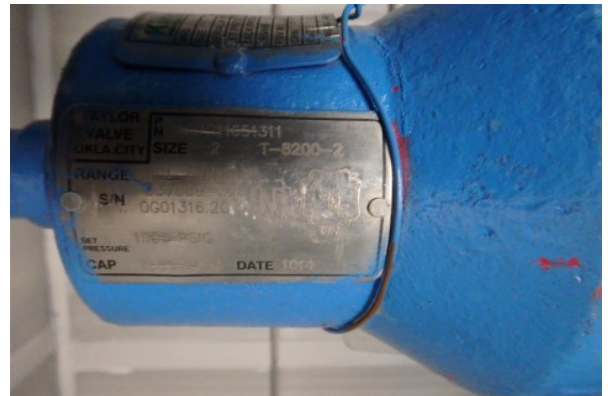
Figure: 8

NAMEPLATE

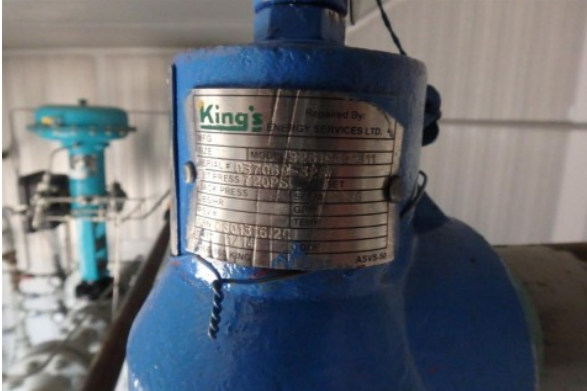
Figure: 9

REPAIR NAMEPLATE

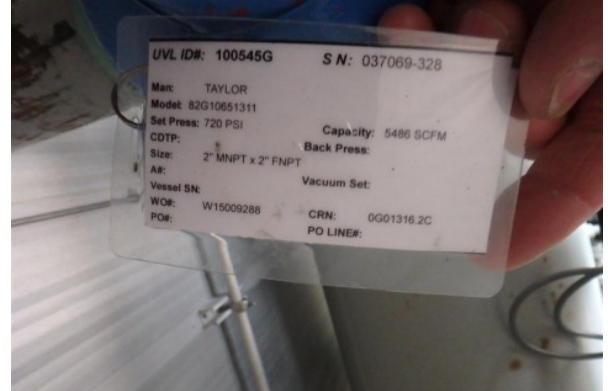
Figure: 10

SERVICE TAG

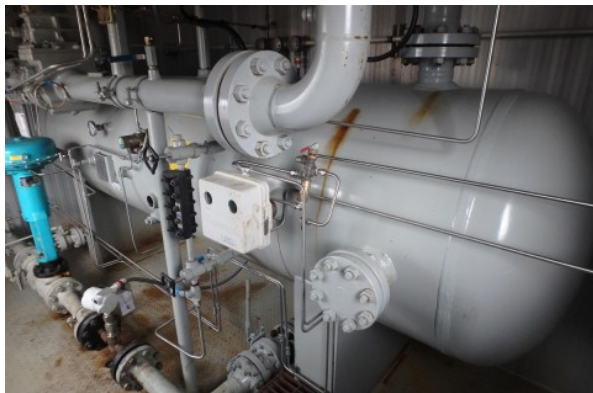
Figure: 11

The vessel was located inside a building.
The nameplate was legible and securely attached.
The exterior was fully painted, and the paint was in serviceable condition.
The heads and shell appeared to be in serviceable condition.
There was no damage, distortion, or stress evident on piping connections.
The vessel was adequately supported, with no makeshift structural attachments on any of the pressure containing components.

VESSEL

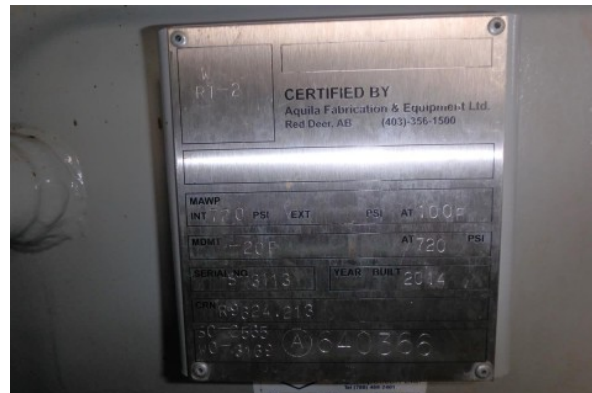
Figure: 12

NAMEPLATE

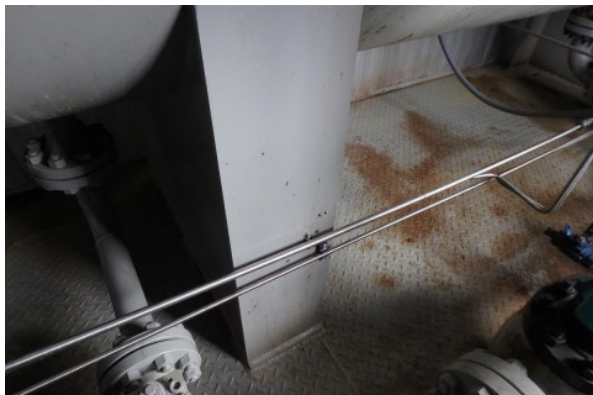
Figure: 13

SUPPORT

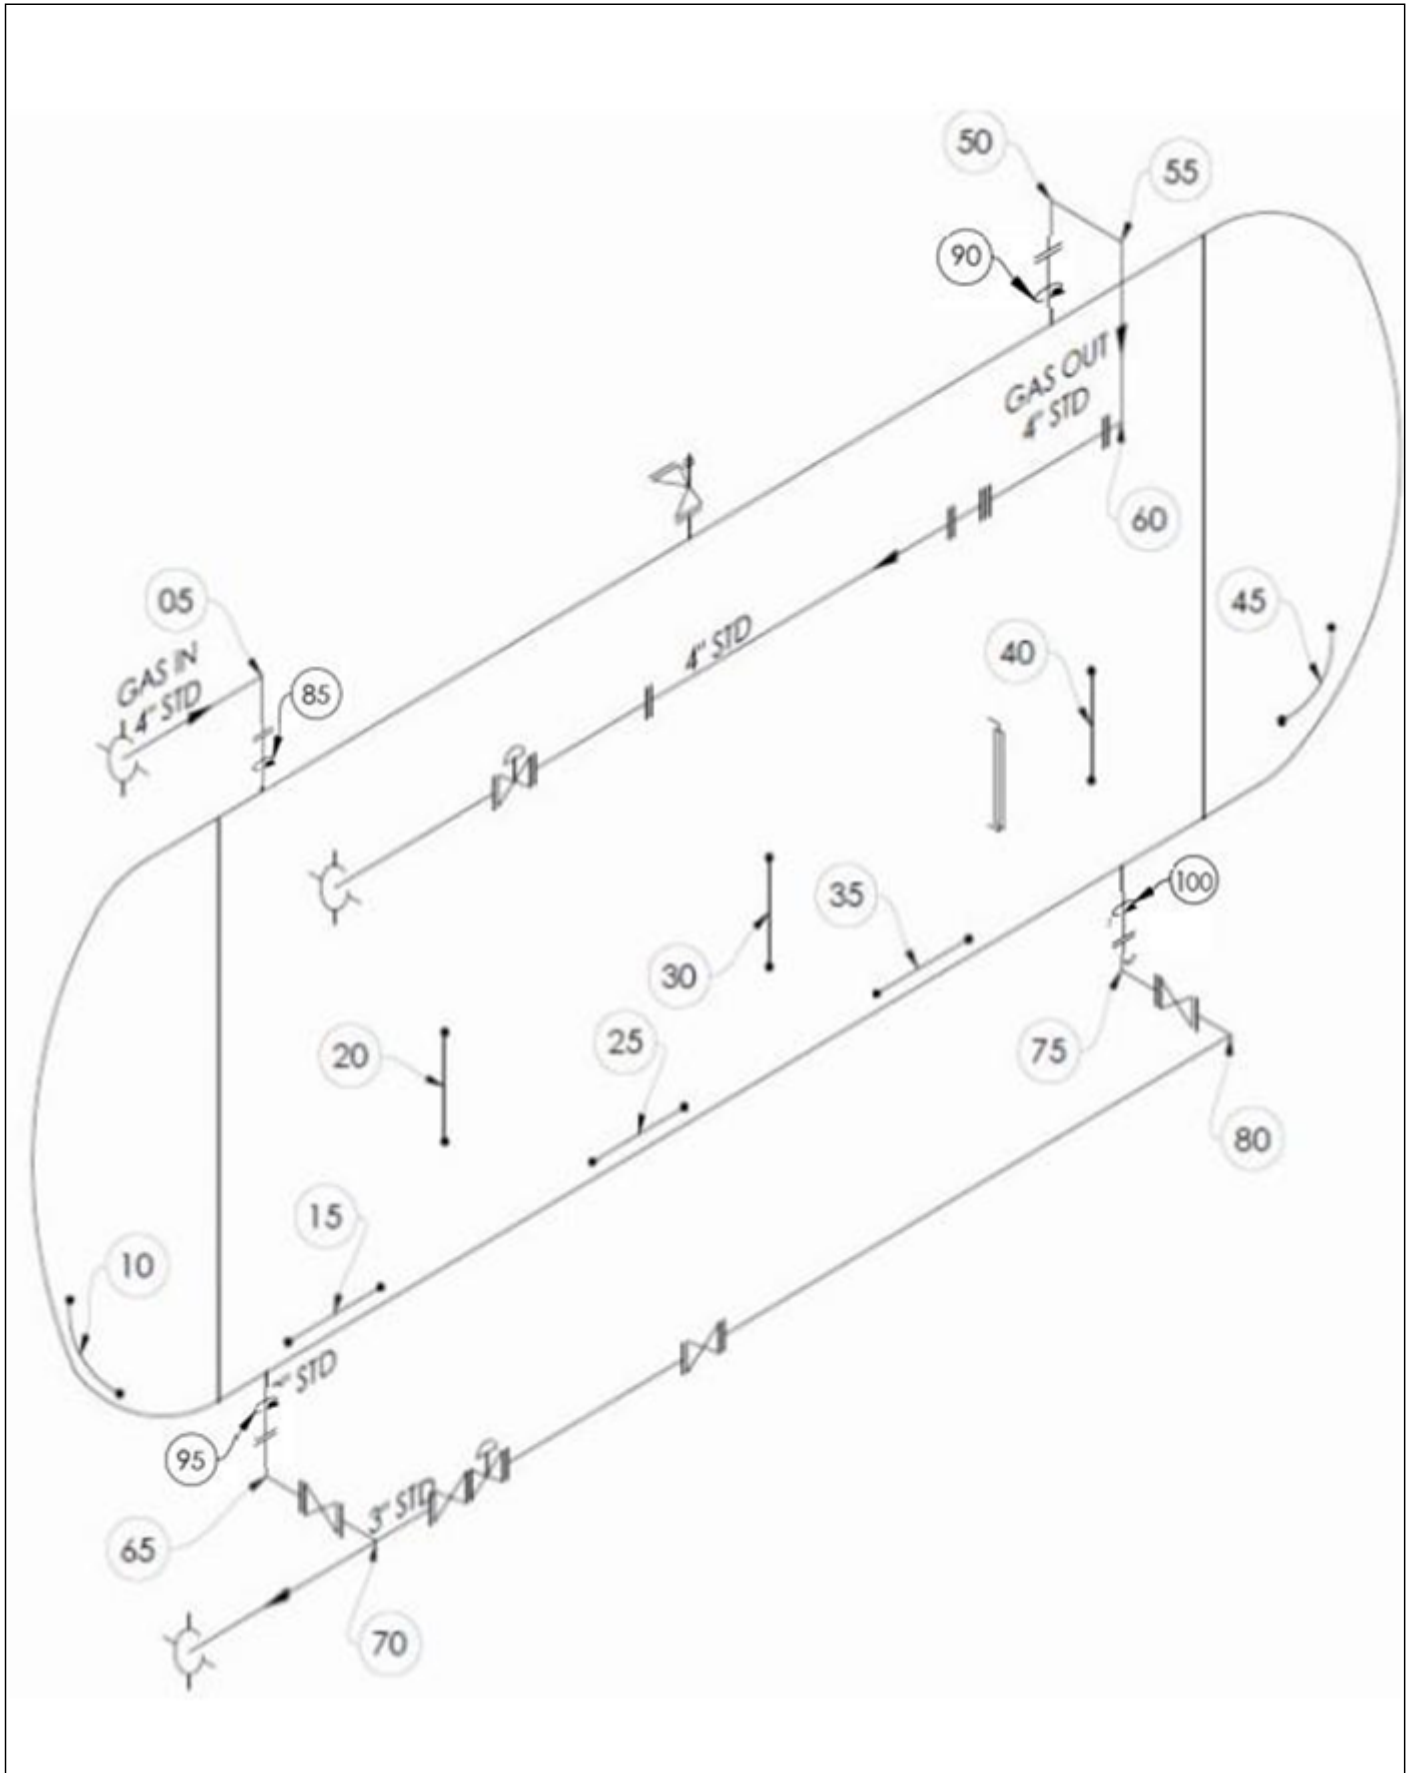
ISO

The measurements obtained from the inspection locations showed the thicknesses of all the components inspected to be at or around nominal. There were no signs of wall thinning, internal corrosion, erosion, laminations or inclusions at the time of inspection.
