Cummins QSK19, Unit G20 Borescope report.

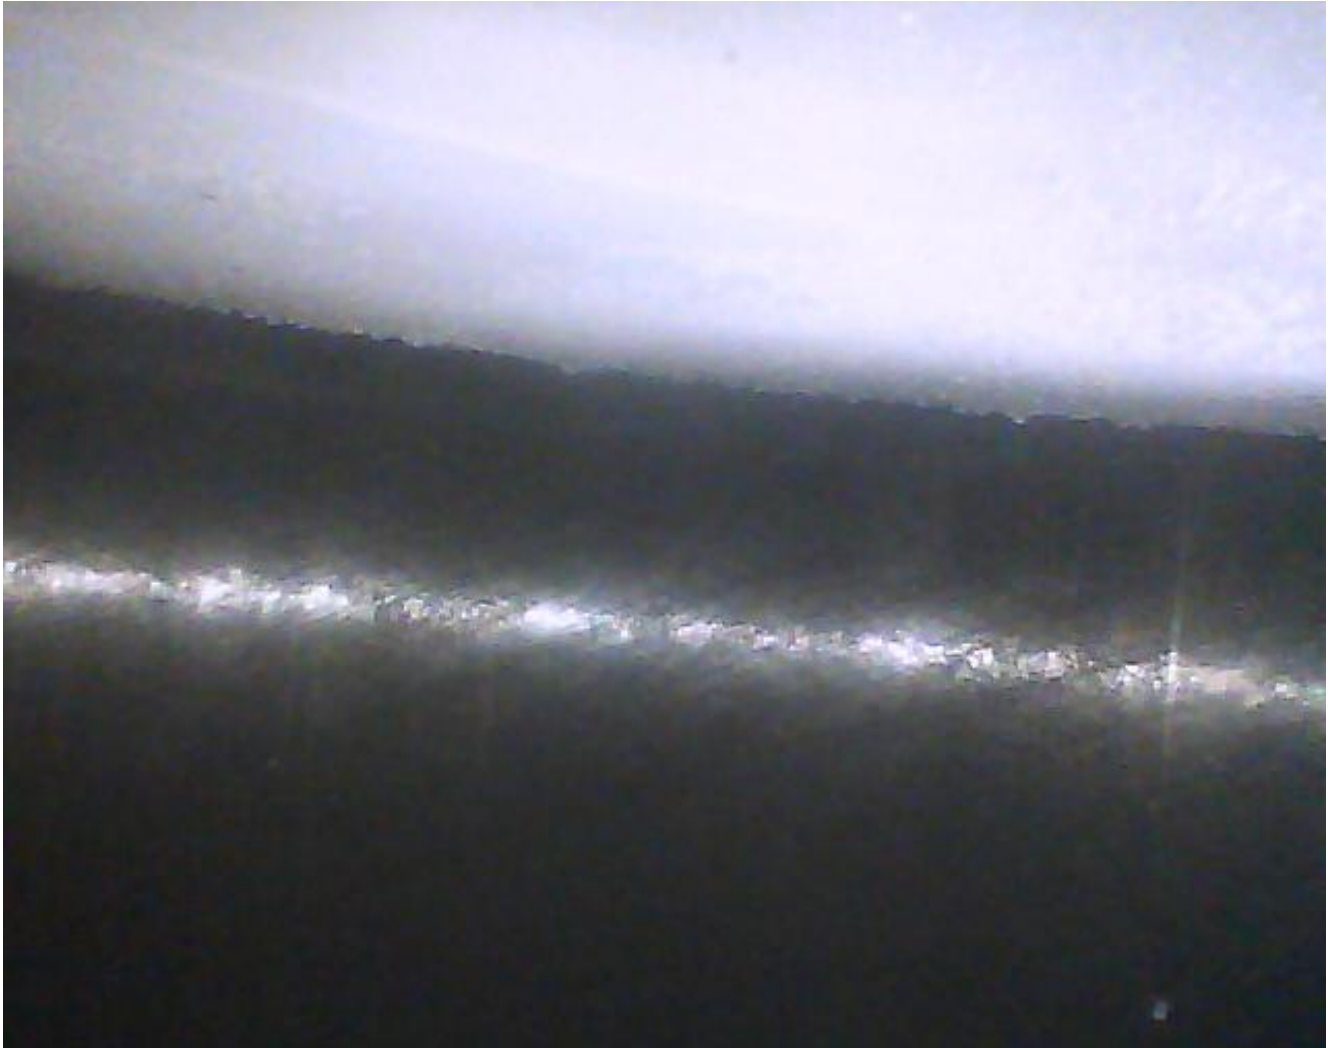
Cylinder #1 piston crown and liner.

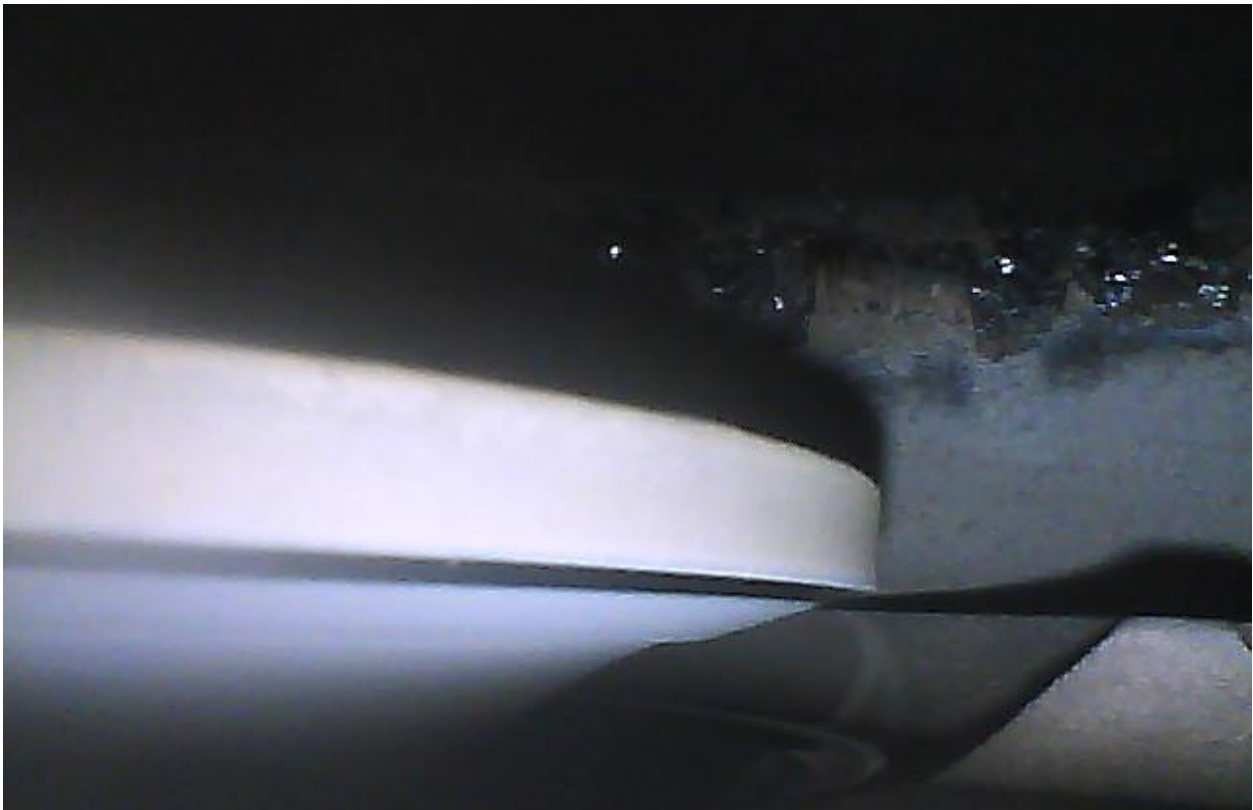
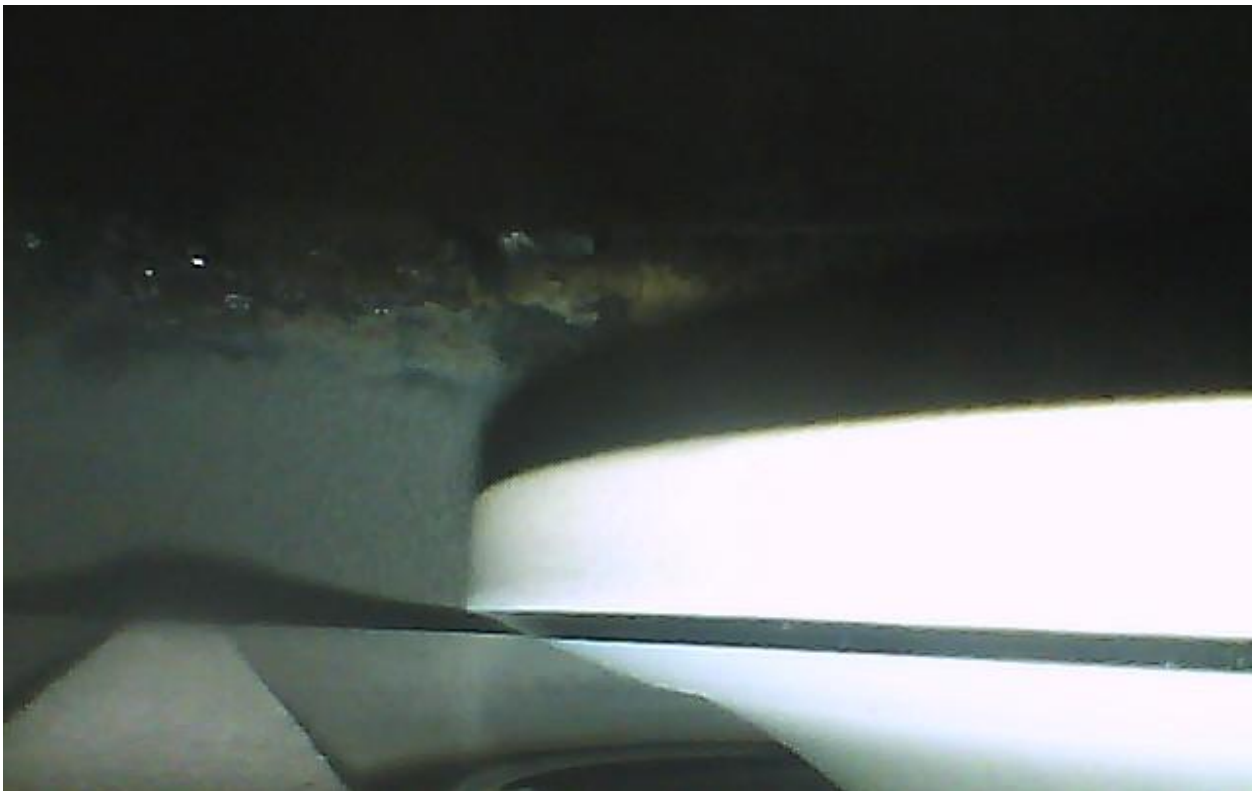
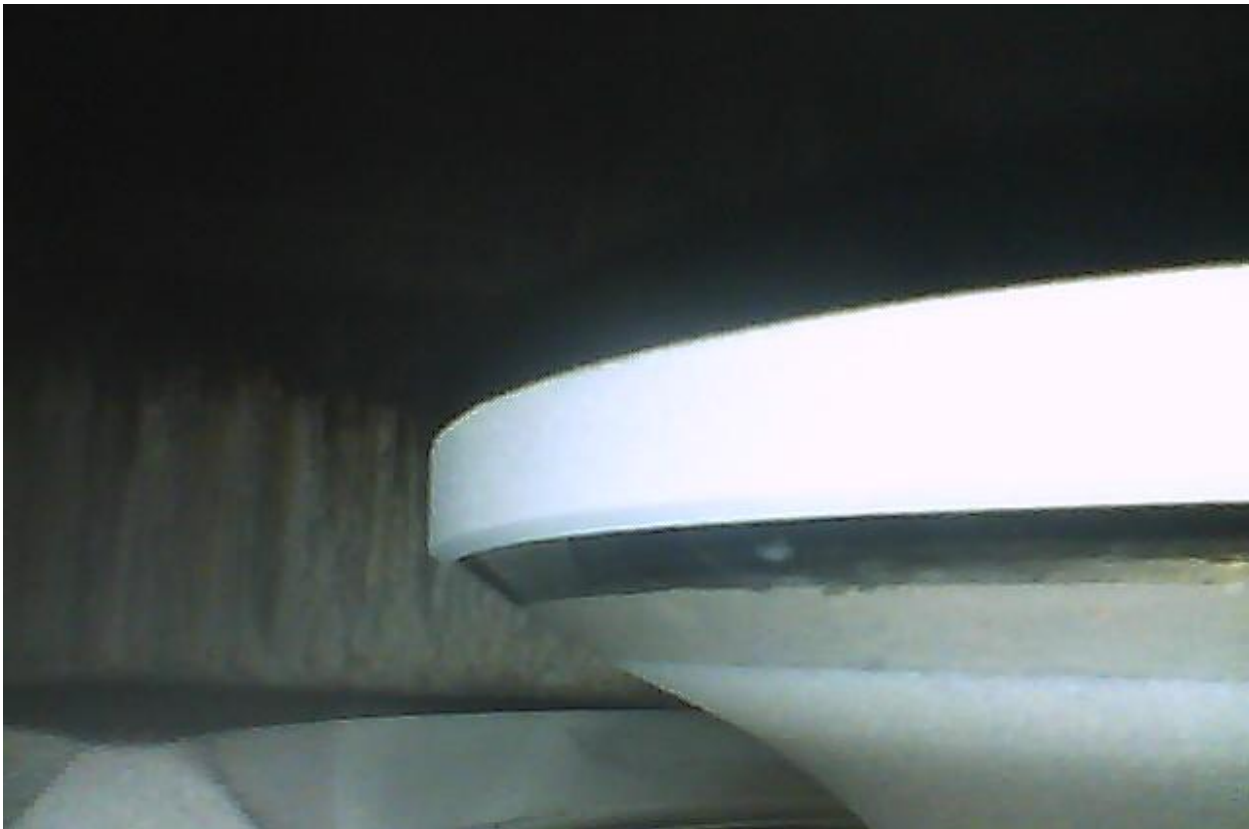
The next set of pictures show a few different valves, both intake and exhaust, from 3 different cylinders on the engine. These are very representative of all the valves except for one.

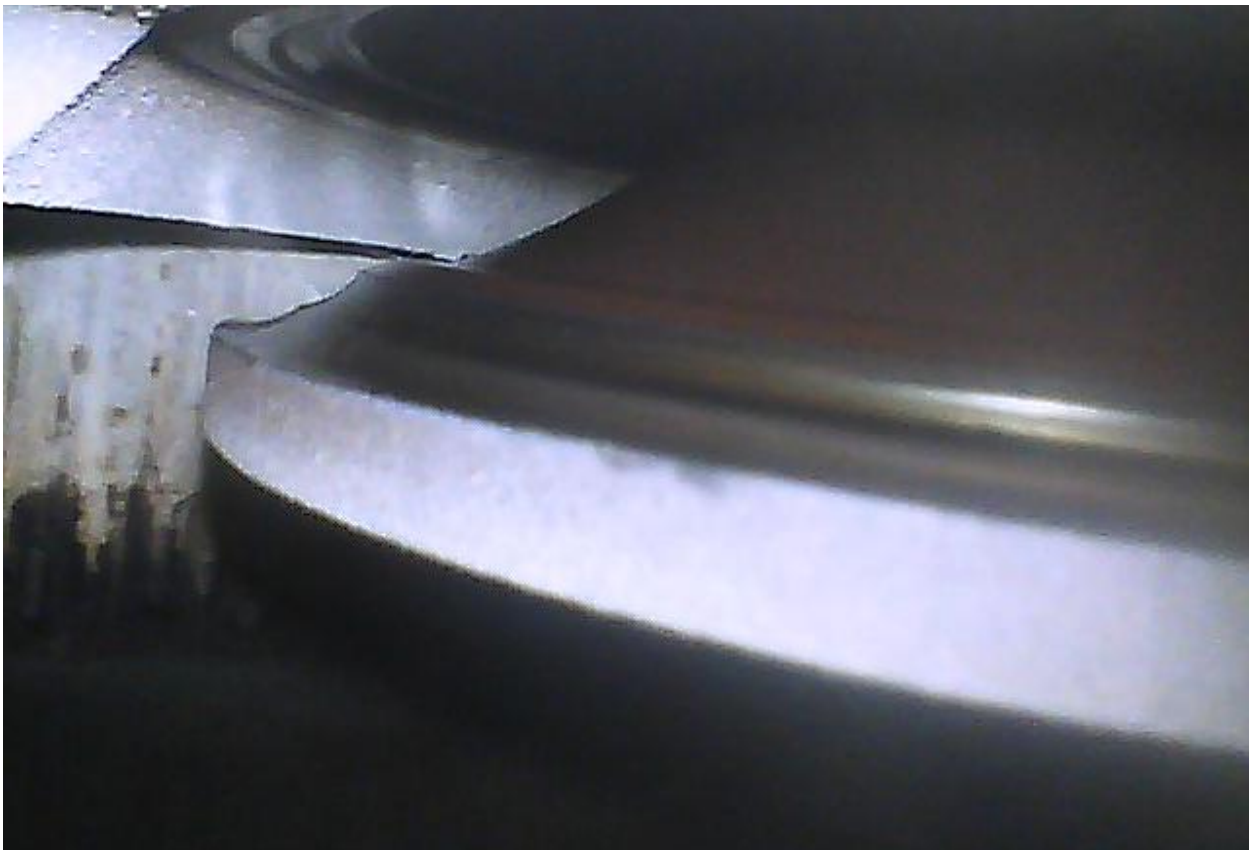
The next valve is an exhaust valve (one of the 2) that shows some recession and wear on both the valve face and seat. This is the only suspect valve in the engine.

Summary; The engine is good shape, especially for the hours on it. The only possible recommendation is replace cylinder #6 head. But it likely run as is for sometime yet. The only part missing off this engine are batteries and the spark plug wires, everything else appears to be there.

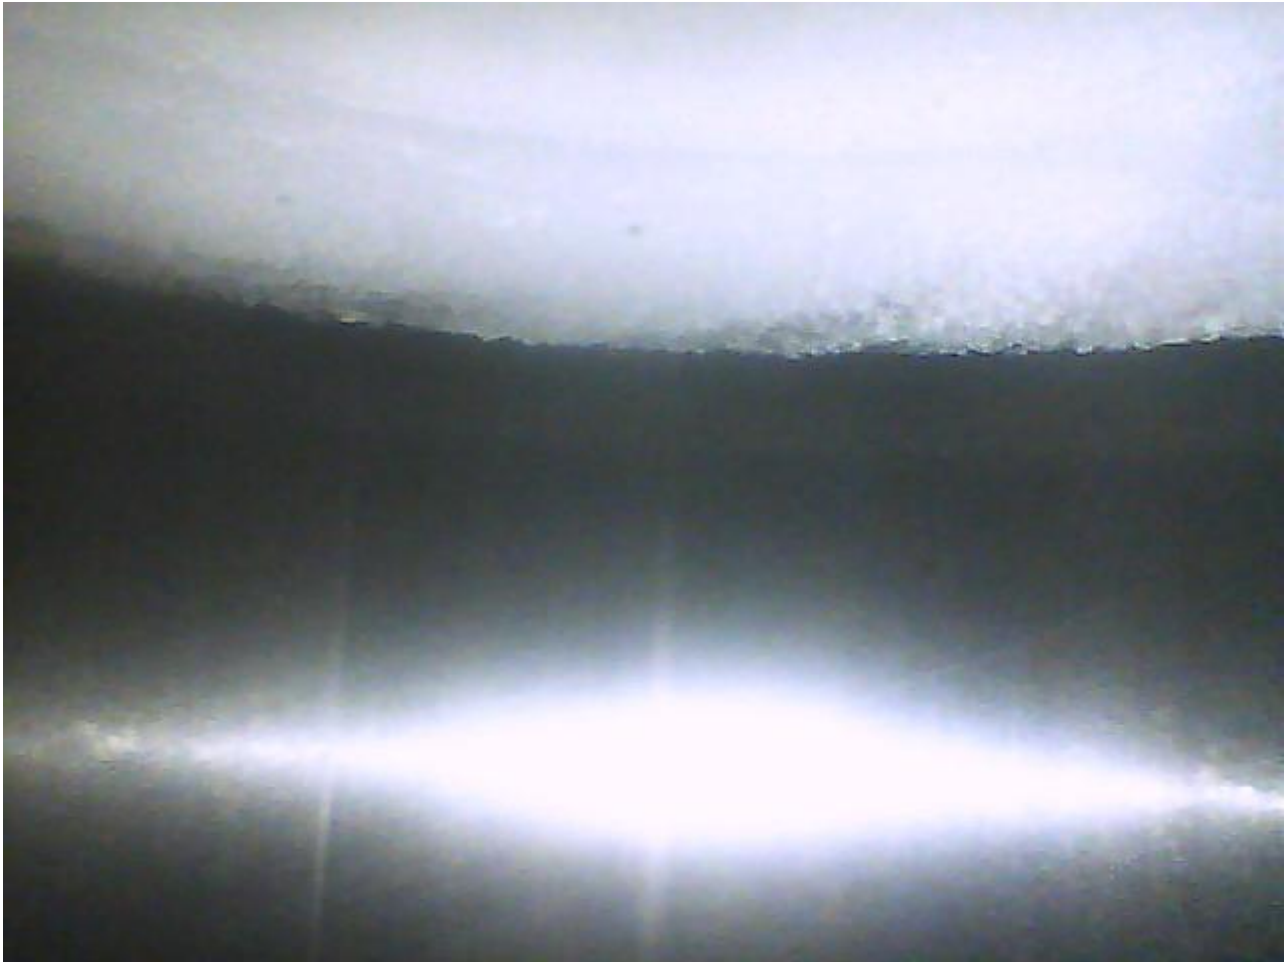
Cylinder #2 piston and liner

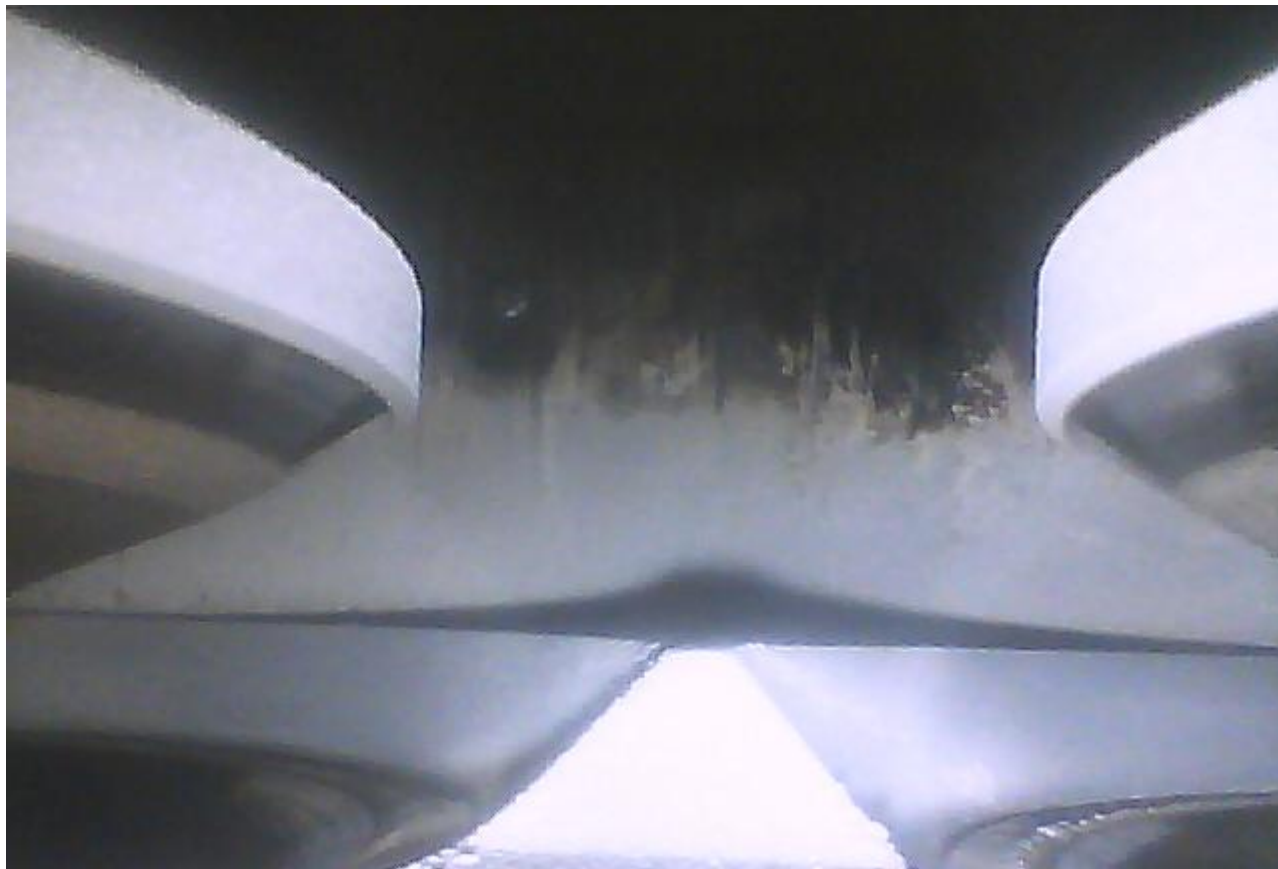
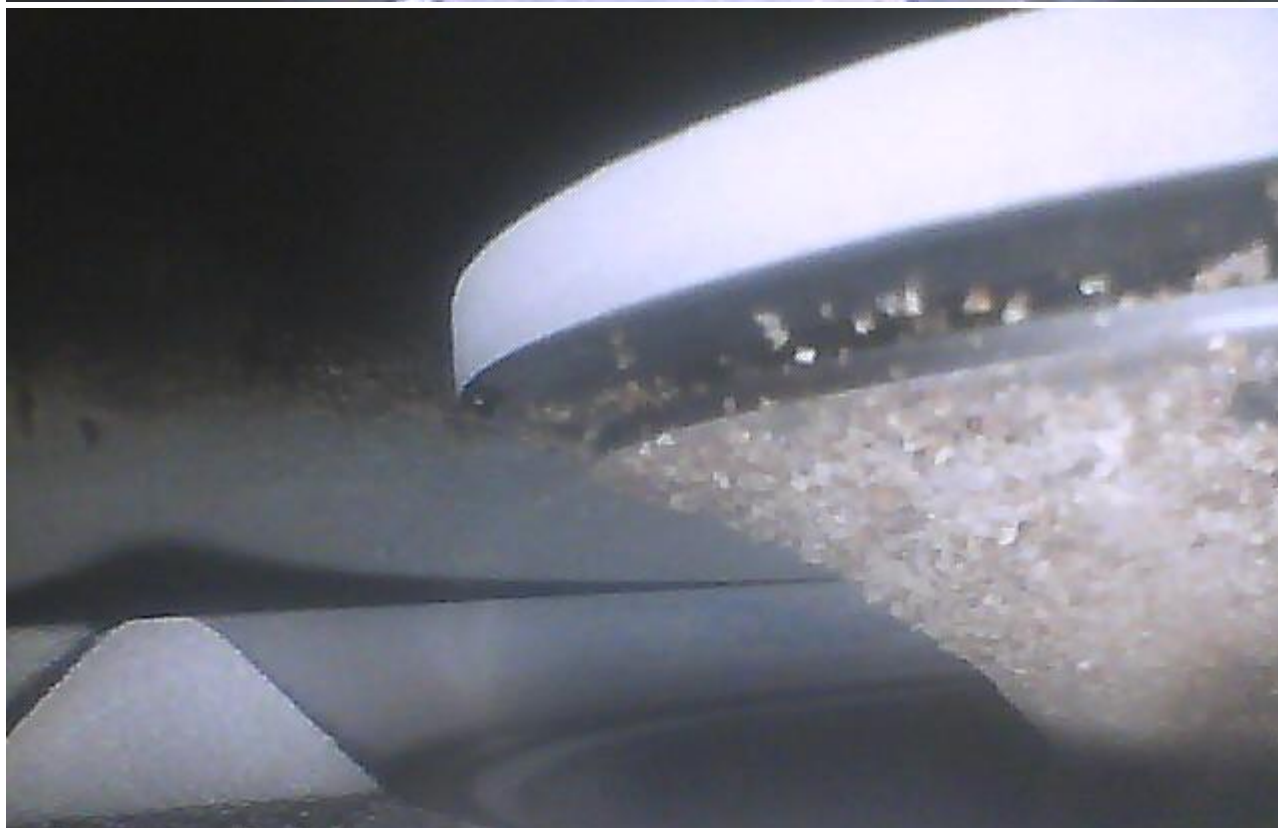
The next set of pictures show a few different valves, both intake and exhaust, from 3 different cylinders on the engine. These are very representative of all the valves except for one set.

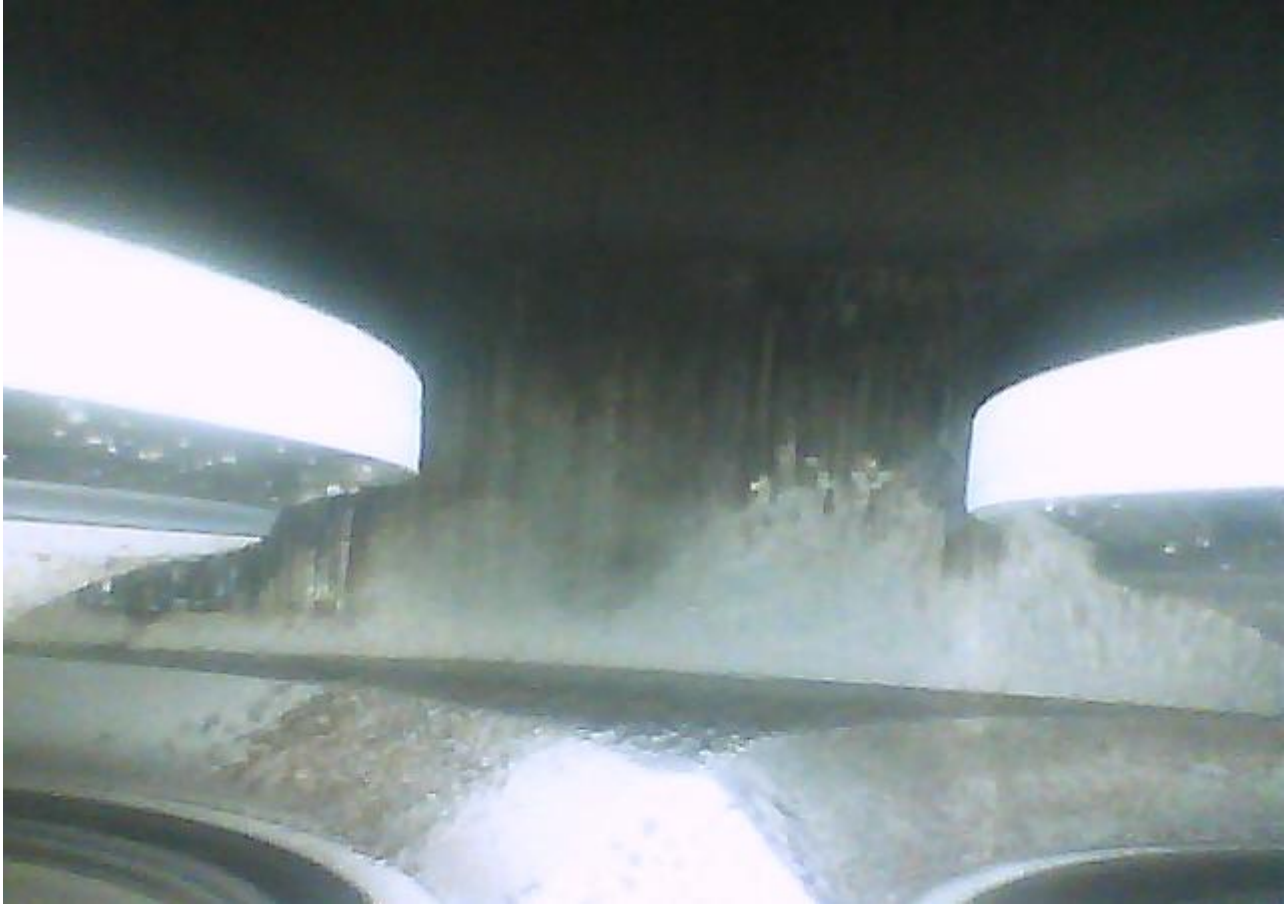
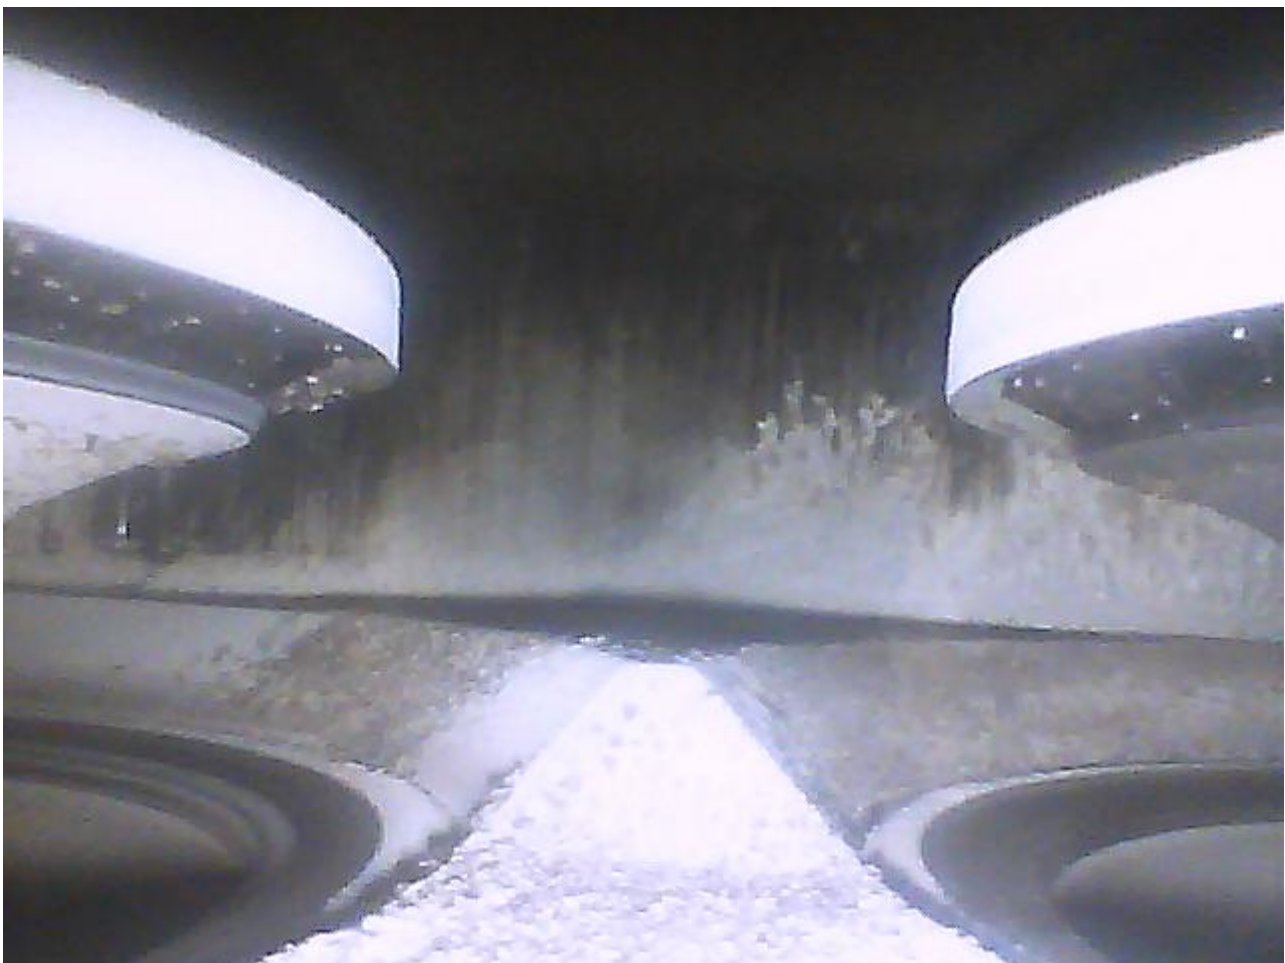
The next picture is on the cylinder #5 exhaust valves showing some slight recession
