Client: Fuelled	Facility: CNRL Wapiti Field	Date: August 22, 2025
LSD: 06-03-69-06W6M (CNRL)	Equipment Inspected: Flare Knockout Drum SN 10154B	LII Job #: 13752

Job Scope: To perform external/internal informational visual inspections, and Ultrasonic Testing (UT) on a horizontal Flare Knockout Drum (FKOD), Serial Number (SN) 10154B. This FKOD is out of service and currently located at the CNRL 06-03-069-06W6M Wapiti location.

Visual Inspection Information – Flare Knockout Drum (SN 10154B)

**Informational Visual Inspection
Report**
**Informational Visual Inspection_SN
10154B FKOD_aug2025**

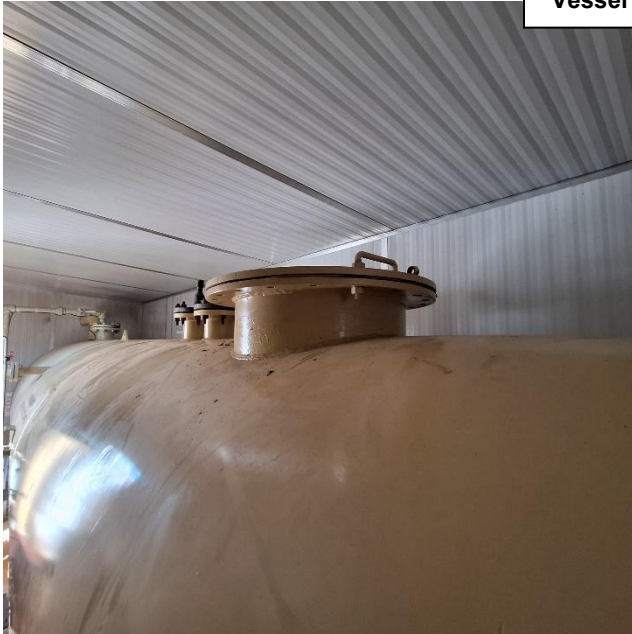
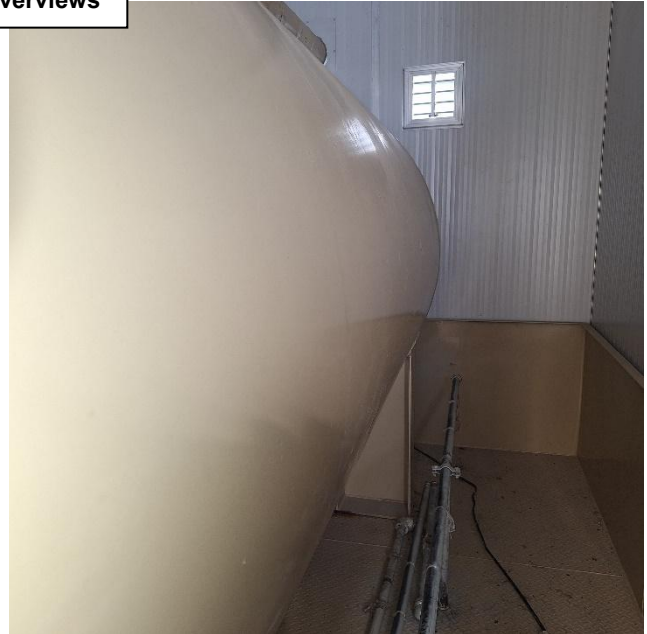
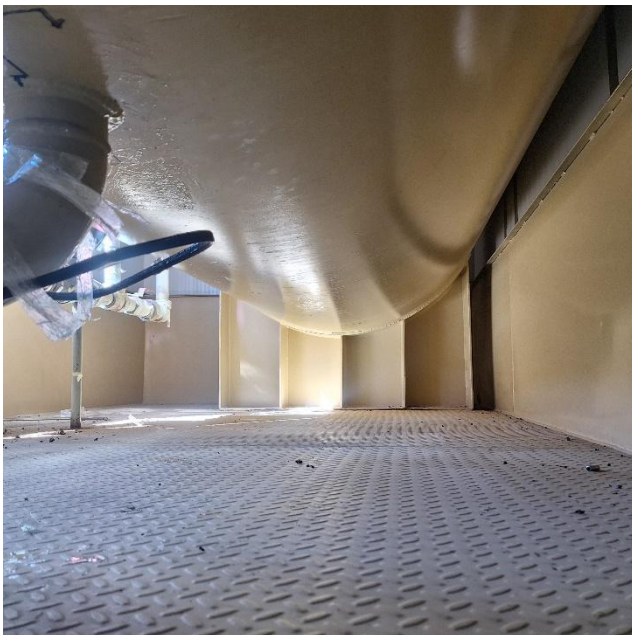
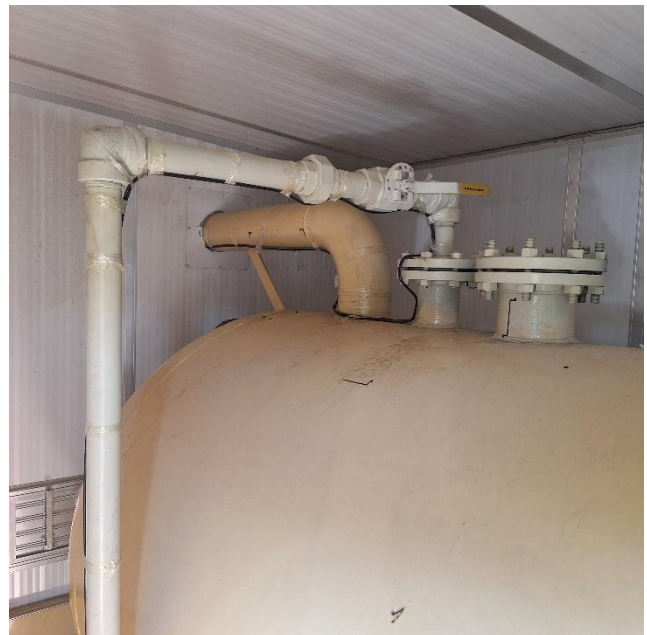
Vessel Overviews

- **External Surface:** This vessel is carbon steel, painted, and uninsulated. No visible signs of damage.
- **Insulation:** This vessel is uninsulated and inside a utilidor building. The building appears to be well sealed with no visible signs of damage.

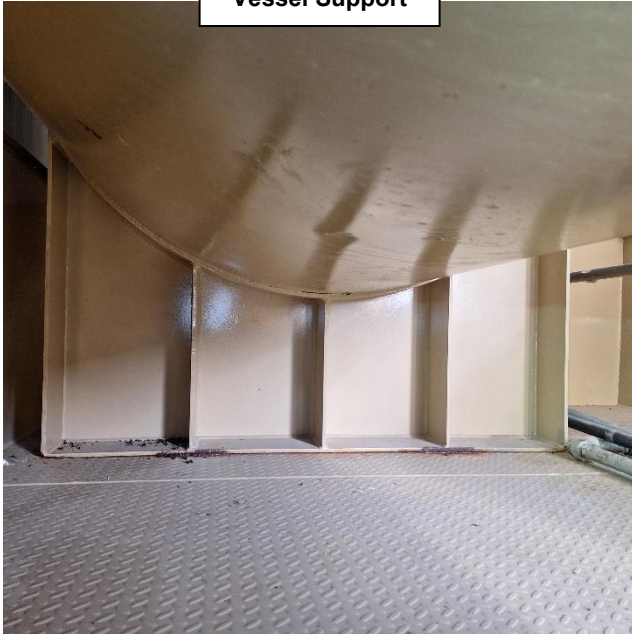
Vessel Support

- **Nameplate:** Firmly fastened and legible.
- **Foundation/Support:** This vessel is supported by two saddle supports welded to the skid floor. There is a steel dyke inside the building for secondary containment. No visible signs of damage.

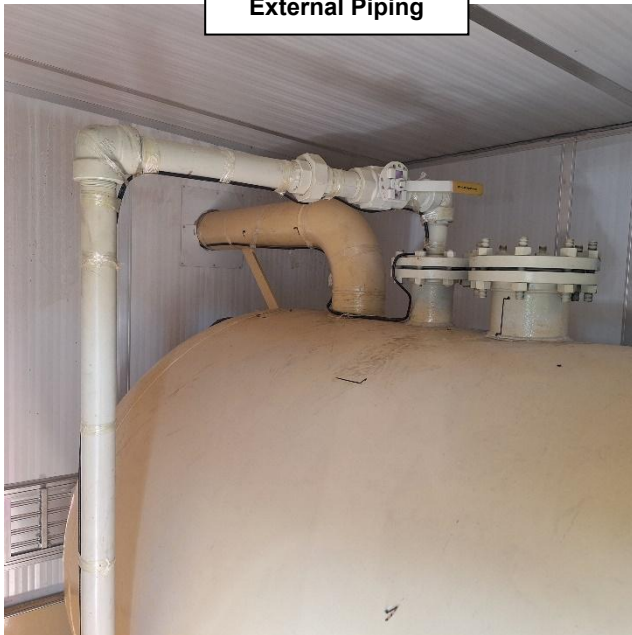
External Piping

- **Ladder/Platform:** No ladders or platforms.
- **External Piping:** All visible external piping is uninsulated and painted. All piping appears to be properly supported with no visible signs of damage.

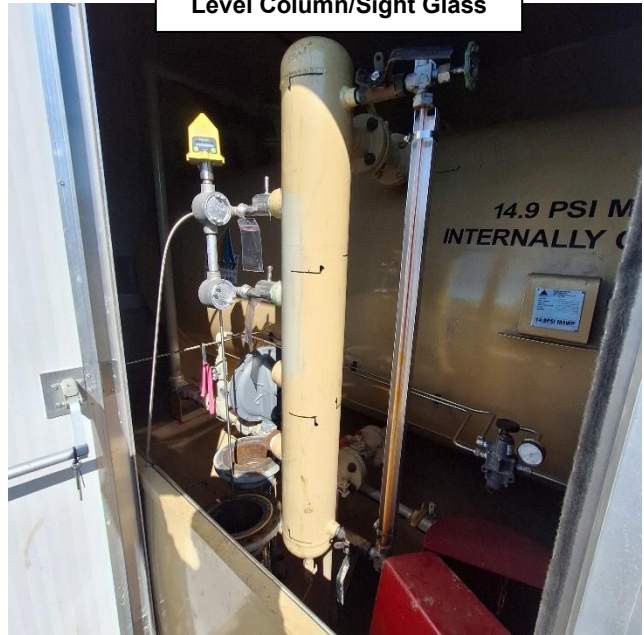
Level Column/Sight Glass

- **External Components:** This FKOD has one Catadyne heater and one level column with a sight glass and a high level shut down switch installed. All components appear to be intact.

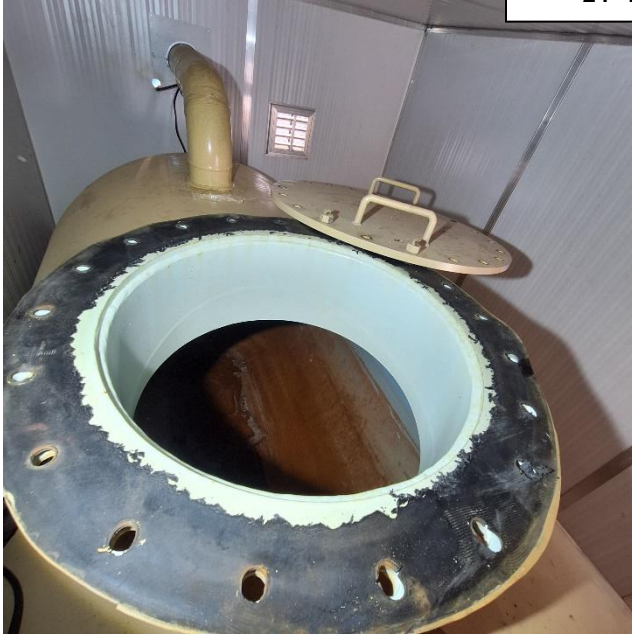
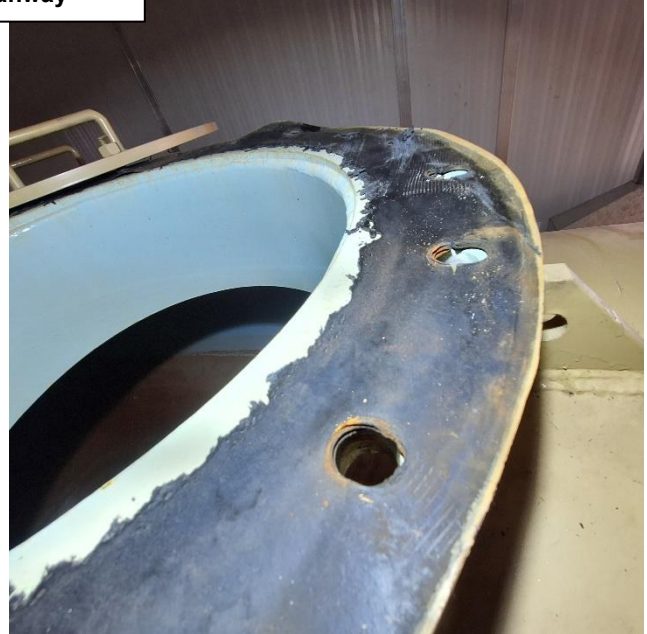
24" Manway

- **Nozzles:** No visible signs of damage or deflection. The internal coating on the 6" inlet and outlet nozzle is damaged.
- **Manway:** This vessel has a 24" internally coated manway on the top of the vessel. The existing rubber gasket has deteriorated and should be replaced.

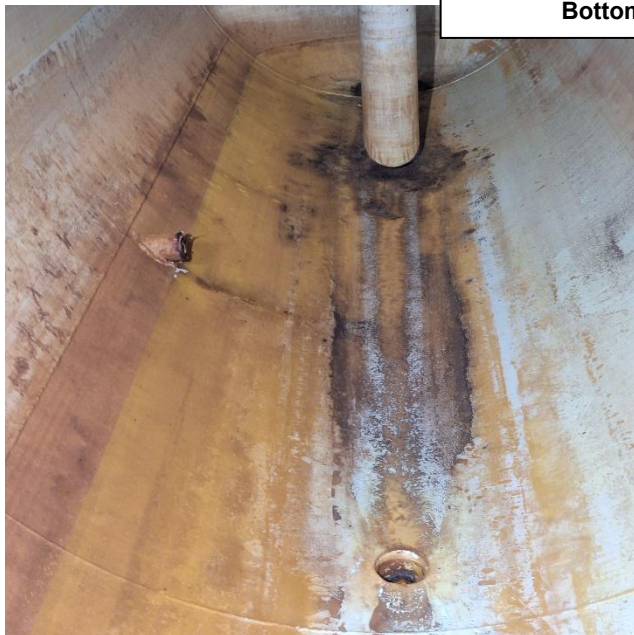
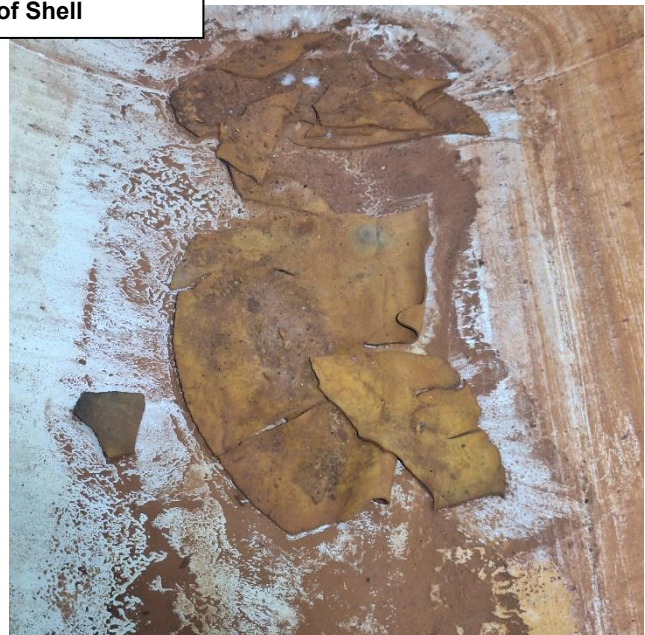
Bottom of Shell

- **UT:** A UT baseline survey was conducted on the vessel shell, heads, nozzles and external piping. Reflectors resembling small diameter pitting corrosion were detected in the bottom portion of the vessel and heads. The internal coating appears to be intact, leading to the conclusion that there may have been existing damage prior to coating the vessel. The minimum remaining wall thickness (MRWT) found in the shell was 8.0mm, and the MRWT found in the head was 7.7mm. This vessel has no stated corrosion allowance. See Lance Inspections UTS report (**UT_SN 10154B_aug2025**) for CML locations and thickness results.

- **Internal Components:** Inspected from the manway at the top of the vessel with a light and camera. This vessel is internally coated with no visible sign of coating damage in the shells of heads. There was limited visual access to the 6:00 portion of the vessel due to product residual. Coating damage was observed in the inlet and outlet nozzles, with corrosion identified during UT.
