TUBE EXAMINATION REPORT

NB66141

Torrey Tank Battery

August 17 2019

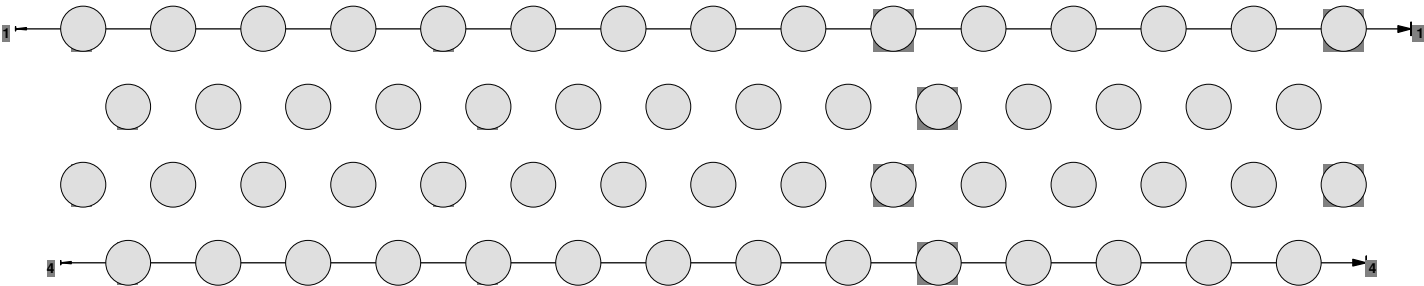
DESCRIPTION	SYMBOL	QTY	DESCRIPTION	SYMBOL	QTY	DESCRIPTION	SYMBOL	QTY
TUBE COUNT		58(100%)	20-29.9%		0(0%)	70-79.9%		0(0%)
TOTAL TESTED		58(100.00%)	30-39.9%		0(0%)	80-89.9%		0(0%)
NDD		58(100.00%)	40-49.9%		0(0%)	90%-THRU WALL		0(0%)
0-9.9%		0(0%)	50-59.9%		0(0%)	OBS-NO DATA		0(0%)
10-19.9%		0(0%)	60-69.9%		0(0%)	PLUGGED		0(0%)

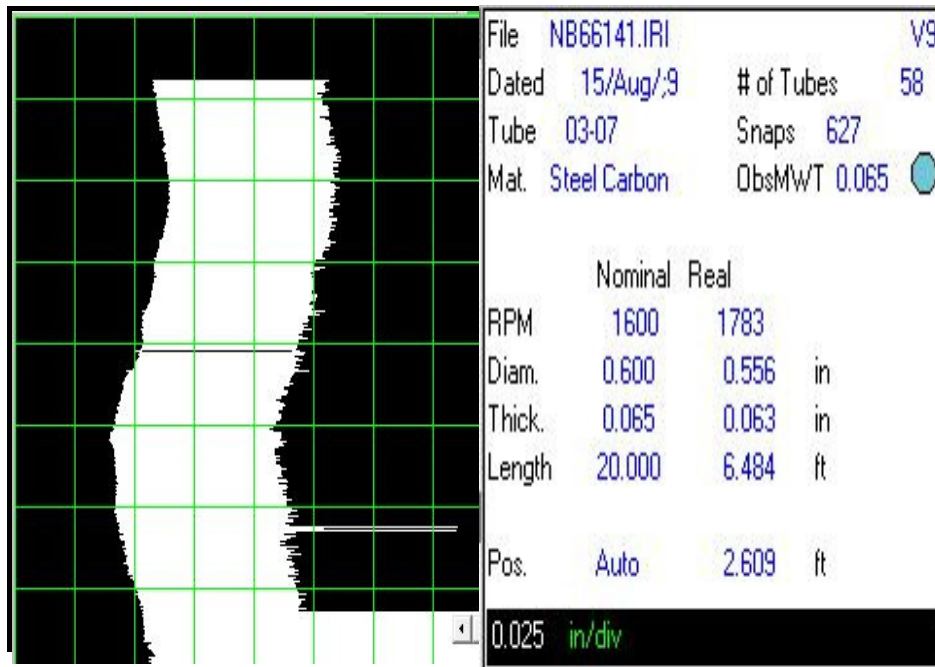
Nominal 0.065" Wall Reading

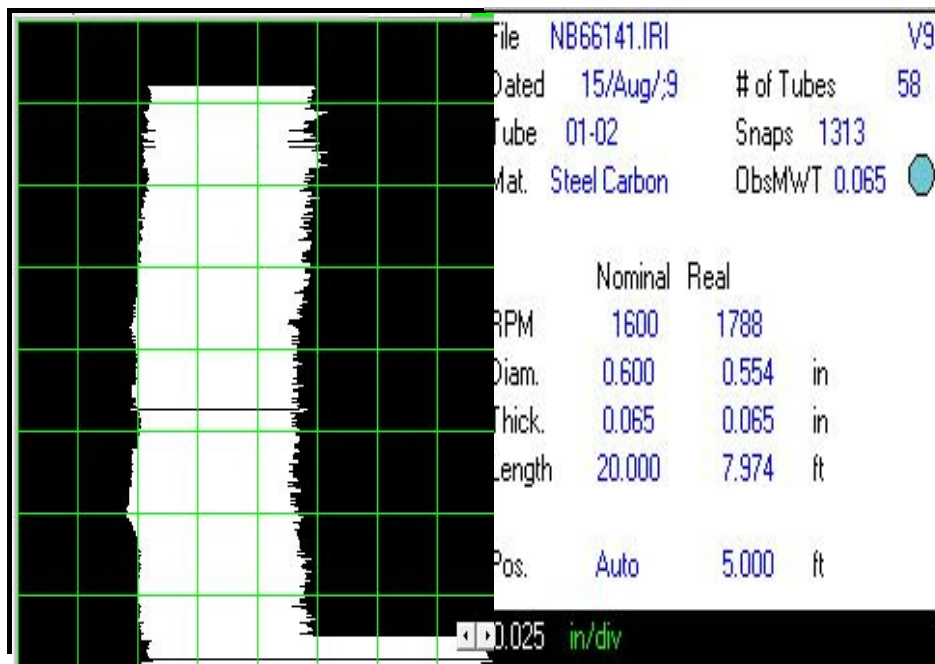
Nominal 0.065" Wall Reading
