Client	Midstream Equipment	Inspection Date	Jun 6, 2025		
Prov. Reg. #	AB RAE27028	Inspection Type	VE / UT / PSV		
Equipment Type	Blowcase/Separator Bridle	Location	27 DURUM DRIVE, AB MIDSTREAM YARD		
Tag/Equip.		LSD	AB		
Status	Not in Service	Downhole LSD			
Manufacturer	Ips Manufacturing Limited	Area			
Serial Number	F-2269-001CG	Year Built	2004		
CRN #	0H6091.2	Service	Sour		
Comp/Unit Id	UNIT 1378	Manway	None		
Nat.Board #		Coating			
Interim Insp'n		Interim Type			
Next Thorough Insp	2030	Next Insp Type	VE / UT / PSV		
Length		Height			
Volume	Capacity	Client Reference			
Owner	Midstream Equipment	RT	100%	HT	YES
Foreman		RAE Job No.	PR0004443		
ABSA	Plant: R    Vessel: P    Process: W    Special: Z	ASME	Sec. VIII div. 1		
History Log	Inspection Report Complete - Inspection Date: 2025-June-06 Inspection Type: VE/UT/PSV

The unit was located at the Midstream Equipment yard located just east of Chestermere, AB.

The unit was not in-service at the time of inspection.

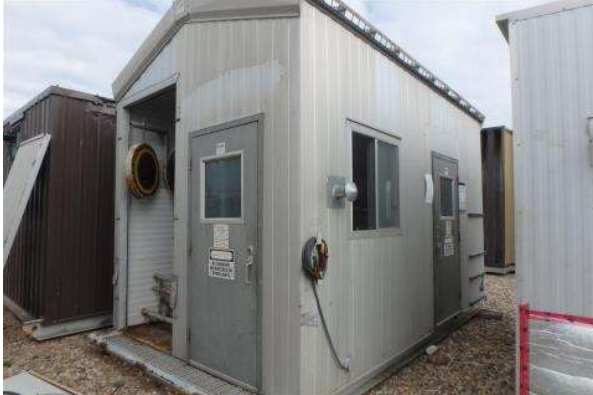
Figure: 1

The building was generally in serviceable condition and well supported.

BUILDING

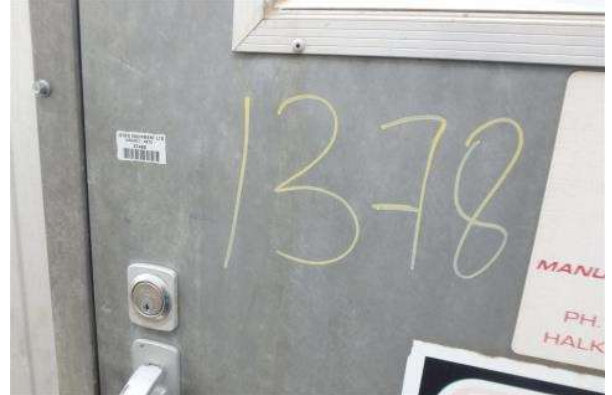
Figure: 2

The building was identified by the unit number written on the door

UNIT NUMBER

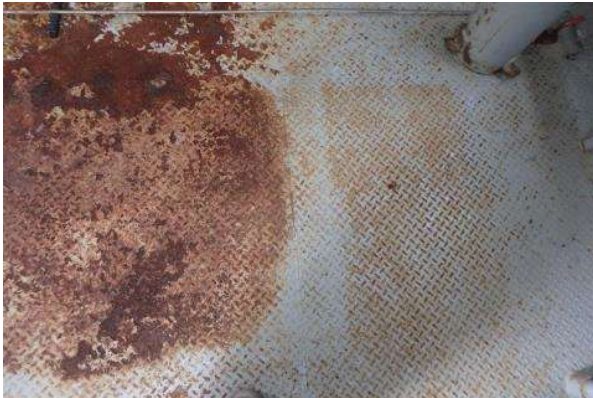
Figure: 3

The checker plate steel floor was clean and in serviceable condition.

FLOOR

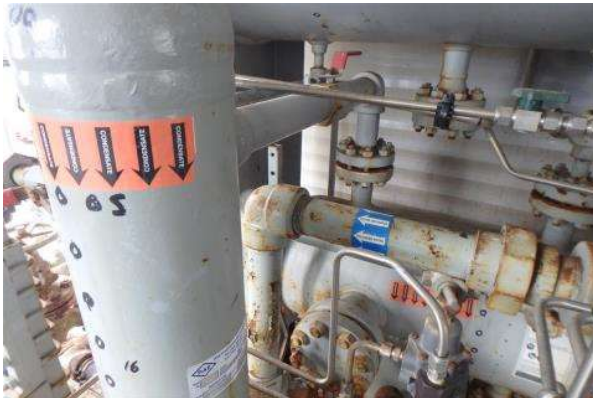
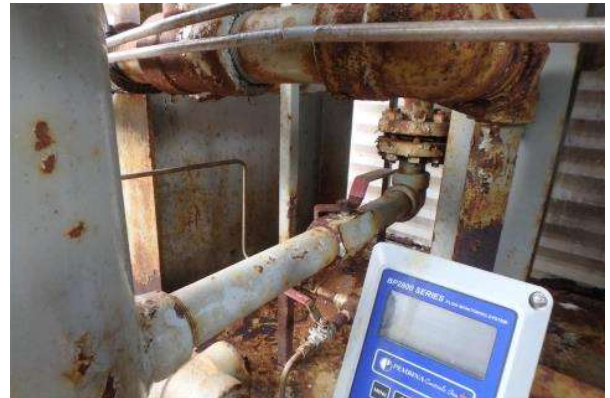
It was noted that the piping was disassembled in areas.  
The piping shall be re-assembled prior to placing the unit into service.

PIPING FROM BLOWCASE

1. The vessel is fit-for-service provided
  - a) The PSV is serviced prior to placing the unit into service.
  - b) The piping is re-assembled prior to placing the unit into service.
2. Nameplate is to be re-secured to the vessel.
3. A permanent Midstream unit label should be affixed to the building door.
4. There should be an installation inspection of the unit after being installed on site to ensure no damage occurred during shipping and to verify proper installation.

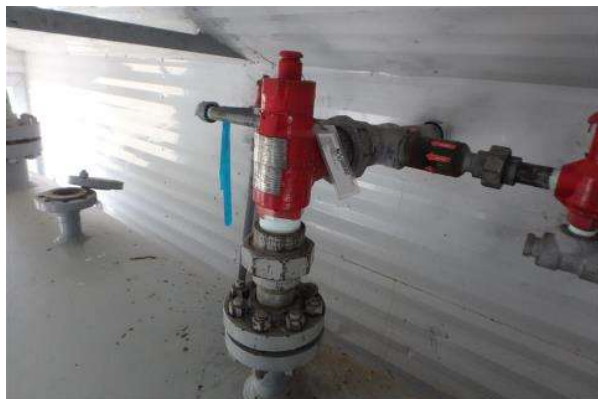
Figure: 6

The PSV is due for servicing and shall be serviced prior to placing the unit into service.

SEPARATOR PSV

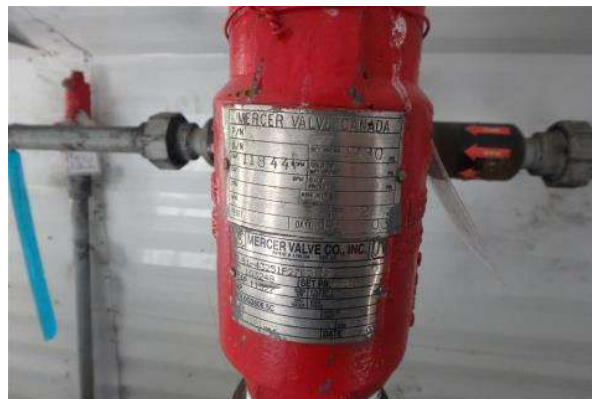
Figure: 7

SEPARATOR PSV NAMEPLATE

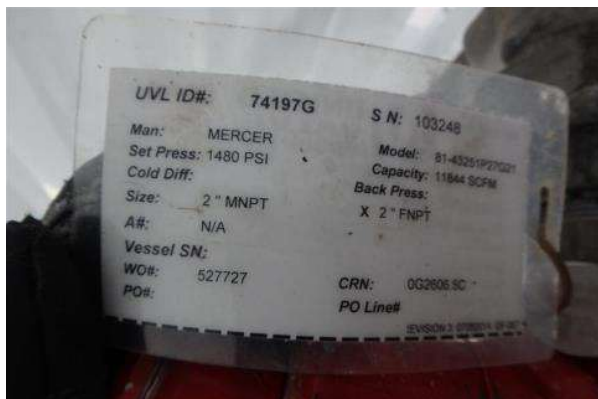
Figure: 8

SEPARATOR SERVICE TAG

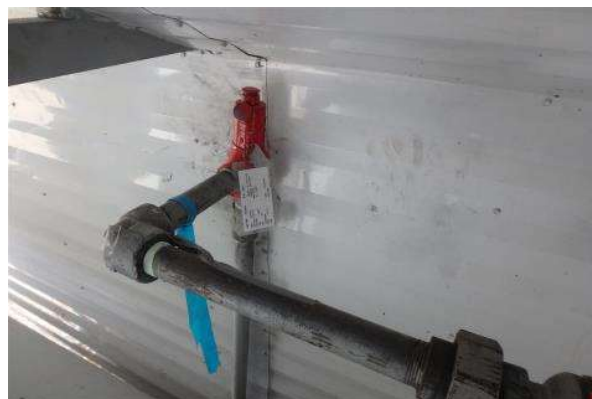
Figure: 9

BLOWCASE PSV

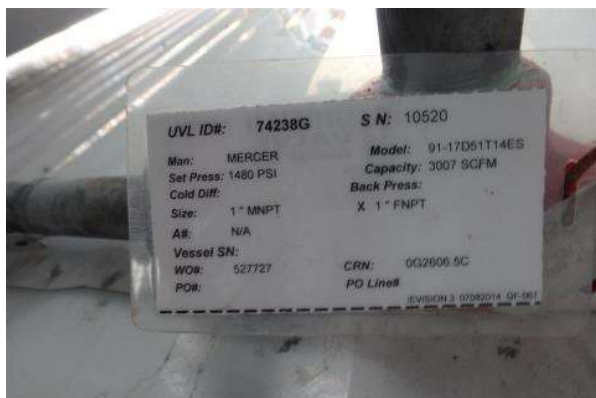
Figure: 10

BLOWCASE SERVICE TAG

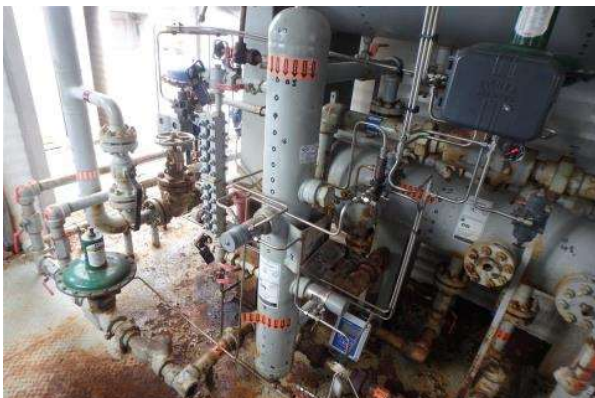
Figure: 11

The vessel is located inside a building.  
The nameplate was legible and securely mounted to the vessel.  
The heads and shell appeared to be in serviceable condition.  
The vessel is not insulated.  
The vessel was fully painted and the paint was in serviceable condition.  
There was scattered minor corrosion visible on the vessel surfaces.  
There was no damage, distortion, or stress evident on piping connections.  
The vessel was horizontal and adequately supported by the associated separator/blowcase piping.  
There are no structural attachments on vessel.

VESSEL

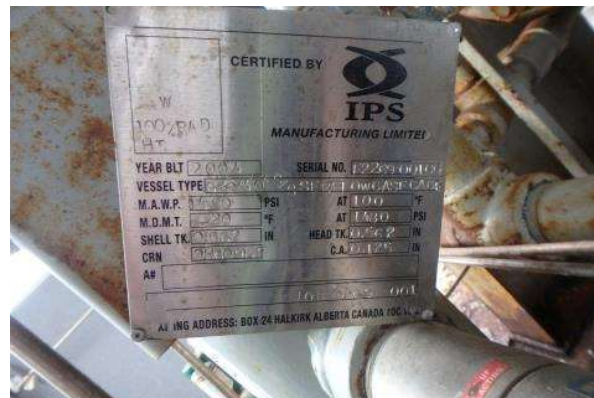
Figure: 12

NAMEPLATE

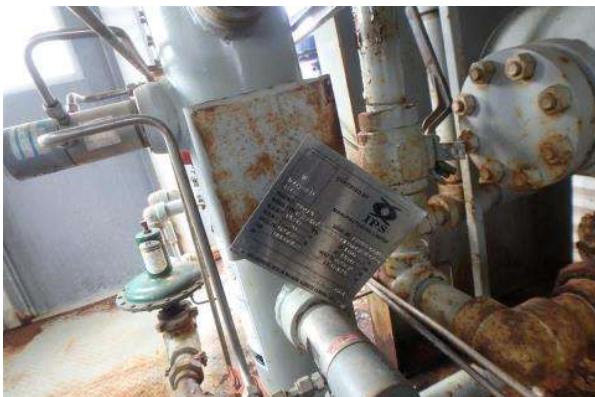
Figure: 13

It was noted that the nameplate was hanging on by one rivet.  
The nameplate shall be properly secured.

NAMEPLATE TO BE RE-SECURED

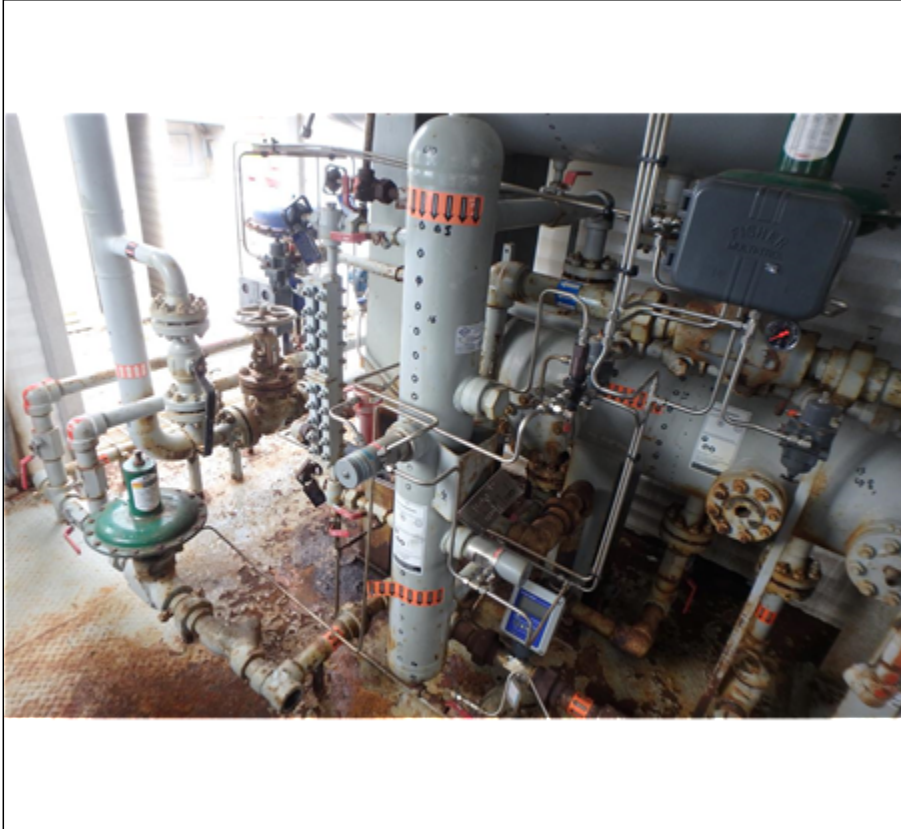
Vessel Overview

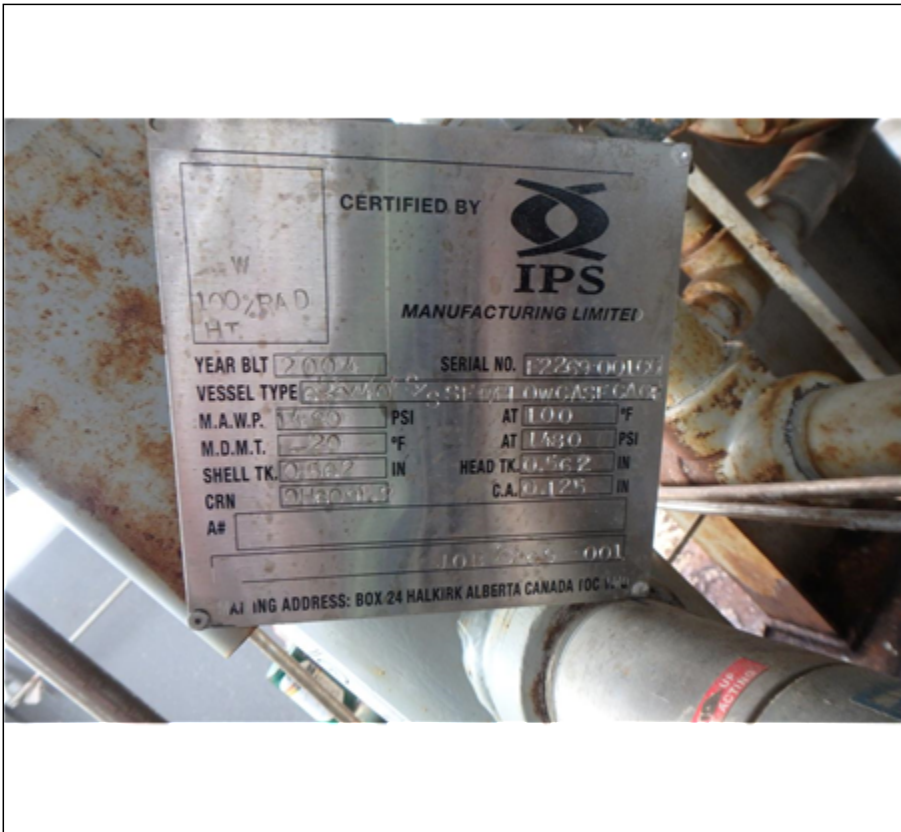
Nameplate

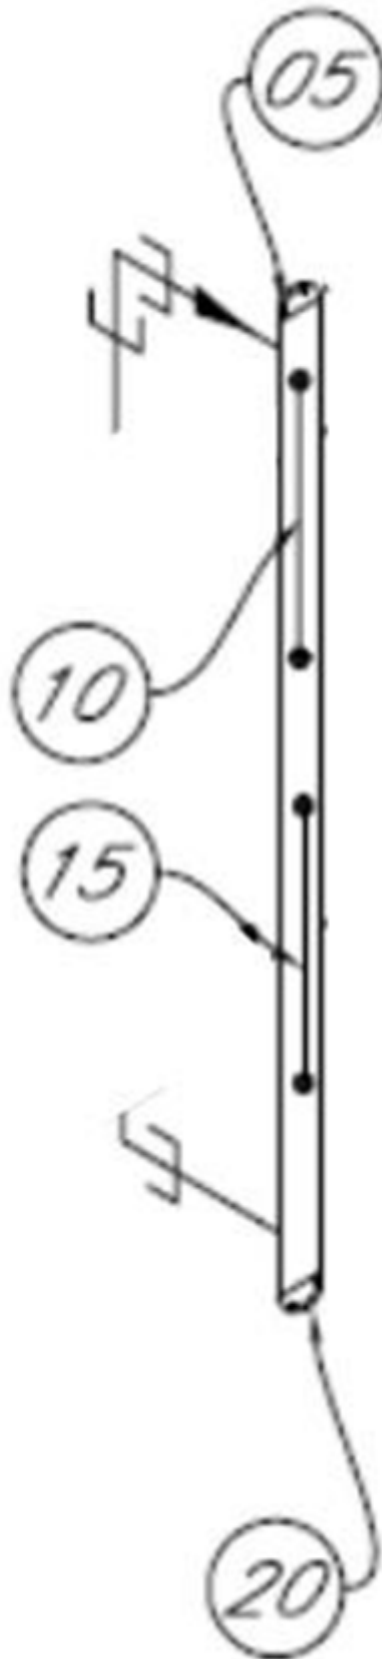
ISO

The measurements obtained from the inspection locations showed the thicknesses of all the components inspected to be at or around nominal. There were no signs of wall thinning, internal corrosion, erosion, laminations or inclusions at the time of inspection. All piping measurements were within the 12.5% mill tolerance, as per ASTM specifications.
