| Client > | FUELLED | A# > | 495835 | Head Mat. > | SA516-70N | OD > | 72" |
| Report# > | 5361-4 | Ser. # > | 12895 | Head Th. > | .313" | Year > | 2003 |
| Equipment > | KNOCKOUT TANK | MAWP > | 50 PSI | Shell Th. > | .375" | RT > | RT-1 |

# Alpine NDT Services Inc.

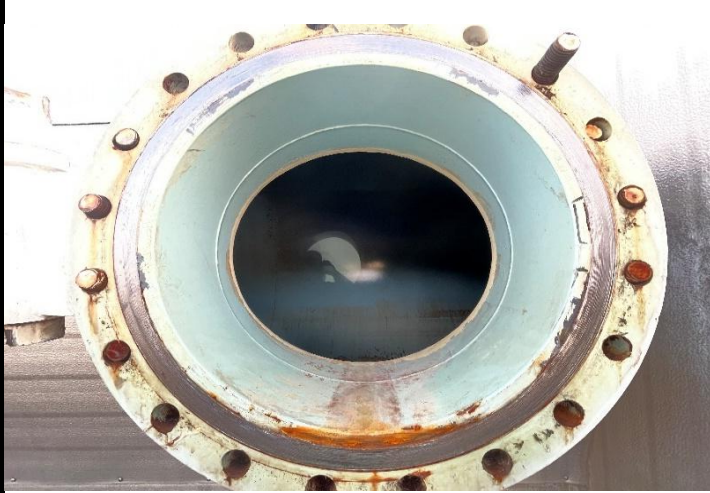
Internal view of manway.

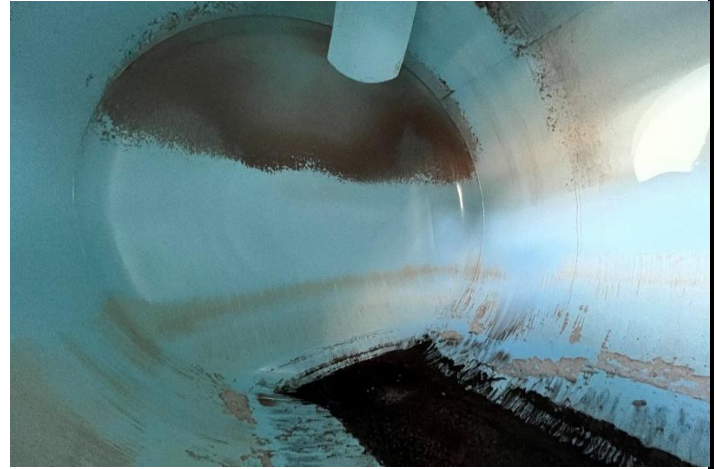
| Component | Disposition | Comments |
|---|---|---|
| Coating | Good | No visual chipping. (Sludge inhibits partial surface view) |

Internal view of head and shell surface. (Sludge on shell & upper head)

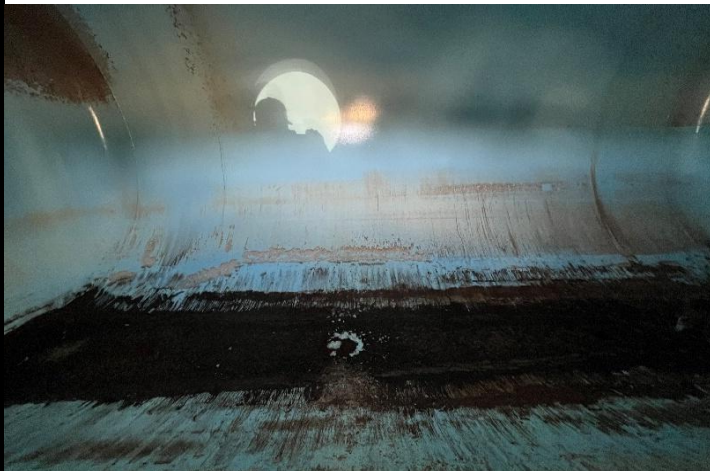
| Component | Disposition | Comments |
|---|---|---|
| Scale | Good | No scale, minor sludge like substance on some of the surfaces. |

Internal view of lower shell surface. (Sludge residue)

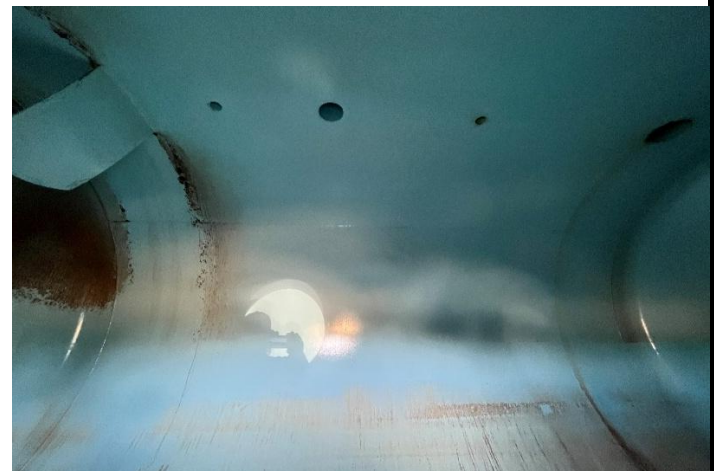
Internal view of upper shell.

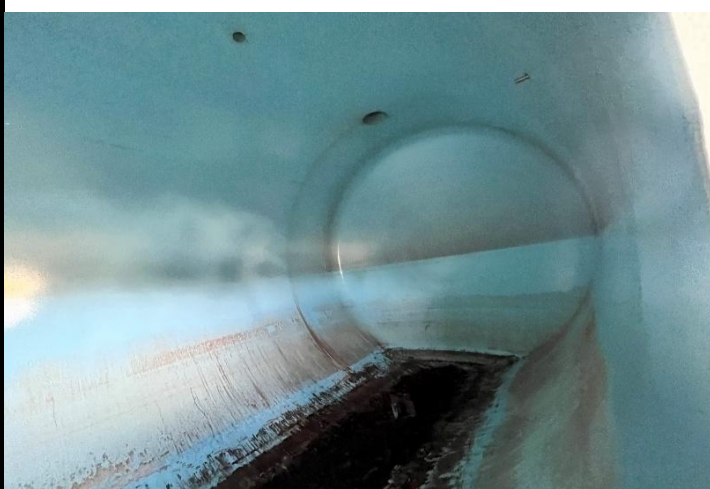
Internal view of head and shell surface (sludge residue).

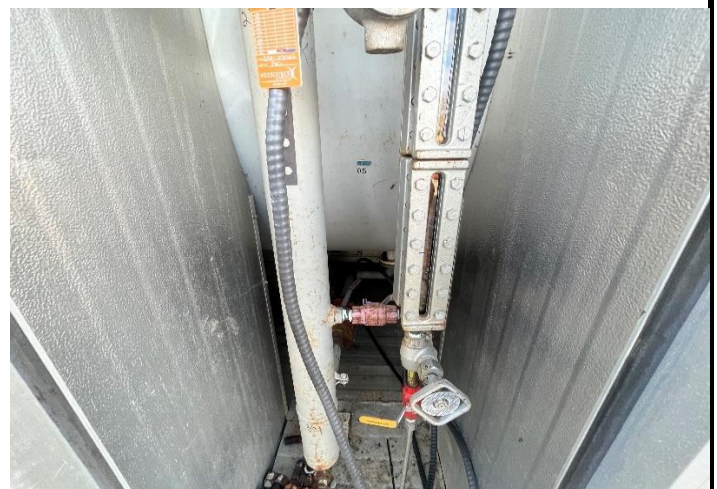
External lower shell view from cabinet.

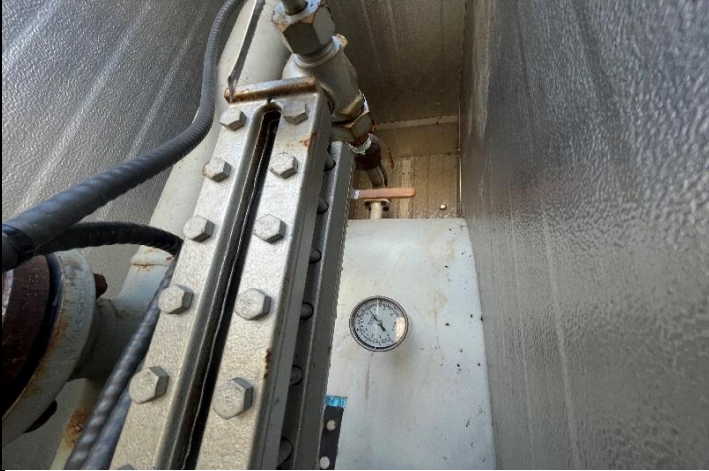
External mid/upper shell view from cabinet.

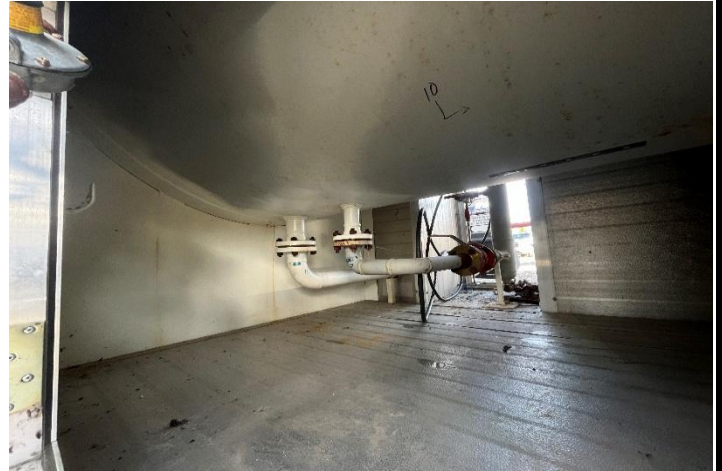
External shell belly view in crawl space.

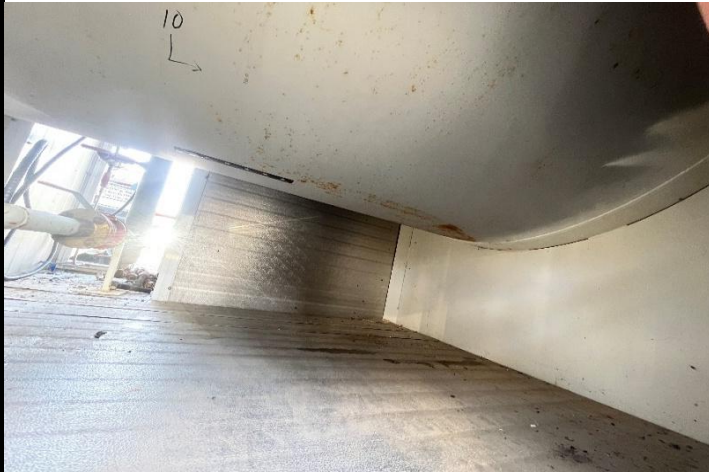
External shell belly view in crawl space. (Superficial rust specs)

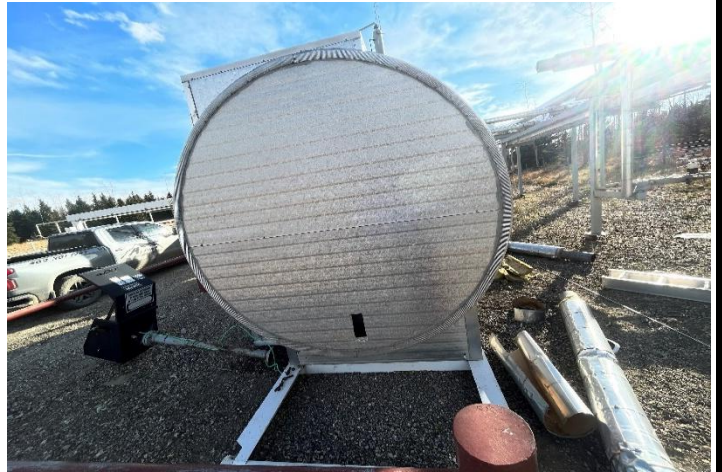
| Component | Disposition | Comments |
|---|---|---|
| Insulation | Good | No Tears, Small Dents (Assumed to be from hail) |

General over view of insulation & skid. (Light hail dents on head)

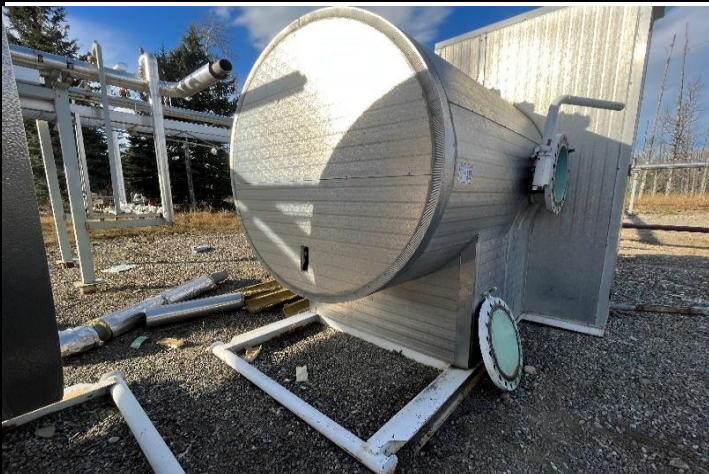
General over view of insulation & skid.

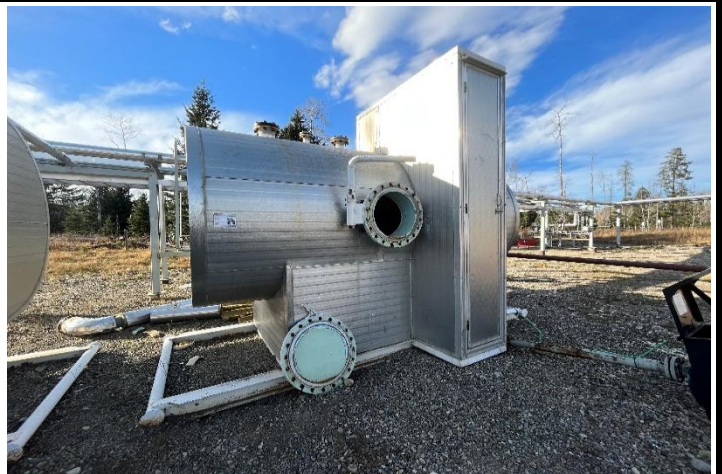
General over view of insulation & skid.
