| Client > | FUELLED | A# > | 495834 | Head Mat. > | SA516-70N | OD > | 72" |
| Report# > | 5361-3 | Ser. # > | 12894 | Head Th. > | .313" | Year > | 2003 |
| Equipment > | KNOCKOUT TANK | MAWP > | 50 PSI | Shell Th. > | .375" | RT > | RT-1 |

# Alpine NDT Services Inc.

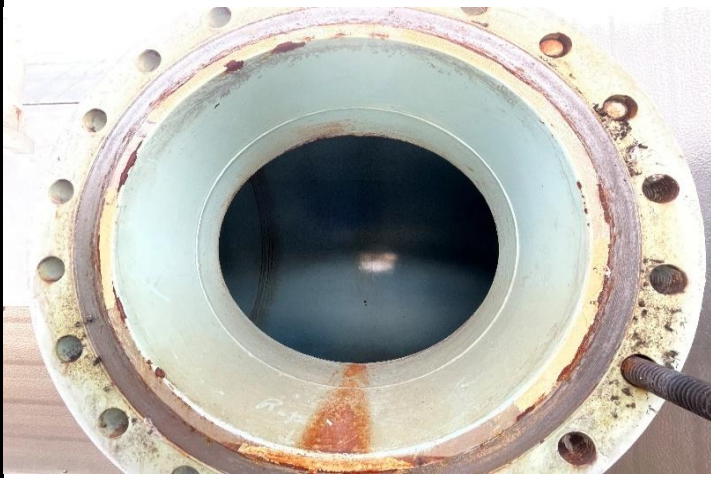
Internal view of manway.

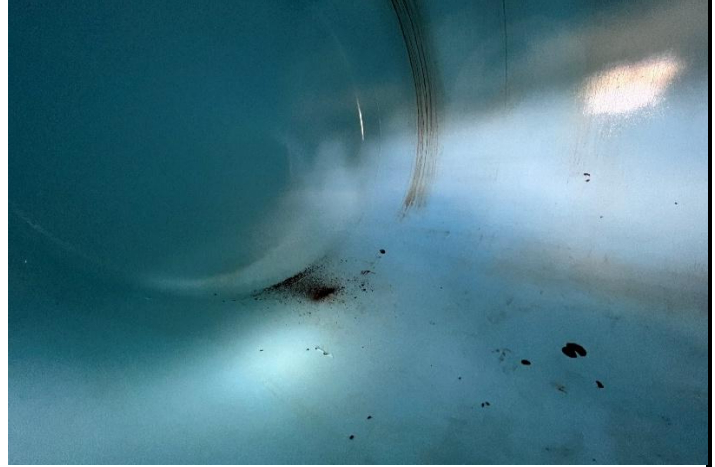
Internal view of head and shell surface.

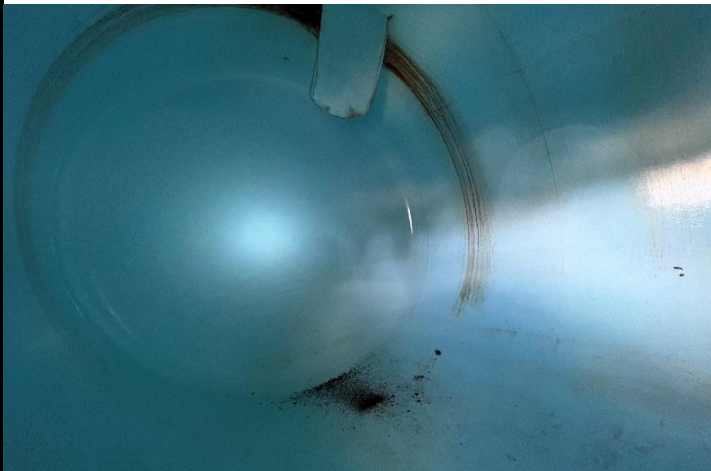
Internal view of head and shell surface.

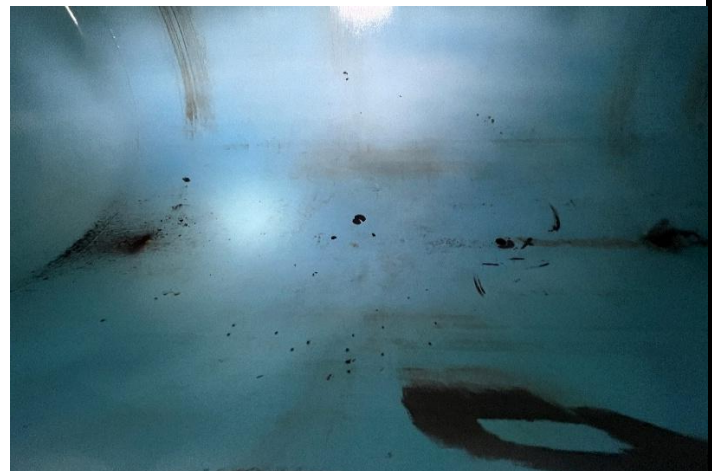
| Component | Disposition | Comments |
|---|---|---|
| Scale | Good | No scale, minor sludge like substance on some of the surfaces. |

Internal view of shell (minor sludge)

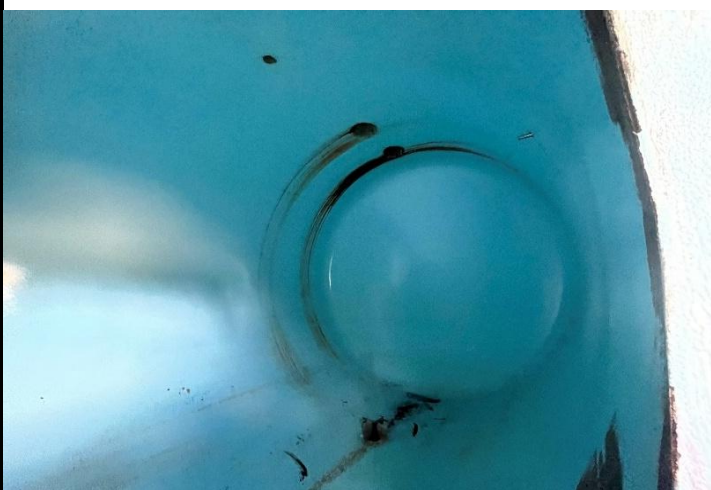
Internal view of head and shell surface (minor sludge).

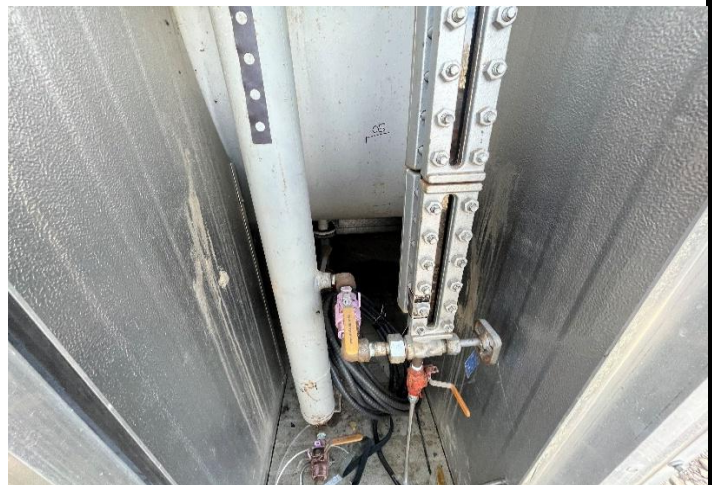
External lower shell view from cabinet.

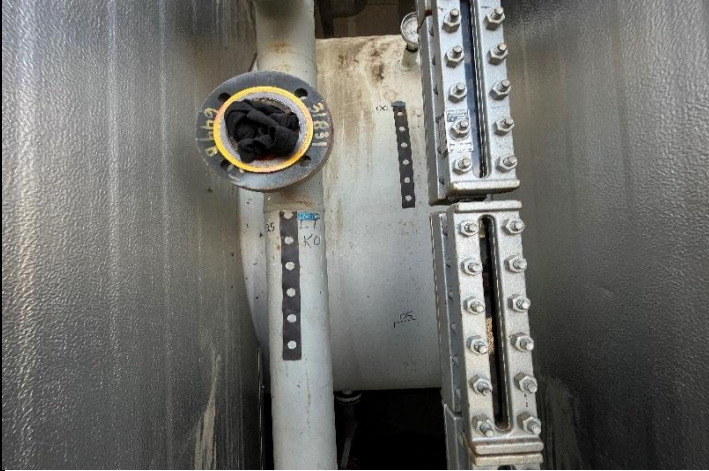
External mid/upper shell view from cabinet.

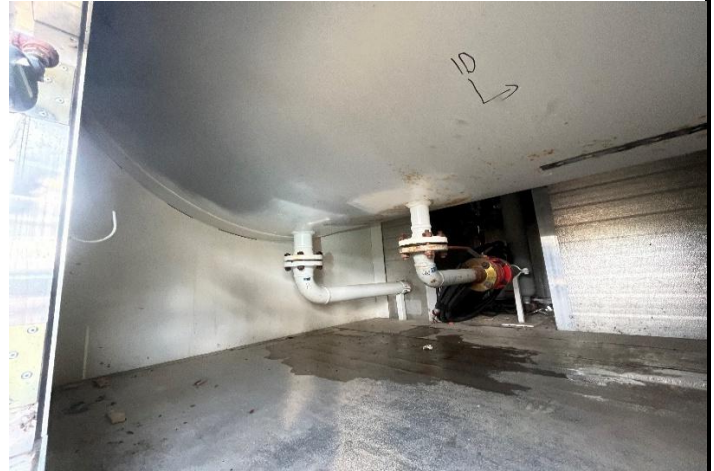
External shell belly view in crawl space. (Superficial rust specs)

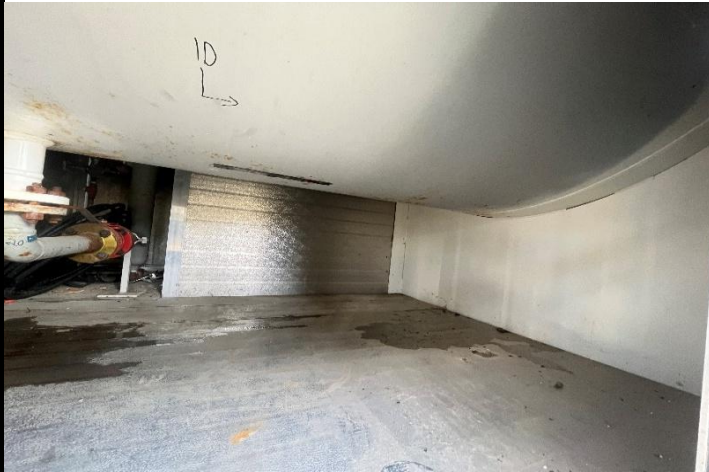
External shell belly view in crawl space. (Superficial rust specs)

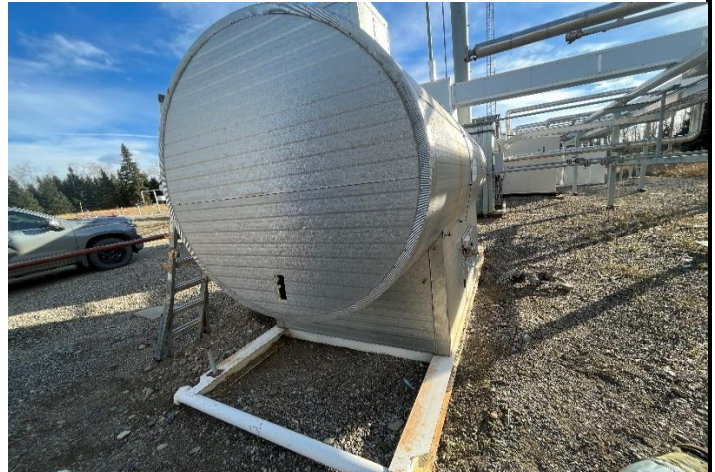
| Component | Disposition | Comments |
|---|---|---|
| Insulation | Good | No Tears, Small Dents (Assumed to be from hail) |

General over view of insulation & skid. (Light hail dents on head)

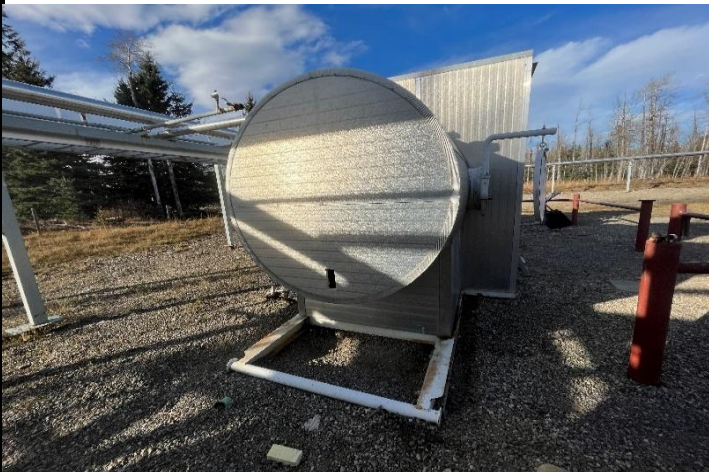
General over view of insulation & skid.

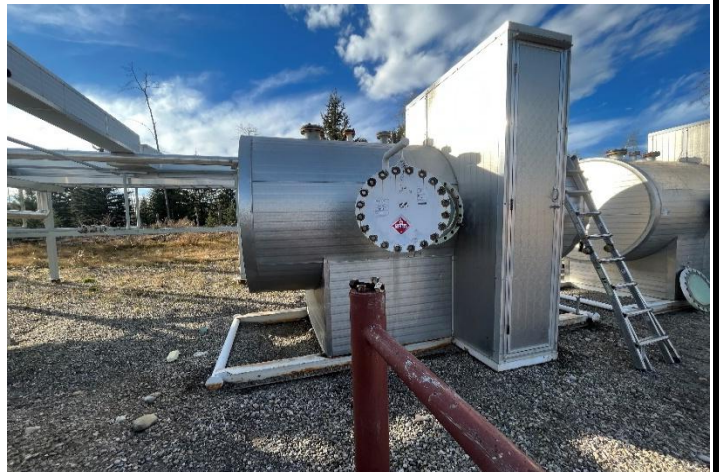
General over view of insulation & skid.
