16-14-020-12W4M  
Co2 STILL COLUMN VENT  
A0551782 14171  
REPORT # A0551782\_\_27OCT2025\_UT\_VE\_VI\_GRADYINSPECTIONLTD

Ultrasonic Report

External Inspection - (Vessel)

Location: Still Column

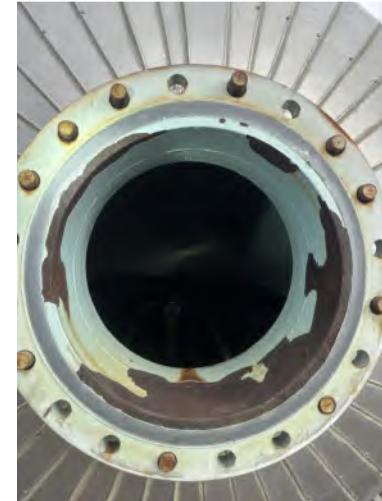
<b>Tubesheet:</b>	N/A		
<b>Channel Section:</b>	N/A		
<b>Bundle / Tubes:</b>	N/A		
<b>Nozzles / Manways:</b>	Fair	Corrosion found on the manway throat to a maximum measured depth of 0.7 mm. Corrosion is within the corrosion allowance of 3.2 mm.	
<b>Welds:</b>	Good		
<b>Vortex Breakers, Drains, etc:</b>	Good	Bolted vortex breaker on 3" nozzle projection. Vortex not removed for inspection.	
<b>Internal Coating:</b>	Fair	<div><input type="checkbox"/> NotCoated <input checked="" type="checkbox"/> Coated</div>	The coating has failed on the manway, nozzles and on the 12:00 portion of the shell. The coating has chipped and flaked, general corrosion visible where the coating has failed on the shell and manway. No visual access to the nozzle coating failures.

**Coating failure on manway throat**

**Recommendations for Next Inspection:** Blast clean and coat vessel.

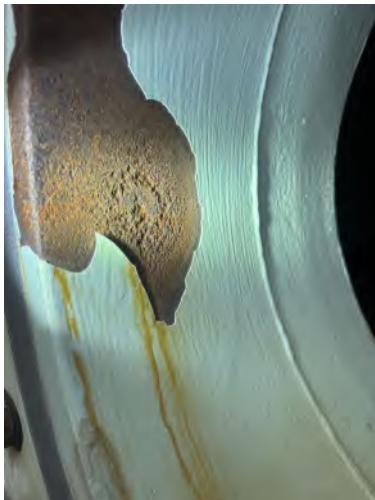
Manway Davits/Quick Closure:	Fair	Corrosion found on manway throat to a maximum measured depth of 0.7 mm. Corrosion is within the corrosion allowance of 3.2 mm.
Nameplate:	Good	Nameplate is legible and readily accessible and securely affixed
Code Variance:

**Corrosion on throat measured to a depth of 0.7 mm**

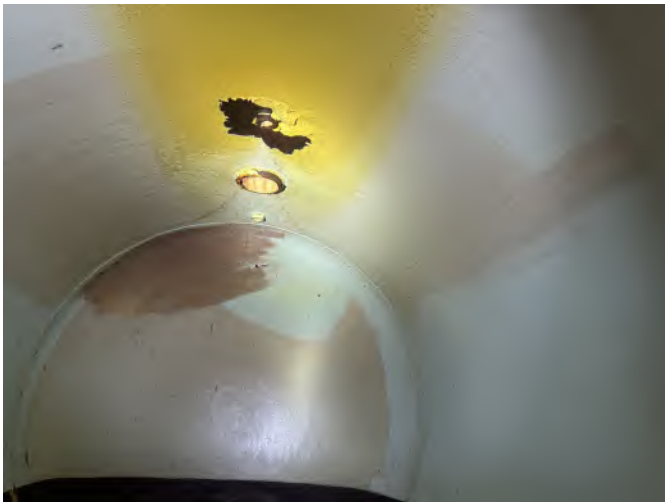
<b>Fit For Service:</b>		Fit For Service.	
<b>Inspection Summary:</b> Overview of Inspection Findings		Minor corrosion found on nozzle throat to a measured depth of 0.7 mm Minor corrosion measured in vapor phase at 12:00 to a measured depth of 0.5 mm,  Coating has failed on the nozzles and vapour space.	
<b>Internal Inspection Items</b>	<b>G/F/P</b>	<b>Comments</b>	
<b>Inlet Area:</b>	Fair	The coating has failed around the nozzle on the shell and on the deflection plate.	
<b>Internal Piping:</b>	Good	Internal stainless steel heating loop in good visual condition.	
<b>Baffles, Deflector Plates, Weir, etc:</b>	N/A		
<b>Trays:</b>	N/A		
<b>Demister Pad:</b>	N/A		
<b>Head (1):</b>	Good	Head in good visual condition.	
<b>Head (2):</b>	Good	Head in good visual condition.	
<b>Shell:</b>	Fair	Coating in vapor space has failed. Minor general corrosion to a maximum measured depth of 0.5 mm was found on the shell at 12:00. Corrosion found in the failed coating section is within the 3.2 mm corrosion allowance.

12:00 coating failure

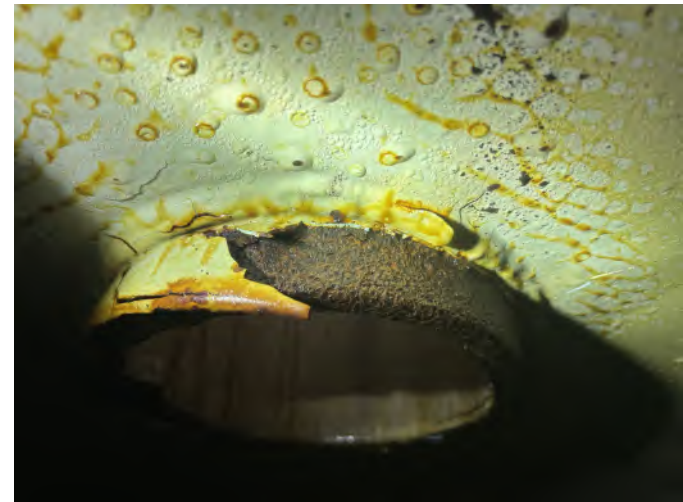
12:00 coating failure

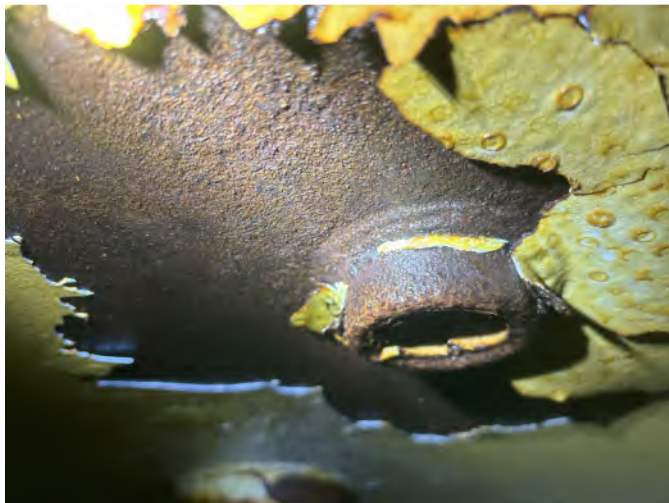
12:00 coating failure

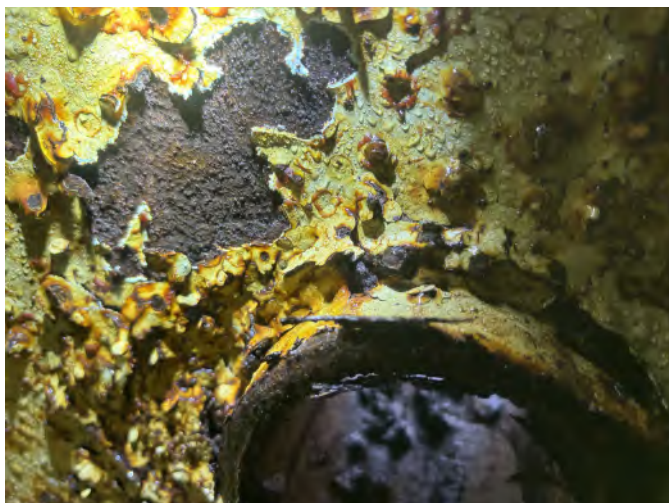
12:00 coating failure

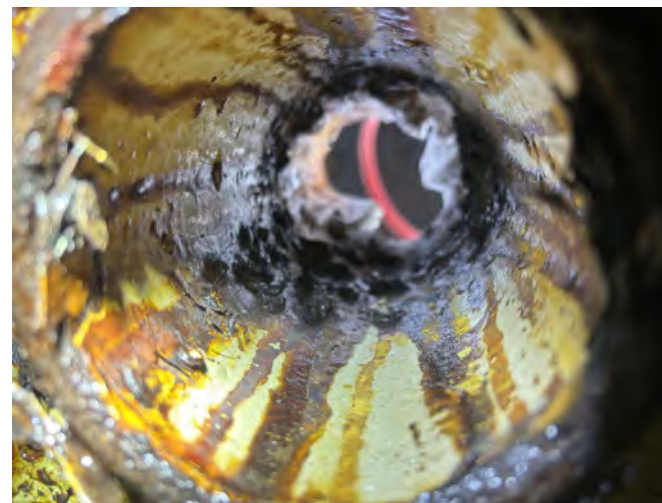
Typical nozzle coating failure

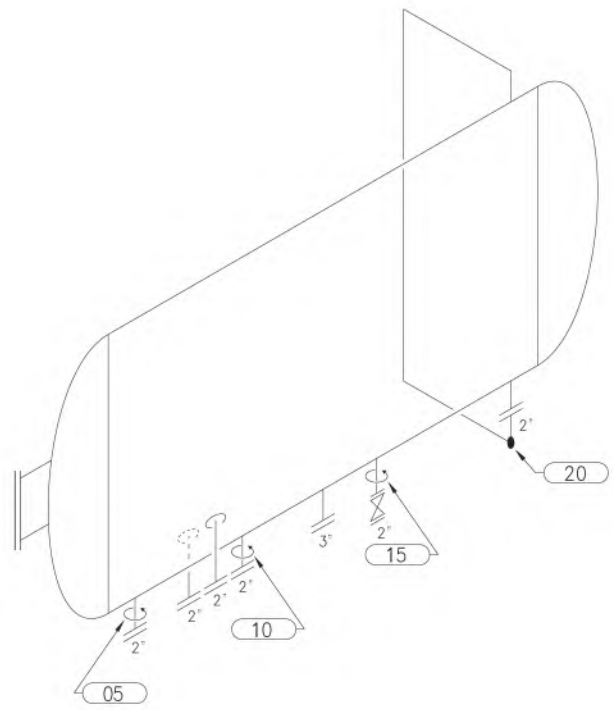
15	8.7			3.4	2.3	2.3	SNozz	2"	-- 160--(8.7mm)	UG45Nozzle	50	25/10/27	9.2	9.6						1	-6%					2028-10-26	3.0			
20	5.5			3.4	2.3	2.3	SNozz	2"	XS 80--(5.5mm)	UG45Nozzle	50	25/10/27	3.6	4.8						1	35%		0.07	2043-12-15	18.1	2028-10-26	3.0	Min @ Top Elbow
