ITEM:	MPI Examination of Propane Storage Tank A # 172957

PROJECT# C31033

DATE:	June 12, 2013	PAGE#	2 of 2
CLIENT:	Crew Energy		
LSD:	05-10-033-26 W4		
INSPECTOR:	Glen Boettger		
LOCATION:	Wimborne		
DISTRICT UNIT:	Martin Larsen's Field		
BUILDING / SKID:	NONE		
PROCESS:	Sweet		
CODE:	ASME Sec VIII		
SPECIFICATION:	Div. 1 Appendix 6		
TECHNIQUE:	MT-3, Rev. 0		
METHOD:	WET, FLUORESCENT		
SURFACE CONDITION:	Bare steel (Buffed)		
SURFACE TEMP:	Ambient		
VESSEL/PART INFORMATION			
VESEL#:	A # 172957		
CRN#:	9156.3214		
SERIAL#:	27134A		
MANUFACTURER:	Western Rock Bit Co. Ltd.		
DATE BUILT:	0/0/1985		
CLIENT ID / TAG:	/		
M.A.W.P.:	1724 KPA		
M.A.W.T.:	66 C		
JOINT EFFICIENCY / RT:	RT-4		
STRESS RELIEVED:	/		
INSULATED:	NO		
MANWAY:	YES		
EQUIPMENT USED			
ARDROX FLUORESCENT MAGNETIC PARTICLE BATCH # 65102512			
MAGNAFLUX Y-6 YOKE PT No. 43530			
MAGNAFLUX BLACKLIGHT MODAL ZB-150F/SB			
DSE-100X RADIOMETER Ser. No.1704233

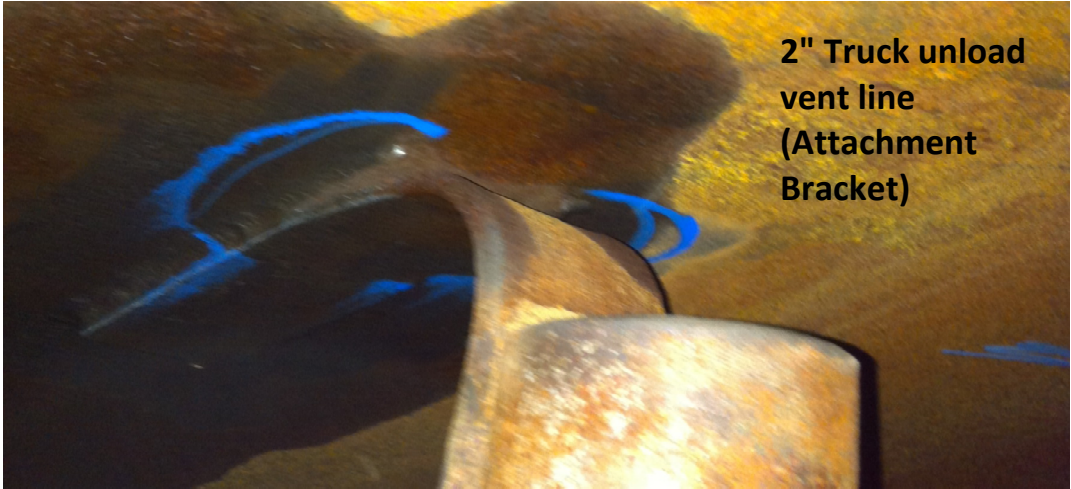
OUNTAIN WEST SERVICES LTD. www.mtnwest.ca Grande Prairie, AB 780-518-9757 Sylvan lake, AB 403-887-3562 Box 5175 Lacombe, AB T4L 1W9	TECHNICIAN: GARRETT VATERS SNT LEVEL II UT/MT/PT CGSB 48.9712 LEVEL II UT #13937
<u>FIGURE 1</u>

<p>Results: The indications shown above in Figures 1 & 2 were noted on the attachment bracket side of the weld, not on the shell side of the weld. These indications were discussed with Senior Inspector Glen Boettger and it was agreed that they do not cause and threat to the integrity of the vessel therefore were left as is. No rejectable indications were noted at time of</p>				
COMMENTS:
