## Field Inspection Report - Long\_Run 3162237\_11/08/2013\_VT\_Internal

<b>Vessel Number</b>	3162237	<b>Vessel Name</b>	GAS/GAS EXCHANGER	<b>Province</b>	Alberta
<b>District</b>	NORTHERN - AB	<b>LSD</b>	03-26-074-01W6	<b>Location</b>	PUSKWASKAU
<b>Method</b>	VT	<b>Access</b>	Internal	<b>Cleaning</b>	Good
<b>Inspection Date (mm/dd/yyyy)</b>	11/08/2013	<b>Inspection Interval (months)</b>	60	<b>Next Inspection (mm/dd/yyyy)</b>	11/08/2018
<b>CRN</b>	N1341.2	<b>Skid Number</b>	PKG62777	<b>Service</b>	Sweet
<b>Internal Access</b>	Yes	<b>Internal Coating</b>	No	<b>Status</b>	In Service
<b>MAWP (PSI)</b>	1320	<b>MAWP (kPa)</b>	9101.14	<b>Outstanding NCRs</b>	0
<b>MAWT (°C)</b>	66.11	<b>MAWT (°F)</b>	151

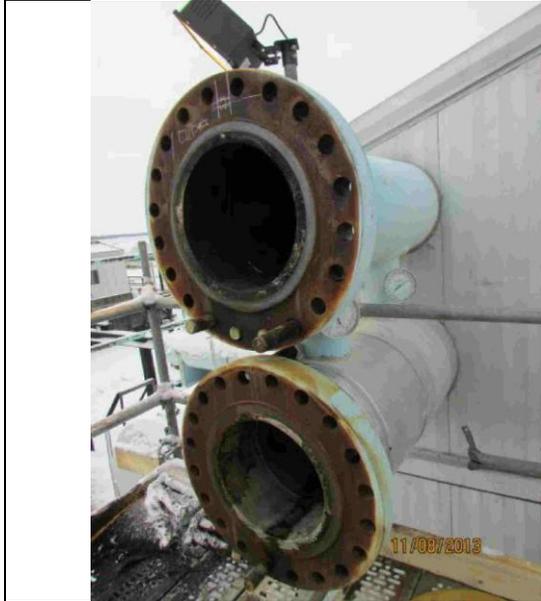
LRE - 3162237 GAS TO GAS EXCH. EXT. EAST  
11-08-13.JPG

All visible shell surfaces and nozzles appear in good condition. Name plate is intact and legible. Vessel supports, foundation and electrical grounding appear good. The external coating and insulation and cladding appears to be in good condition. Associated piping, supports and components appear in good condition and alignment with no signs of leaks or defects present at the time of inspection. No evidence of short studding or nut rounding at time of inspection.

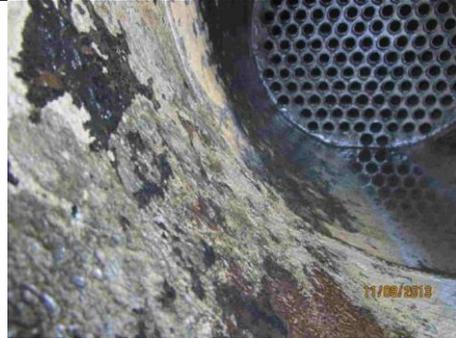
LRE - 3162237 GAS TO GAS EXCH. INT WEST TOP  
11-08-13 (3).JPG

Tubes protrude through tube sheet by 3/16", but lower tubes have eroded flush with the tube sheet. The ID of the tubes appear to be very thin and should have Remote Field Testing (RFT) completed to determine remaining wall of tubes. Tubes maybe losing there ability at the rolled area in tube sheet to retain a good seal. The tube sheet itself does not look like it has any substantial wall loss or pitting. The integral head walls are etched from erosion, but to no significant depth. Dollar plate for the end also has the light etching. All circs and Cat. D welds appear in good order. The nozzles are clear. Gasket faces in good condition.

- Complete a Remote Field Test (RFT) on 50% of tubes or possibly IRIS.
- Exchanger was given a 60 month inspection window based on the exchanger leaking between tubes to shell, not external to vessel. Would highly recommend RFT ASAP to get a base line of remaining life of tubes. May require FGG to use the IRIS technique to determine wall loss at tube sheet.
- Clean tubes better as this will be required to complete RFT. 40K dual lance on an indexing stand.
- Internally inspect again in 5 years.
- Pop-A Plug for exchanger tube plugging. Call the Pickford Group for details and search Pop-A Plug on the internet.

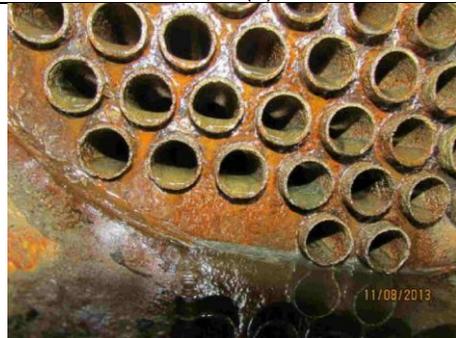
LRE - 3162237 GAS TO GAS EXCH. INT. EAST  
BOTTOM 11-08-13 (4).JPG

Tubes protrude through tube sheet by 3/16", but lower tubes have eroded almost flush with the tube sheet. The ID of the tubes appear to be very thin and should have Remote Field Testing (RFT) completed to determine remaining wall of tubes. Tubes maybe losing there ability at the rolled area in tube sheet to retain a good seal. The tube sheet itself does not look like it has any substantial wall loss or pitting. The integral head walls are etched from erosion and has thin oval worm like corrosion noted on the bottom 1/3 of head, but to no significant depth. Dollar plate for the end also has the light etching. All circs and Cat. D welds appear in good order. The nozzles are clear. Gasket faces in good condition.
