## Field Inspection Report - Long\_Run 3162251\_11/06/2013\_VT\_Internal

<b>Vessel Number</b>	3162251	<b>Vessel Name</b>	GLYCOL REBOILER	<b>Province</b>	Alberta
<b>District</b>	NORTHERN - AB	<b>LSD</b>	03-26-074-01W6	<b>Location</b>	PUSKWASKAU
<b>Method</b>	VT	<b>Access</b>	Internal	<b>Cleaning</b>	Poor
<b>Inspection Date (mm/dd/yyyy)</b>	11/06/2013	<b>Inspection Interval (months)</b>	60	<b>Next Inspection (mm/dd/yyyy)</b>	11/06/2018
<b>CRN</b>	N1350.2	<b>Skid Number</b>	PKG62777	<b>Service</b>	
<b>Internal Access</b>	Yes	<b>Internal Coating</b>	No	<b>Status</b>	In Service
<b>MAWP (PSI)</b>	5	<b>MAWP (kPa)</b>	34.47	<b>Outstanding NCRs</b>	0
<b>MAWT (°C)</b>	260	<b>MAWT (°F)</b>	500

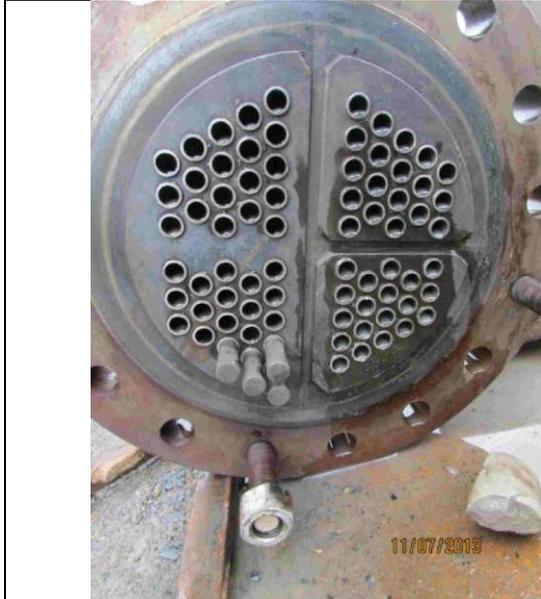
LRE - 3162251 GLYCOL REBOILER BUNDLE .  
11-06-13 (5).JPG

3/4" x 105" long U-tube bundle with 4 passes and having 19 tubes/pass. Stainless steel tubes with carbon steel tube sheet, baffles and tie rods. No concerns with tube losses. There is some minor corrosion noted on the carbon steel surfaces, none of any concern. Tie rod nuts are a little loose as the nuts that are doubled have some losses as well as the baffle plates. Baffles are 47" apart and tube sheet is 2" thick. There appears to be no fretting of the tubes through the baffles, but some of these locations appear to be excessive in size compared to the tubes. Gasket surfaces are good. There is 4 tubes plugged in one pass on one end, assuming this is to assist in tube velocity through the tubes. Would recommend Pop-A-Plug as they are easily installed and removed.
