FORM: IMS001 – Devon Standard Inspection Form

Equipment:			
District:	Fairview	Equipment Name:	Glycol Reboiler
Plant / Area:	Puskwaskau	Equipment Number:	95261-AI-1
LSD:	3-26-74-1W6	Manufacturer:	Propak
Functional Block (Process Unit):	DPCU	Manufacture Serial Number:	95261-AI-1
Equipment Type:	Indirect fired Heater (Noncode-Vessel)	Provincial Registration Number:	NA
CRN:	N1350.2		
Inspection Personnel:			
Inspection Company:	Devon	Extent of Inspection:	Full Internal
Name of Inspector:	Jason McGovern	Date of Inspection:	June 17, 2009
Inspection Summary:			
<ul style="list-style-type: none"> - Short term corrosion rate = 0.100"/y on nozzle neck of tube bundle. Weld Build up completed. - Flange face between still column and reboiler is thinning - UT Inspection is required on Still Column shell on end connecting to reboiler. - Recommendation to tie vent line into underground sump system to eliminate oxygen from the system. 			
Inspection Details:

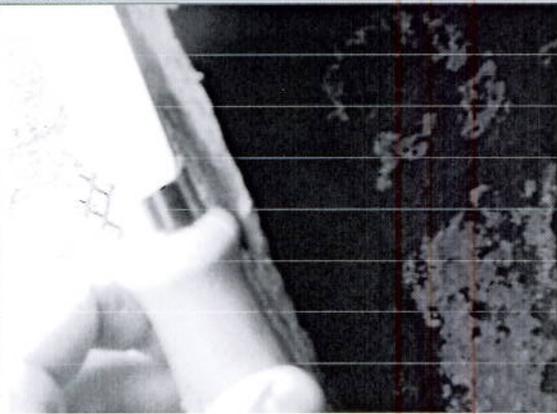
Picture 1 (Desc.): Thinning Flange

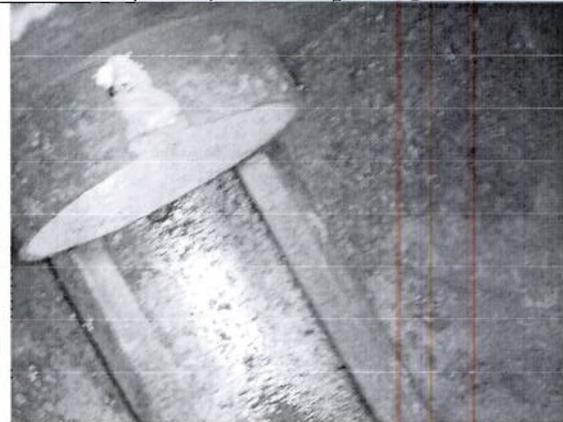
Picture 3 (Desc.): from Still Column Nozzle
