## Field Inspection Report - Long\_Run 3162220\_11/08/2013\_VT\_Internal

<b>Vessel Number</b>	3162220	<b>Vessel Name</b>	CHILLER	<b>Province</b>	Alberta
<b>District</b>	NORTHERN - AB	<b>LSD</b>	03-26-074-01W6	<b>Location</b>	PUSKWASKAU
<b>Method</b>	VT	<b>Access</b>	Internal	<b>Cleaning</b>	Good
<b>Inspection Date (mm/dd/yyyy)</b>	11/08/2013	<b>Inspection Interval (months)</b>	60	<b>Next Inspection (mm/dd/yyyy)</b>	11/08/2018
<b>CRN</b>	N1345.2	<b>Skid Number</b>	PKG62777	<b>Service</b>	
<b>Internal Access</b>	No	<b>Internal Coating</b>	No	<b>Status</b>	In Service
<b>MAWP (PSI)</b>	250	<b>MAWP (kPa)</b>	1723.7	<b>Outstanding NCRs</b>	0
<b>MAWT (°C)</b>	66.11	<b>MAWT (°F)</b>	151

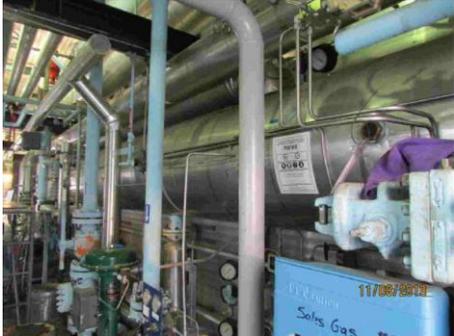
<p>LRE - 3162220 CHILLER EXT. 11-08-13.JPG</p>	<p>LRE - 3162220 CHILLER INT WEST 11-08-13 (1).JPG</p>

All visible shell surfaces and nozzles appear in good condition. Name plate is intact and legible. Vessel supports, foundation and electrical grounding appear good. The external coating, insulation and cladding appears to be in good condition. Associated piping, supports and components appear in good condition and

alignment with no signs of leaks or defects present at the time of inspection. No evidence of short studding or nut rounding at time of inspection.

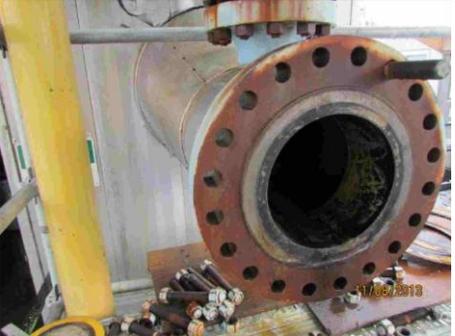
Tubes protrude through tube sheet by 3/16" to 1/4", and show no signs of any corrosion, erosion or mechanical damage only some flash rusting from cleaning. The tube sheet is in excellent condition as well as the shell of the integral head. Dollar plate had corrosion noted on the bottom to a depth of 0.015" in depth, but large in area. All circs and Cat. D welds appear in good order. The nozzles are clear with the inlet line coming in from the bottom of head. The inlet line from the low temp separator has a heavy root pass. Gasket faces in good condition.

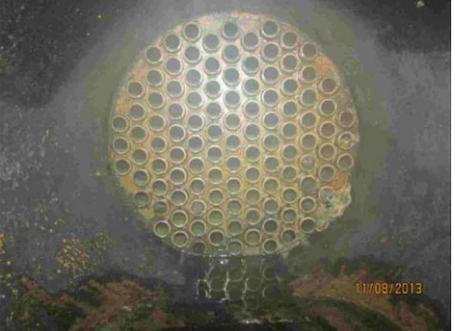
<p>LRE - 3162220 CHILLER INT WEST 11-08-13 (3).JPG</p>	<p>LRE - 3162220 CHILLER INT. EAST 11-08-13 (2).JPG</p>

There was a heavy pasty product on walls of head prior to cleaning some of this product remained after cleaning as well as some flash rusting. Tubes protrude through tube sheet by 3/16" to 1/4", and show no signs of any corrosion, erosion or mechanical damage. The tube sheet is in excellent condition as well as the shell of the integral head. Dollar plate had no damage noted. All circs and Cat. D welds appear in good order. The nozzles are clear with the inlet line coming in from the bottom of head. The inlet line from the low temp separator has a heavy root pass. Gasket faces in good condition.
