Field Inspection Report - Long_Run 3162196_11/07/2013_VT_Internal

Vessel Number	3162196	Vessel Name	LOW TEMP SEPARATOR	Province	Alberta
District	NORTHERN - AB	LSD	03-26-074-01W6	Location	PUSKWASKAU
Method	VT	Access	Internal	Cleaning	Good
Inspection Date (mm/dd/yyyy)	11/07/2013	Inspection Interval (months)	60	Next Inspection (mm/dd/yyyy)	11/07/2018
CRN	N1348.2	Skid Number	PKG62777	Service	SWEET
Internal Access	No	Internal Coating	No	Status	In Service
MAWP (PSI)	1320	MAWP (kPa)	9101.14	Outstanding NCRs	0
MAWT (°C)	66.11	MAWT (°F)	151

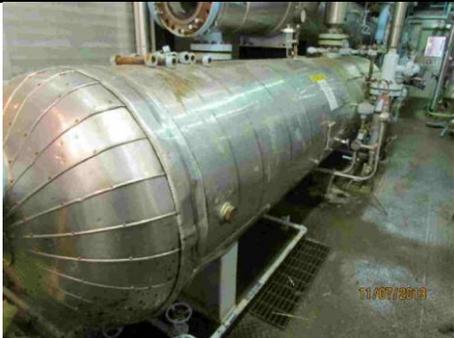
<p>LRE - 3162196 LP SEPARATOR EXT. 11-07-13 (1).JPG</p>	<p>LRE - 3162196 LP SEPARATOR INT. 11-07-13 (1).JPG</p>

All visible shell surfaces and nozzles appear in good condition. Name plate is intact and legible. Vessel supports, foundation, and electrical grounding appear good. 2 saddles supporting vessel are tight on both ends. Exterior surface is painted and then insulated and clad for temperature conservation. Cladding has some punctures in the top from something and caps on the ends appear loose. Associated piping, supports and

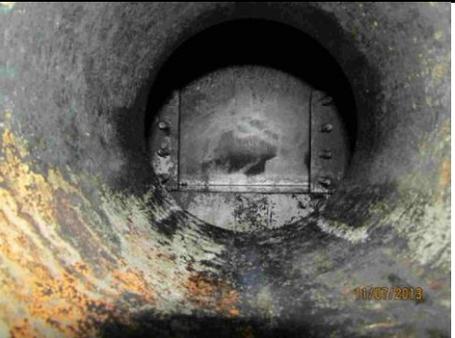
Vessel not internally coated. Internals were not very clean for inspection. Inspection to be conducted with both digital camera and borescope. Pictures were taken of all internal locations assessable with a camera and viewed on computer to see if there was any areas of concern that required follow-up with the borescope. Found there were no obvious areas of concern all the circs, longs, attachment and Cat. D welds appear in good order. Fillet welds for weir are good. Appears as if a section of the weir was not installed or removed once in service as there was an area that the studs were there, but no plate. The bolts are all in place and tight. Cover, and gasket faces are in good condition and working order.
