Field Inspection Report - Long_Run 3162189_11/08/2013_VT_Internal

| Vessel Number | 3162189 | Vessel Name | PROPANE SUBCOOLER | Province | Alberta |

General

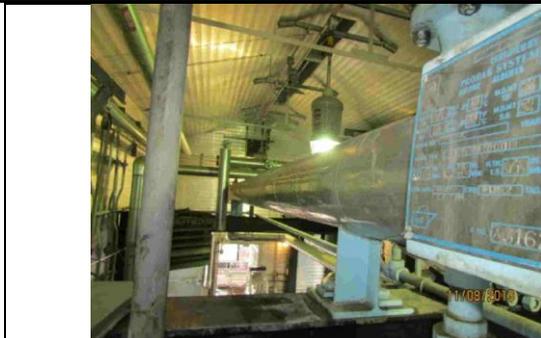
LRE - 3162189 SUB COOLER EXT. 11-08-13.JPG

All visible shell surfaces and nozzles appear in good condition. Name plate is intact and legible. Vessel supports, foundation and electrical grounding appear good. The external coating, insulation and cladding appears to be in good condition. Associated piping, supports and components appear in good condition and

alignment with no signs of leaks or defects present at the time of inspection. Exchanger is supported on 2 saddles that are both tight not allowing thermal expansion. No evidence of short studding or nut rounding at time of inspection.

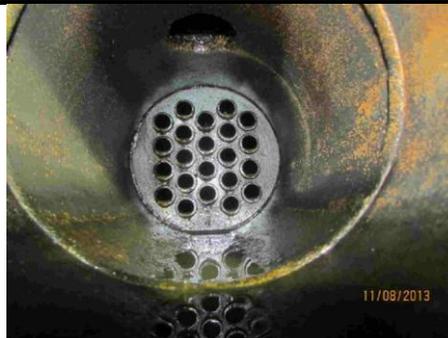
LRE - 3162189 SUB COOLER INT WEST 11-08-13 (2).JPG

Tubes protrude through tube sheet by 1/8", and show no signs of any corrosion, erosion or mechanical damage. The tube sheet is in excellent condition as well as the shell of the integral head. Dollar plate have no damage noted. All circs and Cat. D welds appear in good order. The nozzles are clear. Gasket faces in good condition.
