FORM: IMS001 – Devon Standard Inspection Form

Equipment:			
District:	Fairview	Equipment Name:	Glycol Reboiler
Plant / Area:	Puskwaskau	Equipment Number:	95261-AI-1
LSD:	3-26-74-1W6	Manufacturer:	Propak
Functional Block (Process Unit):	DPCU	Manufacture Serial Number:	95261-AI-1
Equipment Type:	Indirect fired Heater (Noncode-Vessel)	Provincial Registration Number:	NA
CRN:	N1350.2		
Inspection Personnel:			
Inspection Company:	Devon	Extent of Inspection:	Full Internal
Name of Inspector:	Jason McGovern	Date of Inspection:	July 12, 2010
Inspection Summary:			
<ul style="list-style-type: none"> - Short term corrosion rate = 0.70"/y on nozzle neck of tube bundle. Weld Build up completed. - Flange face between still column and reboiler is thinning - UT Inspection is required on Still Column shell on end connecting to reboiler. - System was tied into underground drain system however, this freezes off in the winter and they have to operate as before. Recommendation to install heat tracing on line.

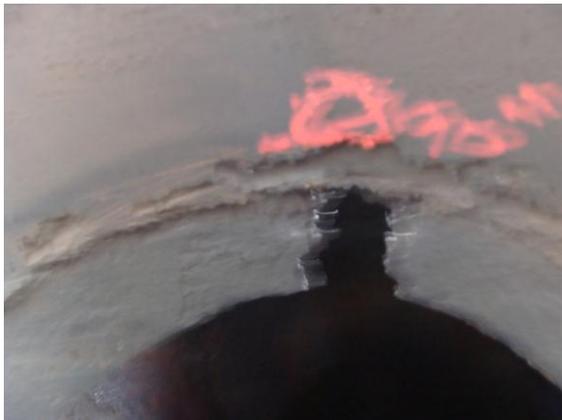
Inspection Details:			
<p>Shell:</p> <ul style="list-style-type: none"> - Corrosion is localize to the 12" nozzle neck to which the tube bundle is attached. Pitting is 0.070"-0.800" deep. Nozzle neck was replaced in Jan 2008, weld build up done in 2009. Corrosion was from 1 o'clock to 3 o'clock moving clockwise. All pits were filled in. - No other area of concern were noted on shell. <p>Tube Bundle:</p> <ul style="list-style-type: none"> - No indications of concern were noted on the bundle. 4 tubes were plugged in 2008 to attempt to reduce corrosion on shell. <p>Channel Head:</p> <ul style="list-style-type: none"> - No indications were noted on the channel head. <p>Still Column:</p> <ul style="list-style-type: none"> - Flange face that connects to reboiler shell is thinning. See attached photos - Internal corrosion was noted on lower shell. Scale was too tough to scrape away, External UT is required to determine extent of corrosion. - Coil has been upgraded to Stainless steel.

Picture 1 (Desc.): 12 o'clock corrosion noted in 2009		Picture 2 (
Picture 3 (Desc.):		Picture 4 (Desc.)

Repairs:			
<ul style="list-style-type: none"> - Weld build up was completed on all areas of corrosion. Build up was not ground flush, in order to provide additional corrosion allowance in effected areas.

NDE Reports:			
Not required.			
Recommendations:			
<p>-It is recommended that the line that vents to underground tank be heat traced. Corrosion rates have been reduced since inspection in 2009.</p> <p>- Next inspection due in 2011.</p>			
Certification:			
Inspector Signature:		Provincial Certification Number:	
Date:	June 18, 2009		
Pictures:
