TANK INSPECTION REPORT

TANK TAG ID# SELECTOR	ST58742
-----------------------	---------

INSPECTION DATE	2022-06-03
TAG NUMBER	ST58742

TANK TYPE	AST - PRODUCED WATER
DESIGN STANDARD	
DESIGN PRESSURE	
MANUFACTURER	GLM
SERIAL NUMBER	J-05-029-2
YEAR BUILT	2005
YEAR INSTALLED

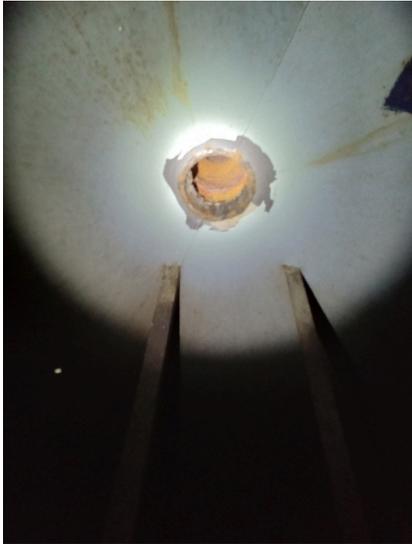
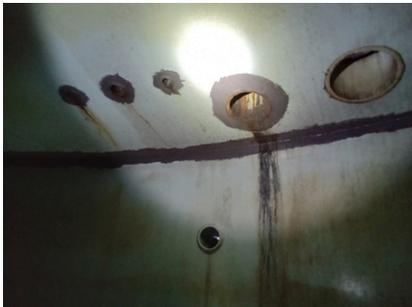
Comments	
T5 - BLISTERS	NA
Comments	
T6 - DEPOSITS	NA
Comments	
T7 -WELDS	GOOD
Comments	
T8 - NOZZLES	YES, SEE NOTE
Comments	Coating failure around roof and shell nozzles.
T9 -SHELL	YES, SEE NOTE
Comments	Pitting and coating failure on tank shell.
T10 - ROOF	YES, SEE NOTE
Comments	
T11 - FLOOR	SEE NOTE
Comments	Pitting and coating failure on tank floor.

IMAGE COMMENT	Roof nozzles

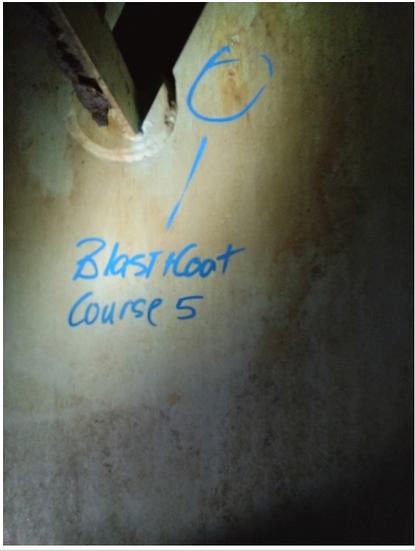
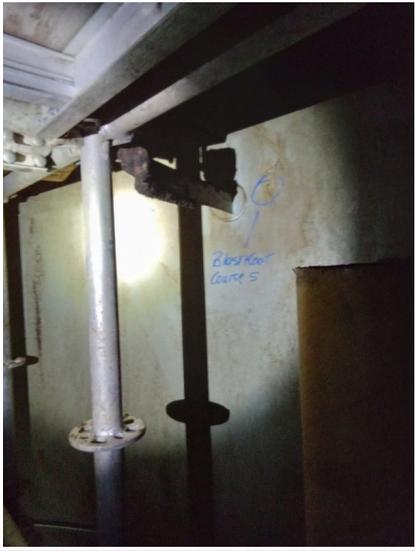
IMAGE COMMENT	5th course from bottom coating repair.

COMMENTS	Upper 4 & 5 shell courses to be coated before removing scaffold. Once scaffold is removed, check areas of tank floor for additional coating repairs areas that were not identified due to scaffold obstruction. Coating repair areas where seen were identified with blue paint stick as shown above in pictures.
-----------------	---

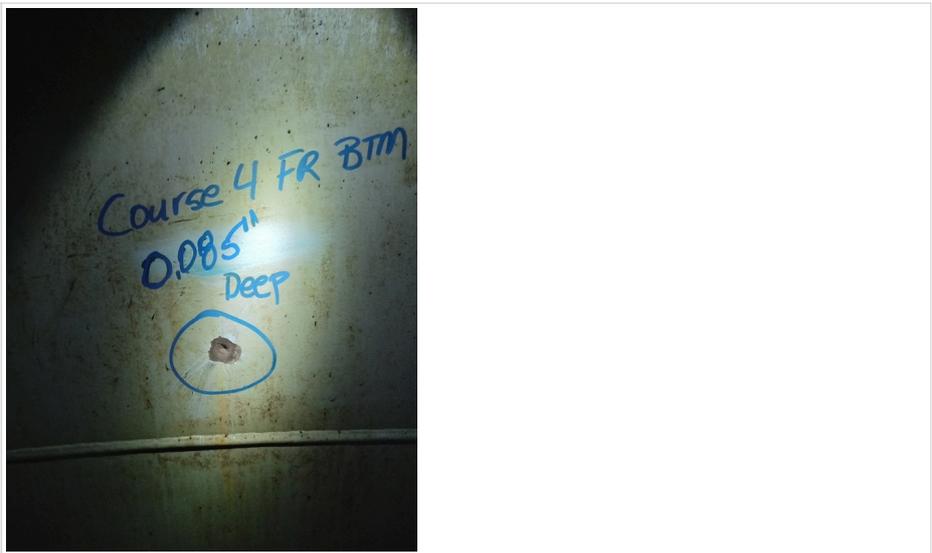
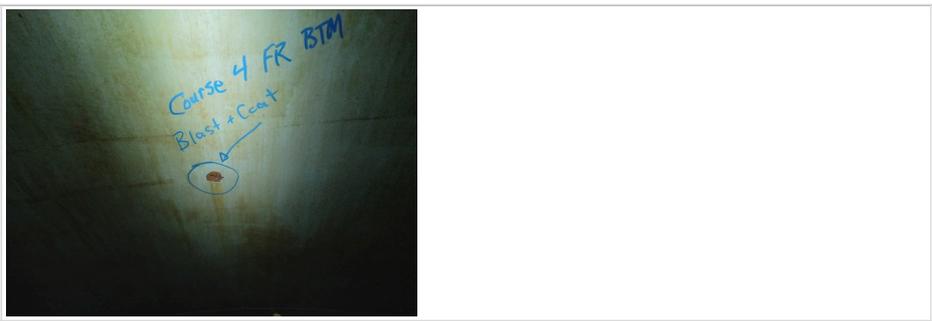
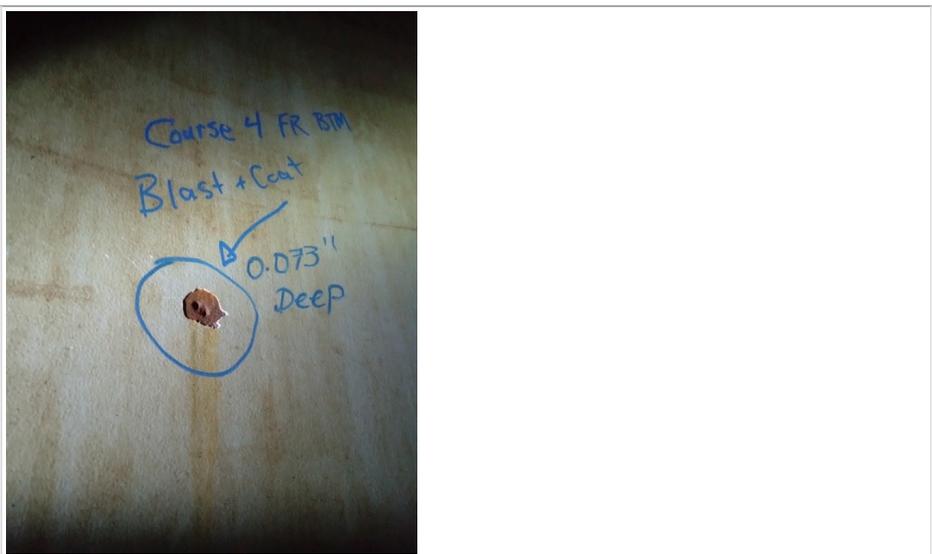
IMAGE COMMENT	4th course from bottom coating repair.

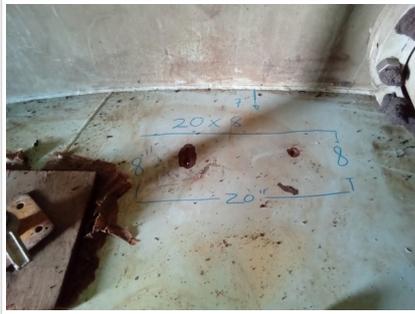
T1 - OTHER (Please Explain In Notes)	YES, SEE NOTE
Comments	Internal Inspection revealed areas of coating failure and corrosion of the parent material within those areas. On the floor parent material it had corroded through the floor causing the product to leak. This area had a plate 20" x 8" repaired over the existing floor material. This plate encompassed 3 different coating failure and pitted areas. Numerous coating failure areas throughout shell and floor were noted during the inspection. These areas were physically marked during the inspection for coating repair.
T2 - CORROSION	YES
Comments	
T3 - ERROSION	NA
Comments	
T4 - DISTORTION	NA

IMAGE COMMENT	Holed through area on floor.

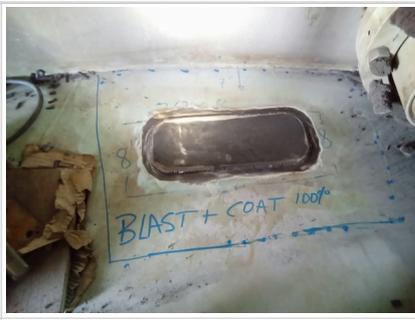
IMAGE COMMENT	Weld repair area requiring coating repair.

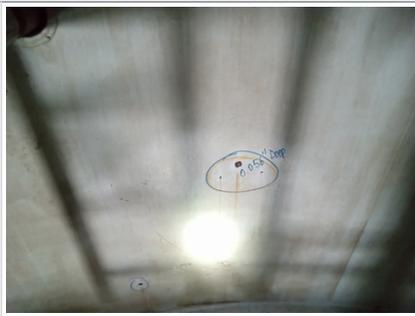
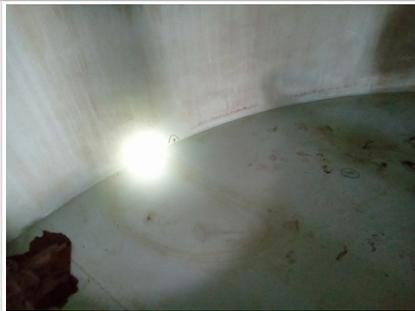
IMAGE COMMENT	Bottom shell coating repair.

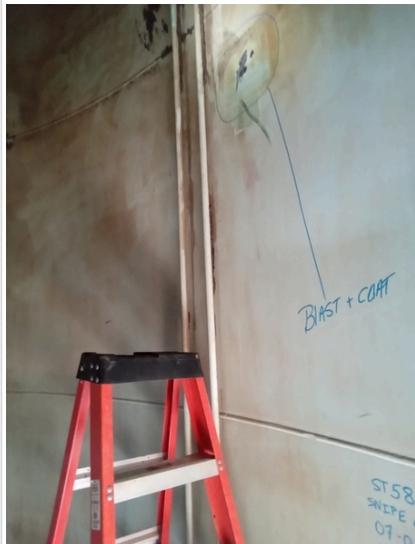
IMAGE COMMENT	2nd course shell coating repair.

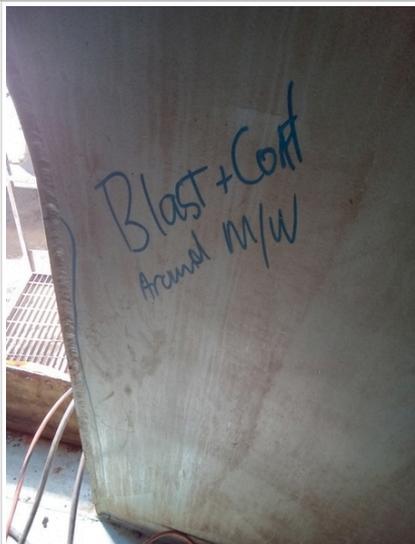
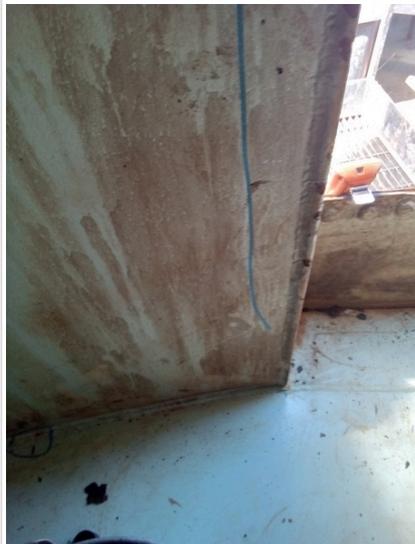
IMAGE COMMENT	Manway coating repair.

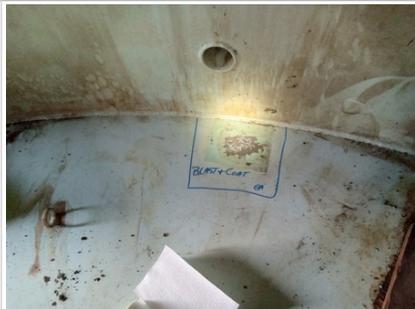
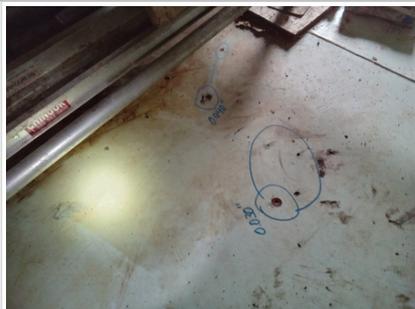
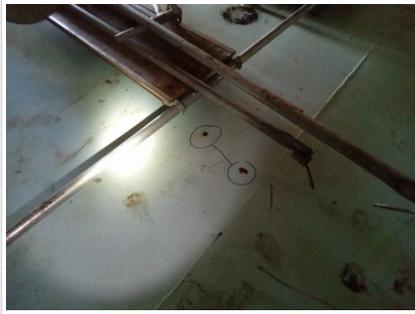
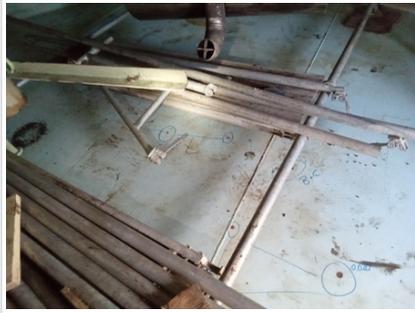
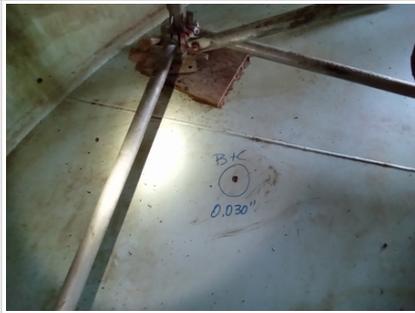
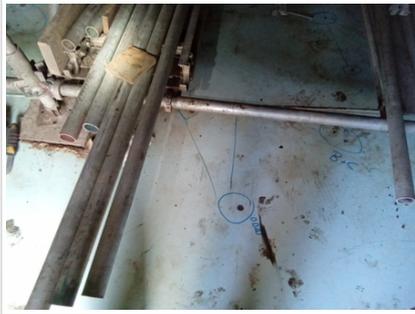
IMAGE COMMENT	Tank floor coating repair.
