TANK INSPECTION REPORT

TANK TAG ID# SELECTOR	ST58741
-----------------------	---------

INSPECTION DATE	2022-08-04
TAG NUMBER	ST58741

TANK TYPE	AST - PRODUCED WATER
DESIGN STANDARD	
DESIGN PRESSURE	
MANUFACTURER	GLM
SERIAL NUMBER	J-05-029-1
YEAR BUILT	2005
YEAR INSTALLED

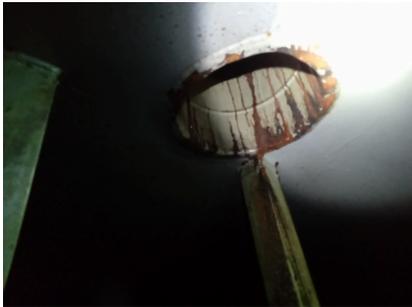
IMAGE COMMENT	Roof top vent nozzle.
