TANK INSPECTION REPORT

TANK TAG ID# SELECTOR	ST58740
-----------------------	---------

INSPECTION TYPE	
UNIT ID	
PLANT ID	
SURFACE LOCATION	07-04-071-18W5
UWID	
SERVICE	
DISTRICT	
FIELD	SNIPE LAKE
PACKAGE NUMBER	H2O TANK FARM

TANK TYPE	AST - PRODUCED WATER
DESIGN STANDARD	
DESIGN PRESSURE	
MANUFACTURER	GLM
SERIAL NUMBER	J-05-029-3
YEAR BUILT	2005
YEAR INSTALLED

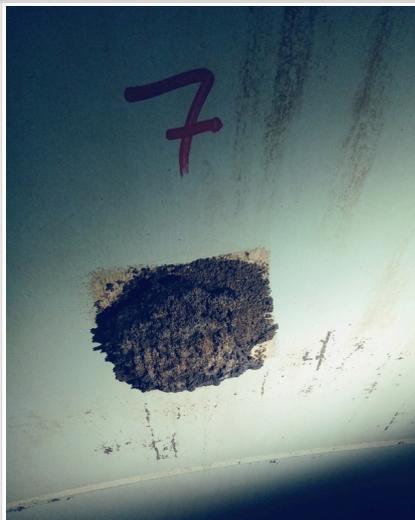
INTERNAL IMAGES (1)

IMAGE COMMENT	Coating holiday, anode has bonded to shell surface.

COMMENTS	Tank had numerous coating failures on shell and floor. All areas were cleaned and recoated after sand blasting. Anodes were nearly 100% consumed and were all replaced in kind. No other issues noted at time of inspection. Tank is fit for service.
----------	---

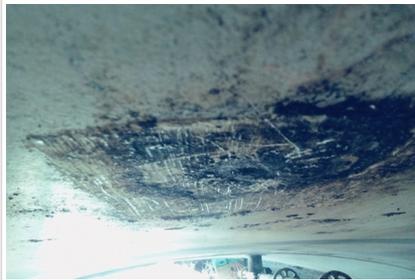
INTERNAL IMAGES (3)

IMAGE COMMENT	Pitting under coating holiday.

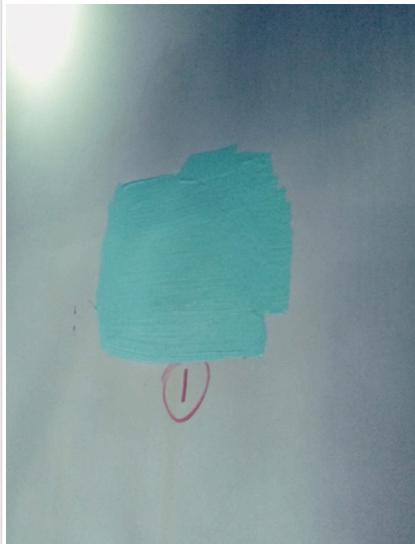
INTERNAL IMAGES (7)

IMAGE COMMENT	Typical holiday coating.
