Field Inspection Report - Long_Run 568797_10/25/2017_VT_Internal

Vessel Number	568797	Vessel Name	BULLET	Province	Alberta
District	NORTHERN - AB	LSD	07-04-071-18W5	Location	SNIPPE LAKE
Method	VT	Access	Internal	Cleaning	Good
Inspection Date (mm/dd/yyyy)	10/25/2017	Inspection Interval (months)	120	Next Inspection (mm/dd/yyyy)	10/25/2027
CRN	A223.4.5.3.2.8.0	Skid Number	N/A	Service	SWEET
Internal Access	Yes	Internal Coating	No	Status	In Service
MAWP (PSI)	250	MAWP (kPa)	1723.7	Outstanding NCRs	0
MAWT (°C)	53.33	MAWT (°F)	128

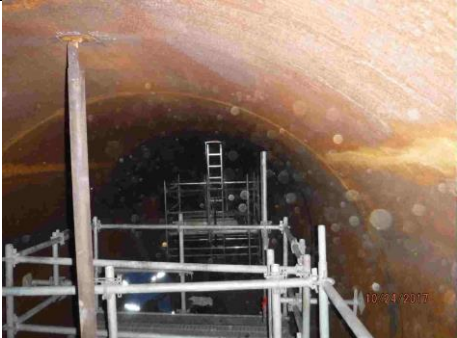
LRE-568797-MECHANICAL DAMAGE-10-24-17.JPG		LRE-568797-MANWAY-10-24-17.JPG

- This vessel was not internally coated.
- All internal Longs, Circs, attachment and Cat. D welds were power buffed and appear in good order.
- No apparent defects, or deterioration at time of inspection.
- Scattered areas of corrosion at maximum depths of 0.020".
- Area near angle iron that appears to be mechanical damage at 0.040"

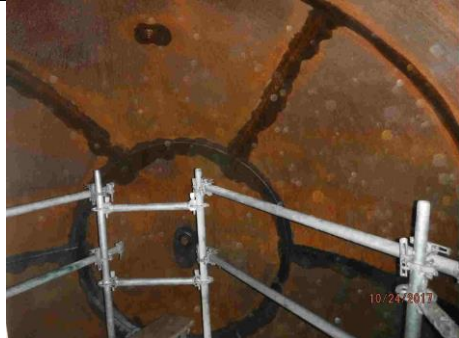
- Broken 1.5" angle iron at 12:00 on inlet.
- Manway and gasket face were in good condition.
- Nozzles were clean and clear.

- It's recommended that the Bullet is thoroughly inspected at a maximum interval of 10yrs.
- Replace Manway gasket.
- Repair angle iron bracket.
