Field Inspection Report - Long_Run 568797_04/19/2019_VT_External

Vessel Number	568797	Vessel Name	BULLET	Province	Alberta
District	NORTHERN - AB	LSD	07-04-071-18W5	Location	SNIPE LAKE
Method	VT	Access	External	Cleaning	Good
Inspection Date (mm/dd/yyyy)	04/19/2019	Inspection Interval (months)	60	Next Inspection (mm/dd/yyyy)	04/19/2024
CRN	A223.4.5.3.2.8.0	Skid Number	N/A	Service	SWEET
Internal Access	Yes	Internal Coating	No	Status	In Service
MAWP (PSI)	250	MAWP (kPa)	1723.7	Outstanding NCRs	0
MAWT (°C)	53.33	MAWT (°F)	128

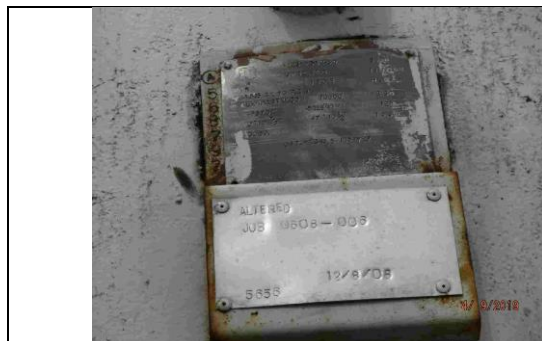
LRE - 568797 - NAMEPLATE - 04-09-19.JPG

- registered in Alberta with the appropriate design CRN
- nameplate is intact and legible with A#
- has adequate PSV protection
- external coating is in fair condition with some coating chips, with no evidence of corrosion
- vessel is plumb and adequately supported
- vessel is grounded

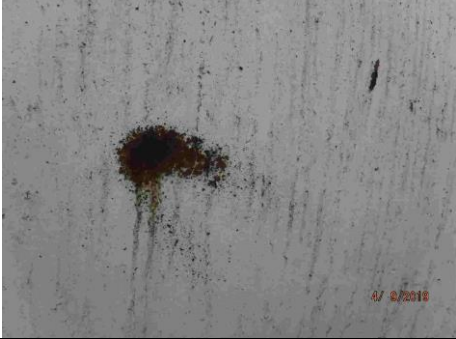
- adequately supported and aligned
- no evidence of short studding/nut rounding
- external coating is in fair condition with some coating chips, with no evidence of corrosion
- insulation and cladding – properly sealed to ensure no moisture and corrosion under the insulation

LRE - 568797 - PAINT DISBONDING - 04-09-19.JPG	...
