**LRE - EXTERNAL INSPECTION~LRE - EXTERNAL AFTERCOOLER
 INSPECTION - NB41344 - 02-12-058-23W4 - 133678_94bb6fc4-c5ab-4224-
 b50b-703ce06e3a78_149854b2-f0bb-482b-9d22-e73998308f46.jpg**

District	CENTRAL - AB
Field	REDWATER NORTH
Facility	REDWATER NORTH
Surface Location	02-12-058-23W4
Skid Number	PKG54928

Vessel Name	INLET SEPARATOR
Orientation	Horizontal
Manway	Yes
Operating Status	In Service

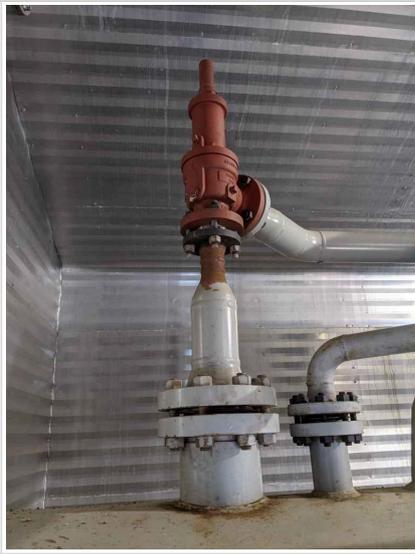
PSV condition	Good
PSV condition comments	PSV set pressure is at or below the MAWP of the equipment it is protecting, is aligned in a vertical plane, has correct code stamping, properly sealed and has been serviced within required service intervals. The outlet piping is sized correctly and discharges to a safe location. No service tag present from PSV install. Mfg date of PSV 01/01/2017.

DESCRIPTION	PSV

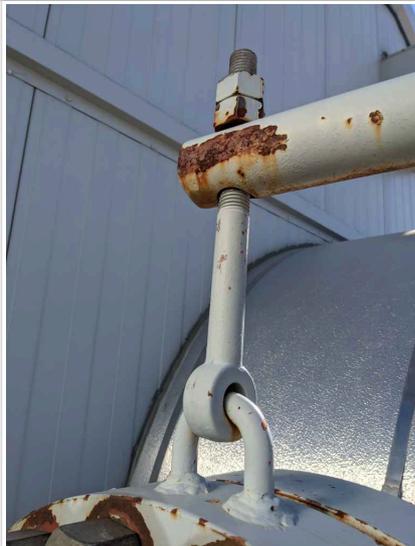
DESCRIPTION	Double nutting on manway

Other condition comments	Manway davit arm is ported for grease nipple but none installed. Recommend installing grease nipple and lubricating rotation mechanism. Eye bolt is double nutted.
--------------------------	--

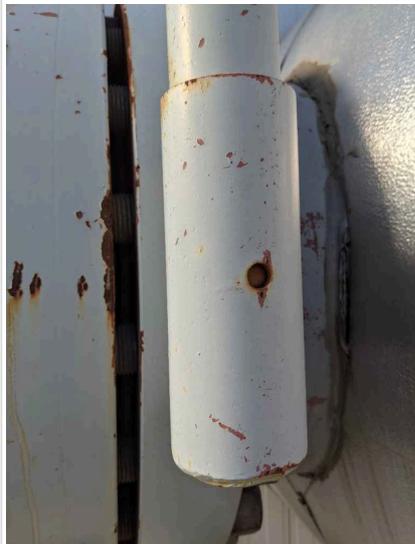
DESCRIPTION	Davit arm rotating mechanism - no grease nipple installed

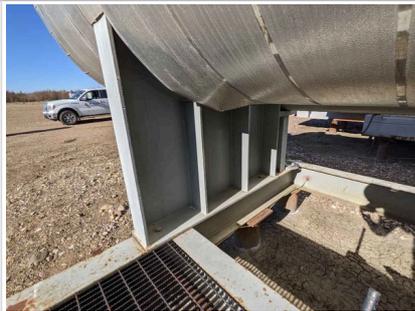
Skirt / saddle condition	Good
Skirt saddle selector	Saddle is structurally sound, attached to sub structure. Saddle to equipment welds appear sound, no leaks or other defects noted.
Skirt saddle condition comments	Saddle is structurally sound, attached to sub structure. Saddle to equipment welds appear sound, no leaks or other defects noted. Attachment of saddle to vessel outside of building could not be assessed due to cladding. Vessel is grounded through skid and associated piping.

DESCRIPTION	Vessel support

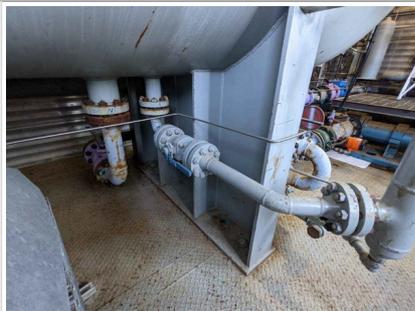
Nozzles condition	Fair
Nozzle selector	-
Nozzles condition comments	Some degradation of coating noted with minor external corrosion visible on nuts and studs. Recommend refreshing coating to prevent further degradation.

DESCRIPTION	Minor surface corrosion on nozzle studs/nuts

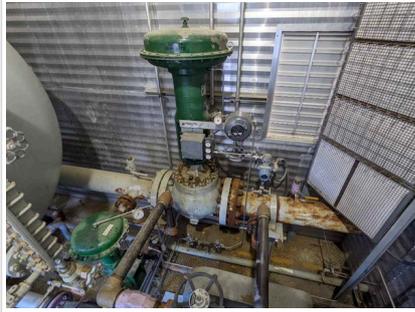
External piping condition	Fair
External piping selector	Painted piping is well supported with no significant deflection or pipe strain noted. Coating has begun to fail resulting in minor surface corrosion. External coating should be refreshed to prevent further degradation.
External piping condition comments	Painted piping is well supported with no significant deflection or pipe strain noted. Coating has begun to fail resulting in minor surface corrosion. External coating should be refreshed to prevent further degradation.

DESCRIPTION	Piping with minor surface degradation
