Field Inspection Report - Long_Run 640530_04/11/2017_VTI_External

Vessel Number	640530	Vessel Name	TREATER	Province	Alberta
District	CENTRAL - AB	LSD	02-12-058-23W4	Location	REDWATER NORTH
Method	VTI	Access	External	Cleaning	
Inspection Date (mm/dd/yyyy)	04/11/2017	Inspection Interval (months)	48	Next Inspection (mm/dd/yyyy)	04/11/2021
CRN	W3705.213	Skid Number	PKG74808	Service	Sweet
Internal Access	Yes	Internal Coating	No	Status	In Service
MAWP (PSI)	75	MAWP (kPa)	517.11	Outstanding NCRs	0
MAWT (°C)	148.89	MAWT (°F)	300

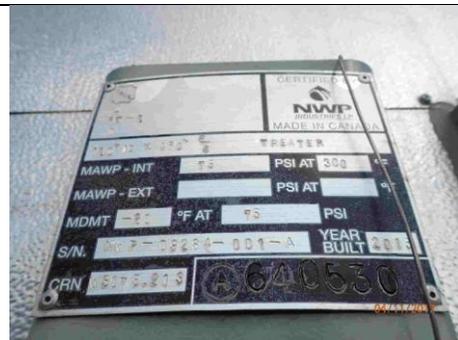
LRE - 640530 - NAMEPLATE 4-2017.jpg

Treater package was installed at the new Redwater location
The Treater is registered in Alberta with the appropriate design CRN, and A# stamping. The nameplate is intact and legible attached to the shell west of the doorway.
External coating is in good condition with no dis-bonding or deterioration. External clad insulation is in as new condition with no damage noted. Treater is adequately supported and grounded through skid / piles, external copper wire. Burner assembly is installed and operational. Anodes are grounded externally to skid.
PSV protection is new, factory serviced and installed in 2017. PSV has correct set pressure, Alberta CRN, and no block valves to restrict relieving capability. The PSV pops to a tank which is open to atmosphere. The PSV info was obtained from the Long Run installation records as it was not accessible at the time of inspection. PSV tags are hanging on the nameplate for installation at next available opportunity.

Attach PSV tags at next opportunity.
Internally inspect in 48 months.
